**Project Number 26725.000.001**

**Preliminary Environmental Site  
Investigation**

*638 Cambridge Road, Te Awamutu, Waikato*

*Mitre 10 Holdings Limited*

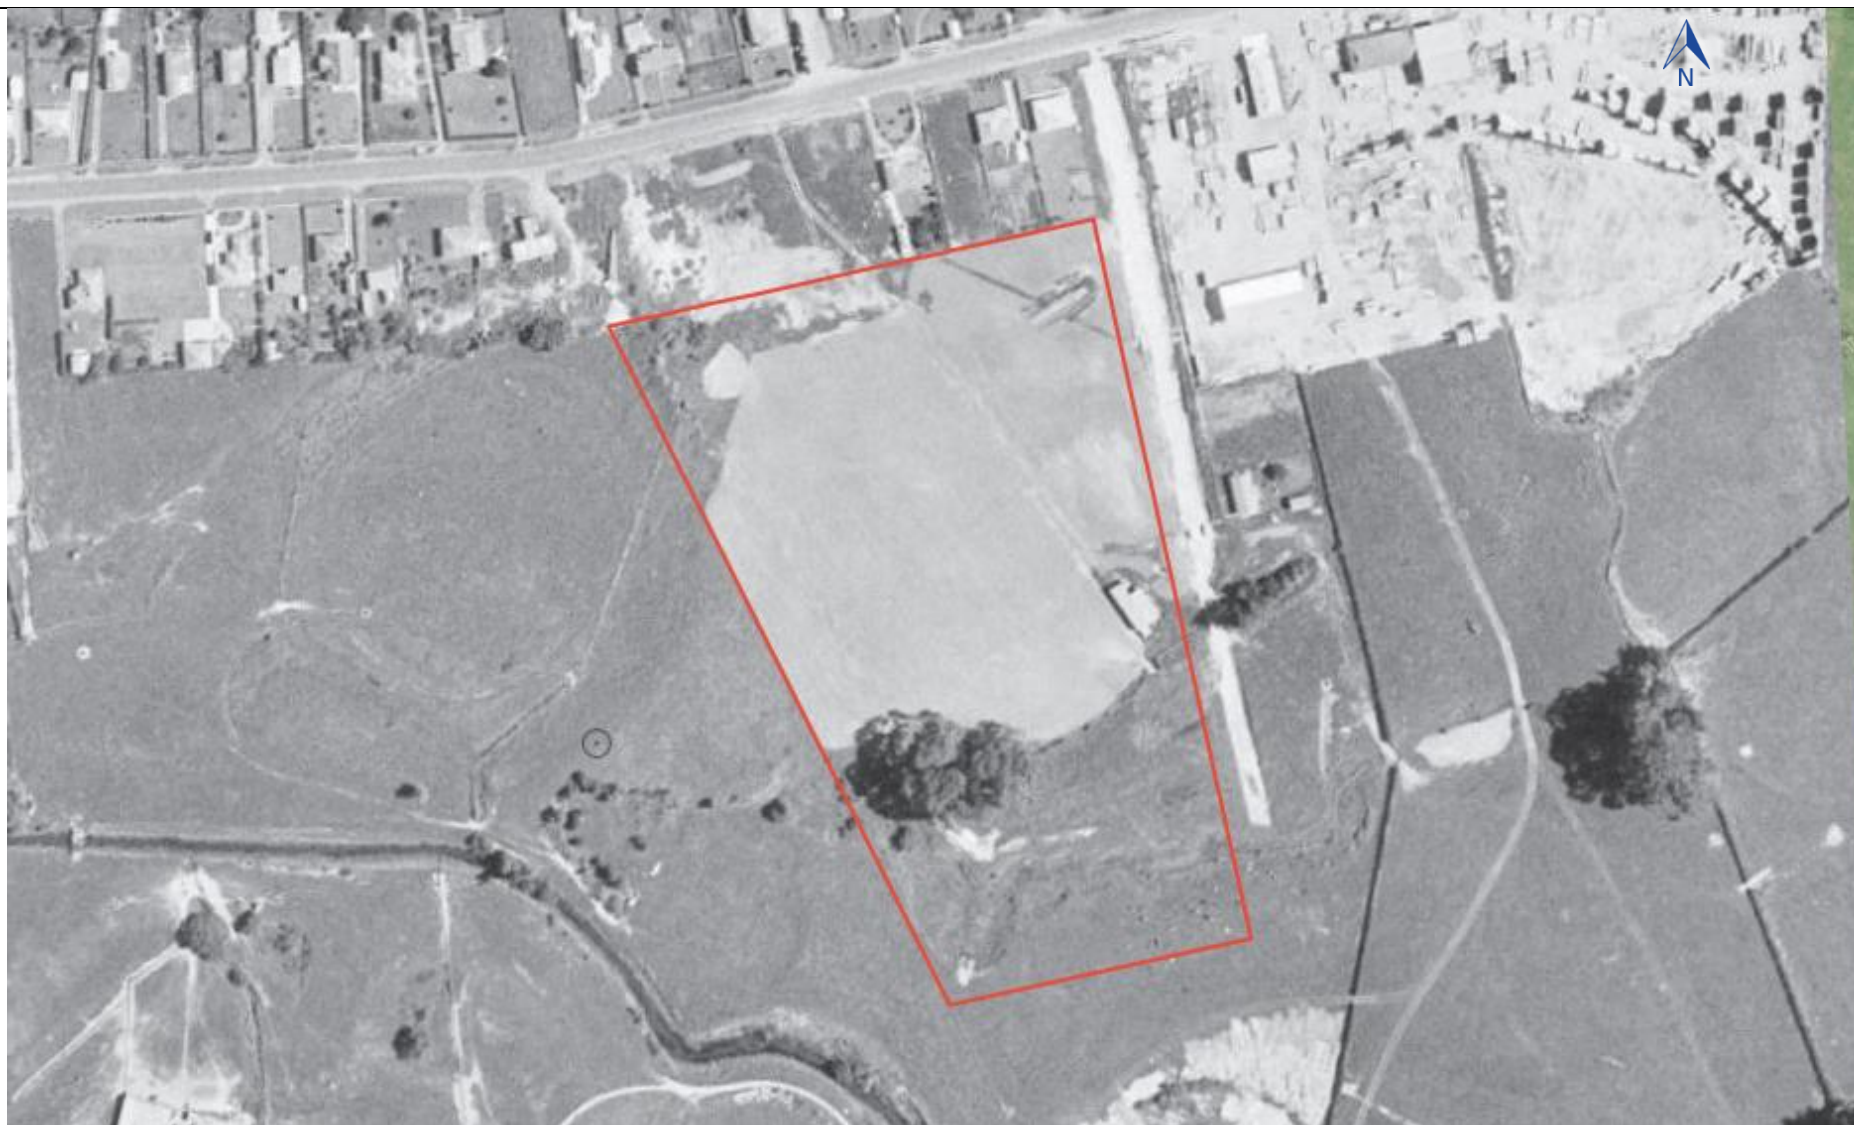
1966 (Retrolens New Zealand). Indicative property boundaries drawn by ENGEO.

| Date | Description |
|---|---|
| 1966 - 1967 | <p>Imported fill can be observed along the northern boundary of the site in the 1966 aerial image as well as the northern two thirds of the site appears to have been applied with a thin layer of topsoil.</p> <p>In the 1967 image, an area of recently placed fill can be observed in the north-western corner of the site.</p> <p>A commercial yard (possibly timber processing) off-site to the northeast first observed in the 1957 aerial image has expanded and is adjacent to road formed along the eastern boundary.</p> |

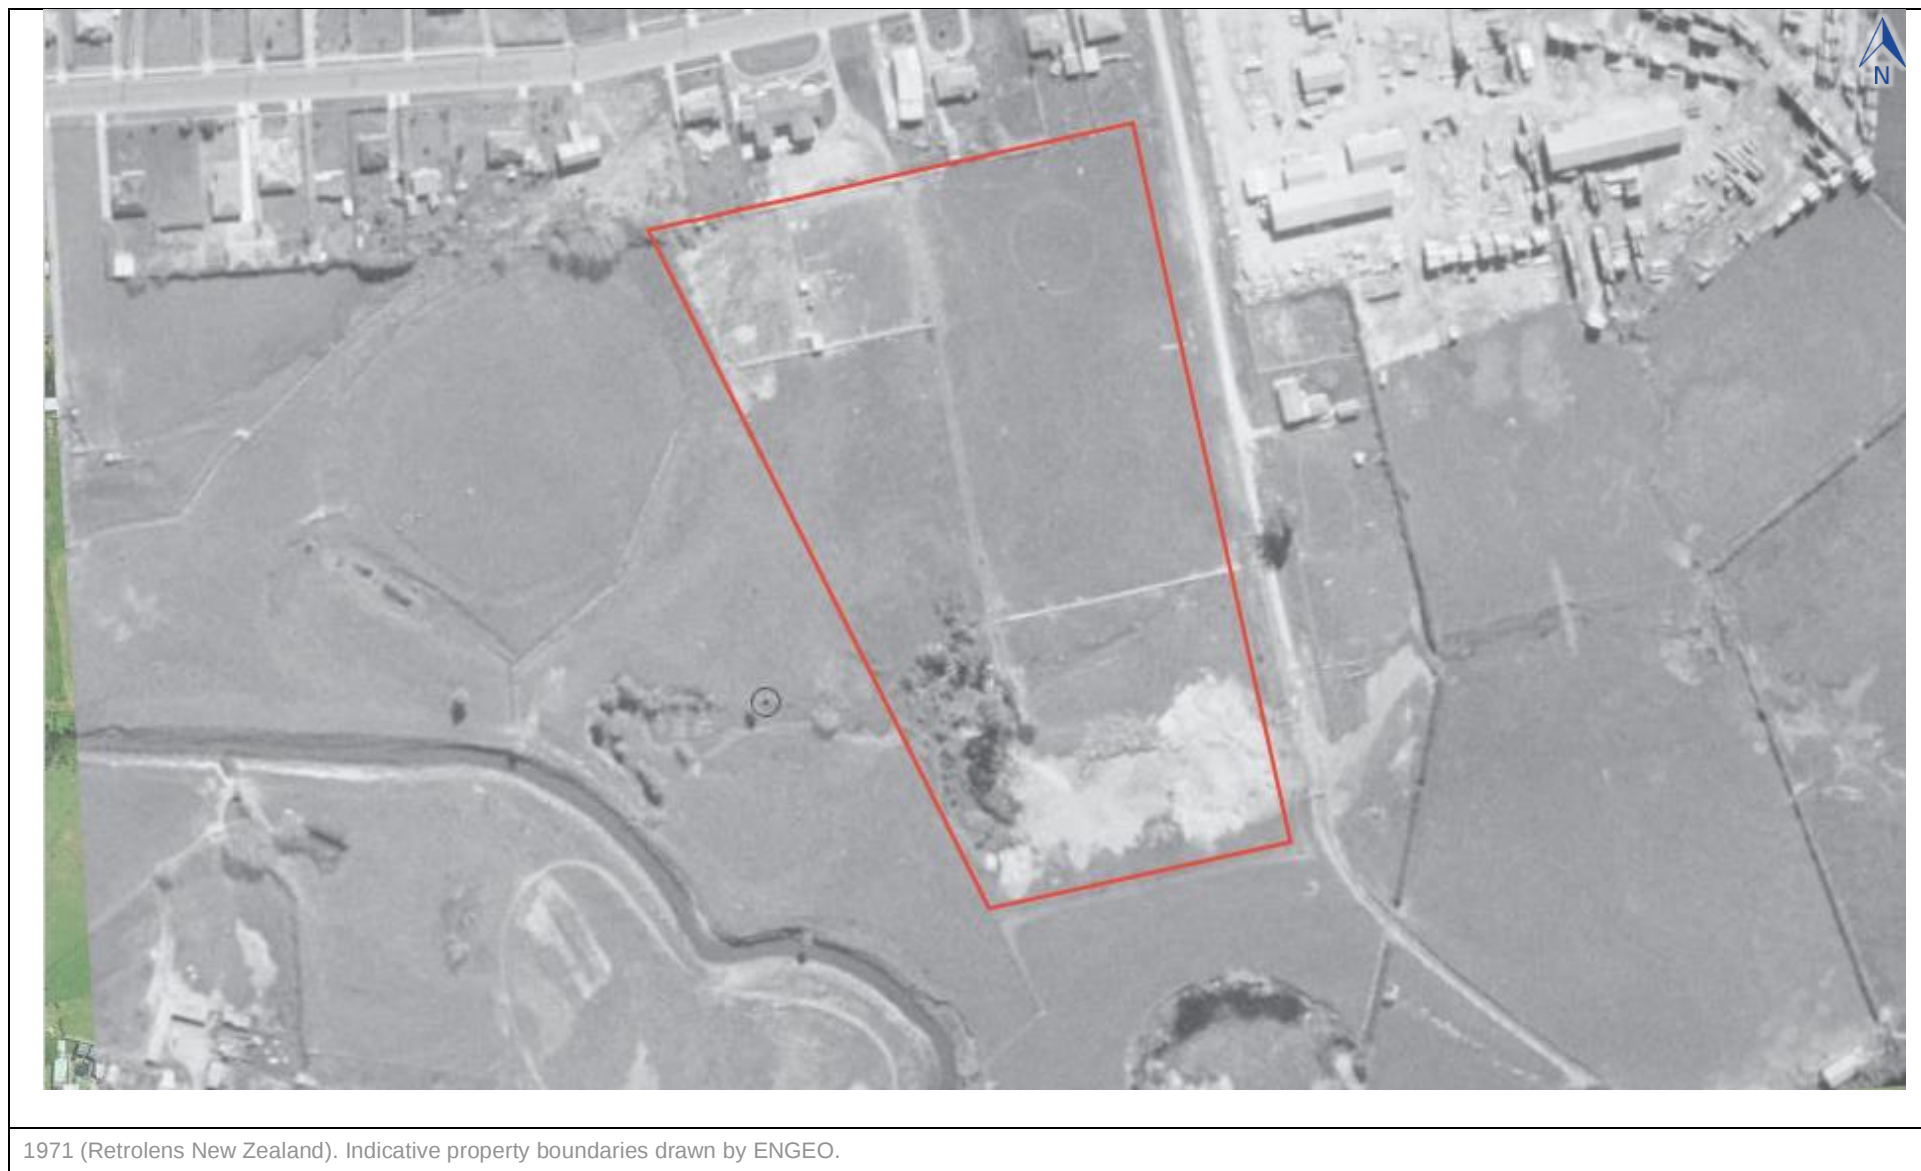
1971 (Retrolens New Zealand). Indicative property boundaries drawn by ENGEO.

| Date | Description |
|---|---|
| 1971 - 1974 | <p>In the 1971 image, the former stream channel in the south of the site has been filled with imported material. Small buildings have been constructed in the north-western area of site.</p> <p>Likewise, in 1974, ongoing filling has been undertaken in the former stream channel in the south of the site.</p> |

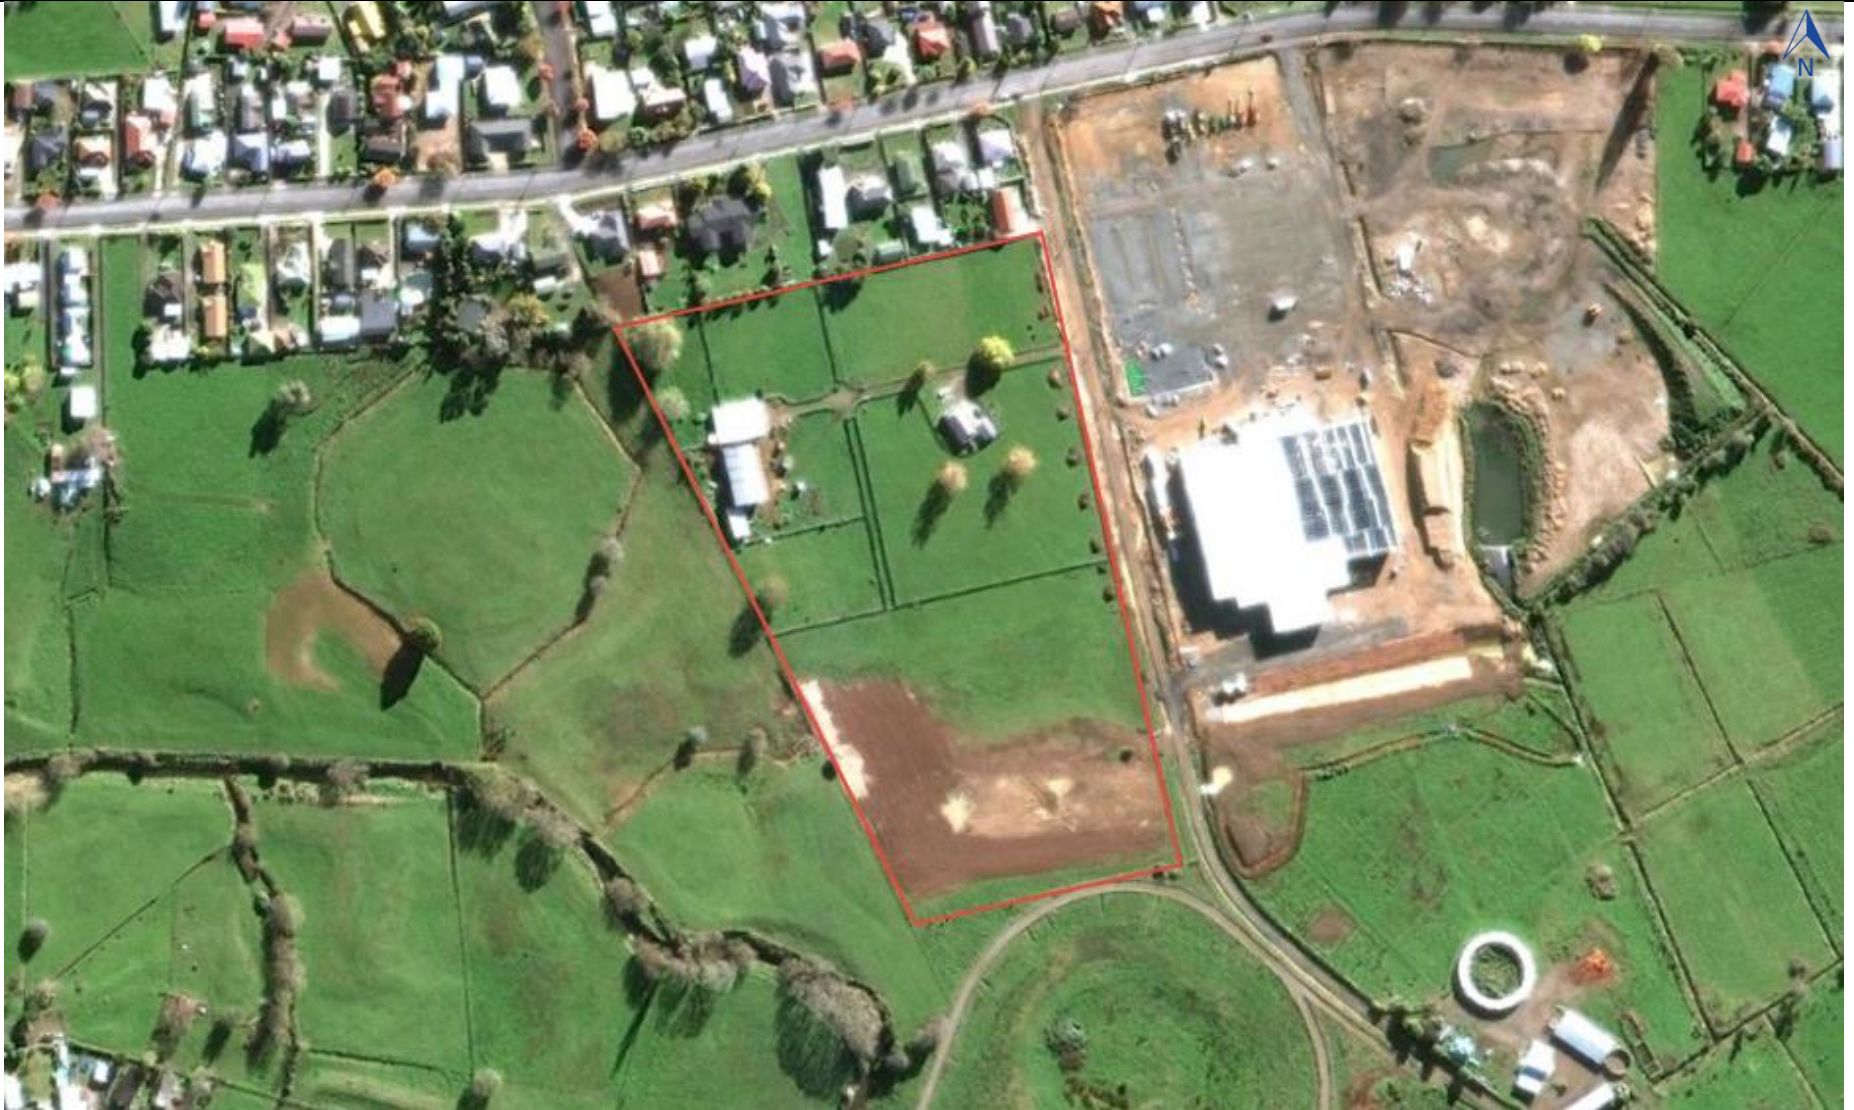
2010 (Google Earth Pro). Indicative property boundaries drawn by ENGEO.

| Date | Description |
|---|---|
| 2010 | <p>An aerial image from 2010 shows shallow earthworks and standing surface water in the southern third of the site.</p> |

| Date | Description |
|---|---|
| November 2009 | A suitability assessment for the installation of a septic tank system against a barn in the central north-western area of site (visible in the 2010 historical aerial in Appendix 1) includes a basic log of soils encountered in two shallow boreholes where the septic tank was to be installed. Material encountered did not indicate the presence of fill or staining, although the purpose of these boreholes was for septic tank design rather than an assessment for contaminants and was not logged in accordance with standard field descriptions NZGS (2004). |
