**Preliminary Site Investigation (PSI) –  
Hamilton Airport Northern Precinct**

For Titanium Park Limited

July 2020

<b>Document Name</b>	R_AA6977_TP_Northern Precinct PSI_v1.0 (July 2020)	
<b>Version History:</b>	1.0	July 2020

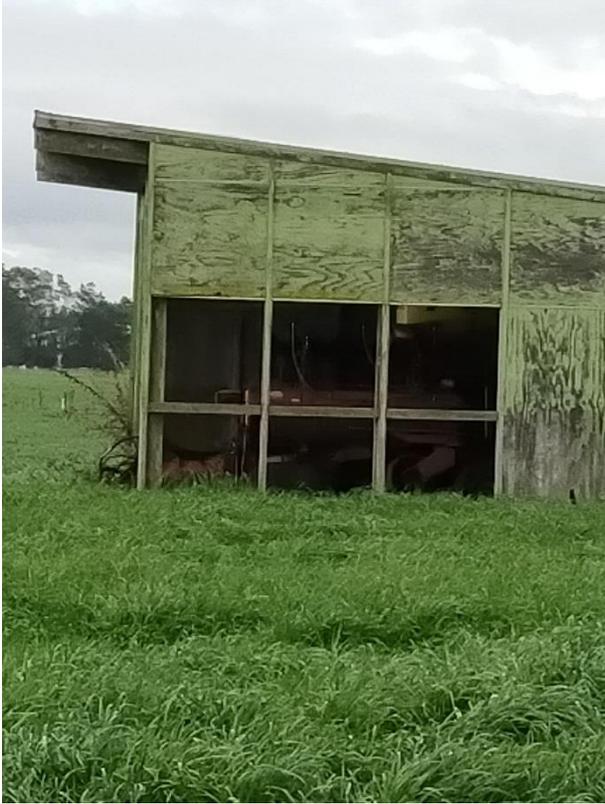
Photo 1: Wooden shed (feature 1)

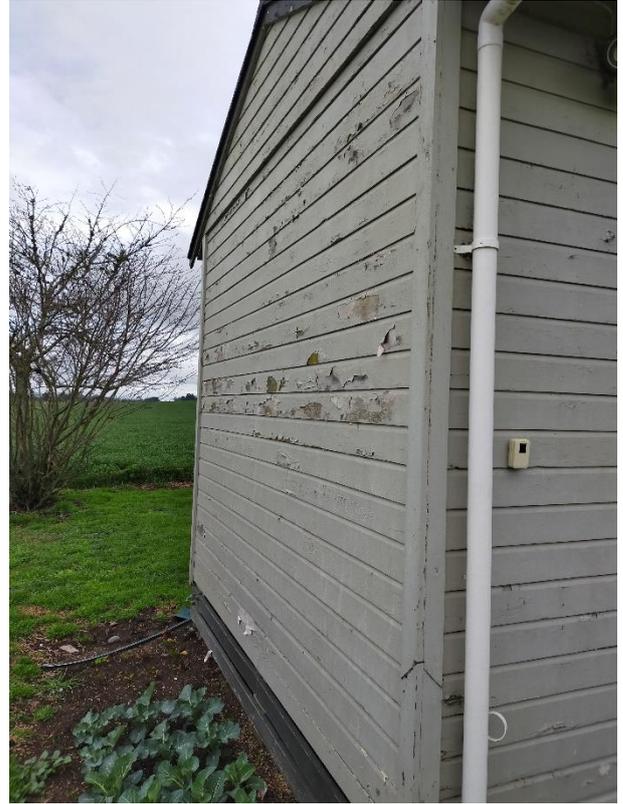
- The neighbouring Bruntwood Nurseries is present directly west of this feature;
- The eastern arm of the track leads to a cottage (feature 2) constructed of wooden weather boards, the soffits within the patio awning addition are likely fibre cement with the potential to be asbestos containing material (ACM), these are in good condition. The paint on the outside of the cottage is flaking and in a deteriorated condition. Directly northeast of the cottage is a supply shed constructed of wood with a corrugated roof containing general household items and a lawnmower;

Photo 2: Cottage (feature 2), with paint in deteriorated condition

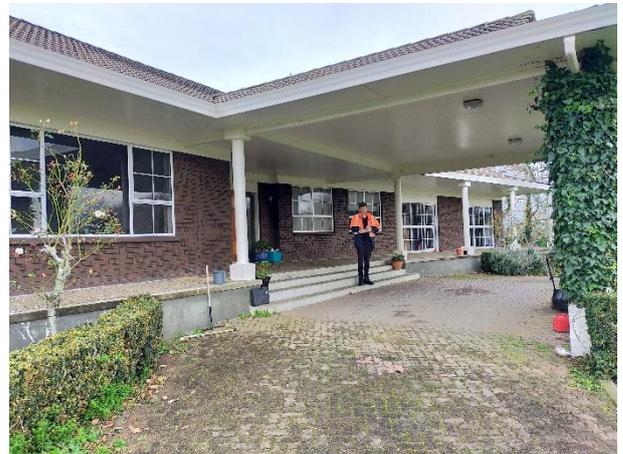
- The south eastern arm of the track leads to a dwelling (feature 3) surrounded by a grassed lawn and trees. The dwelling is constructed of bricks with a breezeblock base and a concrete tile roof. The soffits and under the entry awning are likely fibre cement with the potential to be asbestos containing material (ACM), these are in good condition. A concrete tennis court is located east of the dwelling, with a pool, and a wood storage shed constructed of metal to the south;

Photo 4: Dwelling (feature 3)

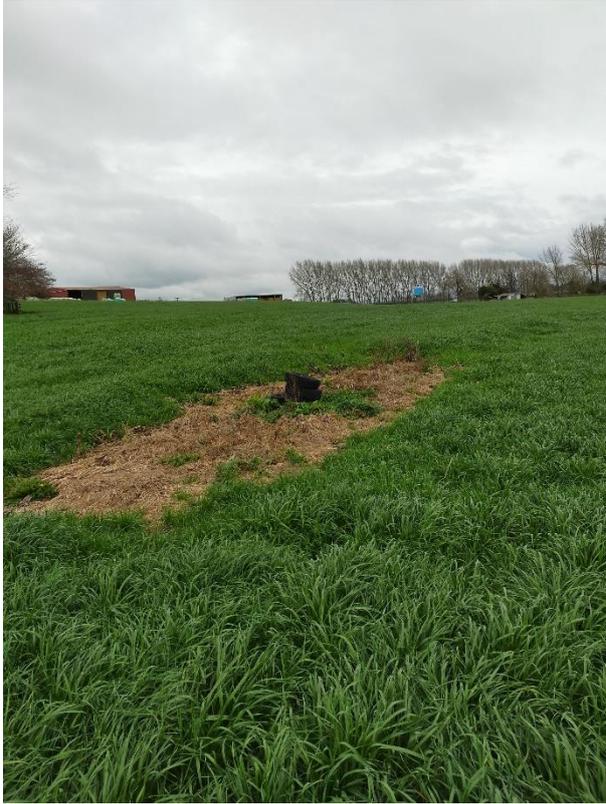
- Northeast of the dwelling, a bare patch in the grass was observed, that consisted of approximately 4 tyres and some buried concrete;
- No evidence was found regarding the horticultural (orchard) area and potential location of pens as identified in the historic aerials;

Photo 5: Farm dump/burial pit location and strained grass growth northeast of dwelling

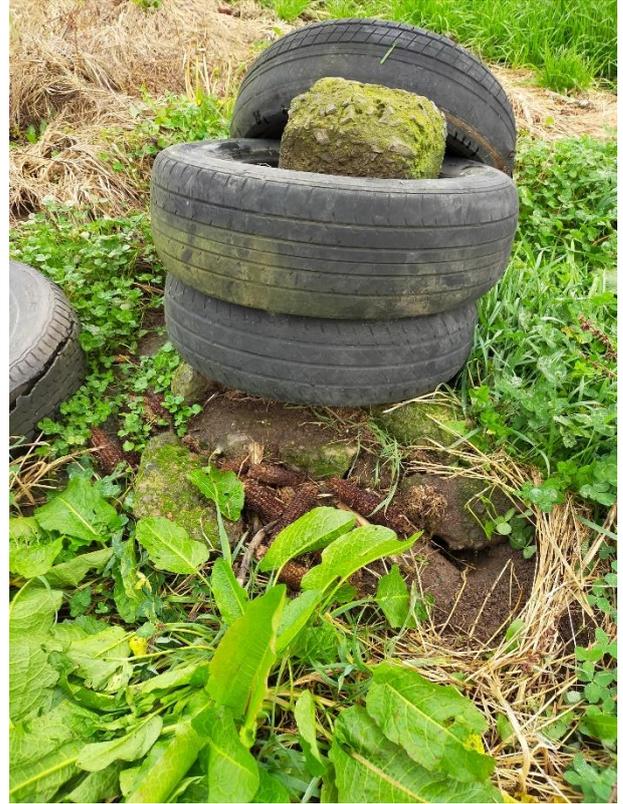
Photo 6: Buried concrete and tyres northeast of dwelling

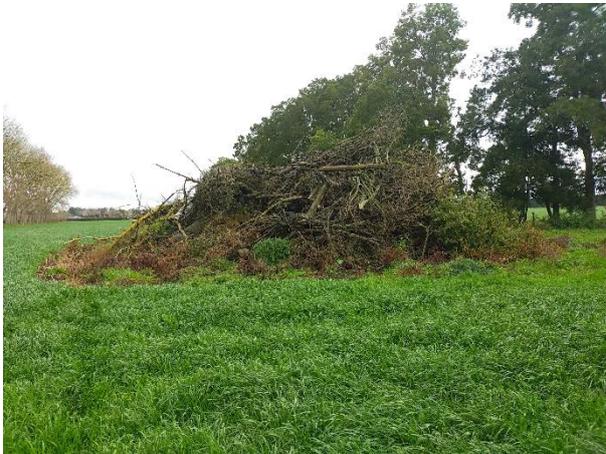
- A pile (feature 4) of greenwaste was observed in a paddock along the south western arm of the track. The pile also contained standard materials commonly observed on farms which include plastic and metal pipes, a recycling bin, a pallet, tree stumps, tyres and a barrel which formerly contained sodium hydroxide;

Photo 7: Pile of Greenwaste (feature 4)

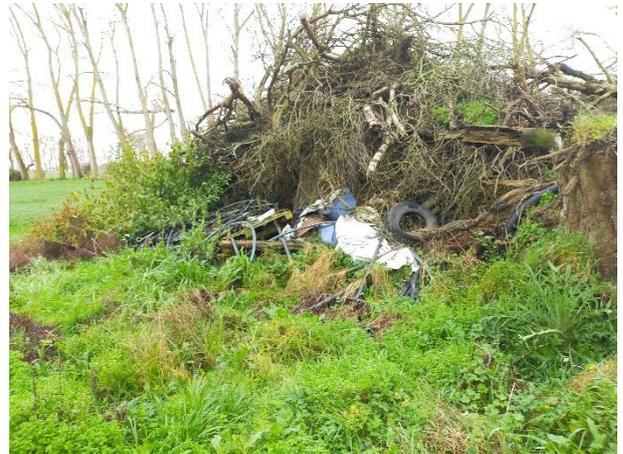
Photo 8: Materials in pile

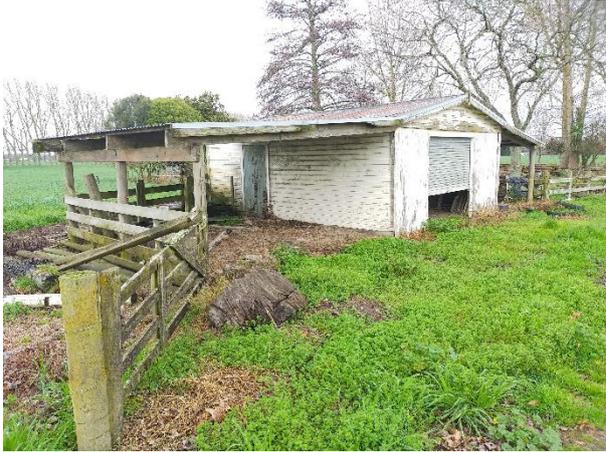
- Further along the south western arm of the track, the garage associated with a former dwelling was identified (feature 5). This has a tin roof with a wooden exterior with deteriorated paint, and contained a pallet, some windows (likely from the removed dwelling) and some minor plastic materials. No potential ACM was identified on this structure;

Photo 9: Garage (feature 5)

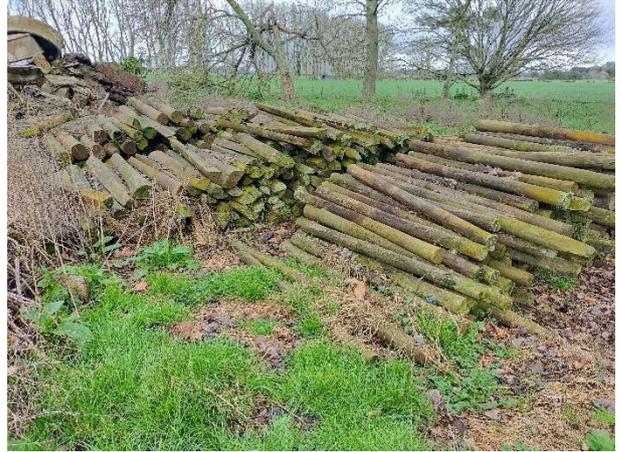
Photo 10: Fence post storage west of garage

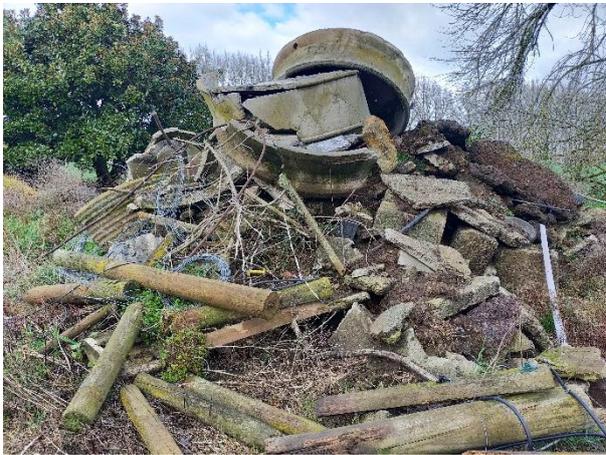
Photo 11: Rubbish pile south of fence posts

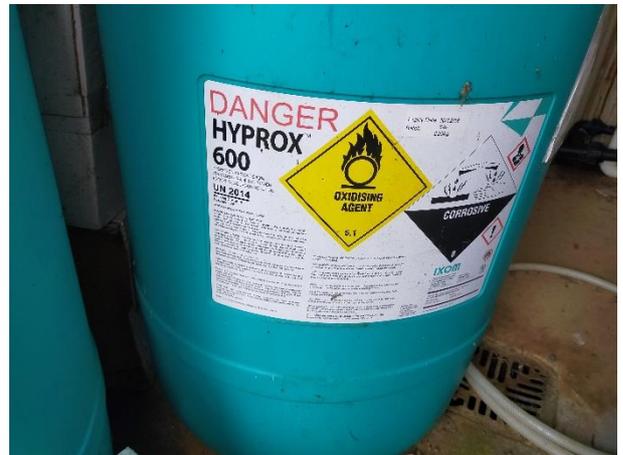
- There are multiple small sheds and structures directly south of the milking shed which include: a metal pump shed, a metal shed with a water conditioning system, a shed containing a barrel of hydrogen peroxide (assumed to be for water treatment) with a concrete floor in good condition, as well as three concrete water tanks;

Photo 18: Hydrogen peroxide barrel on concrete ground in southern most green shed, behind milking shed

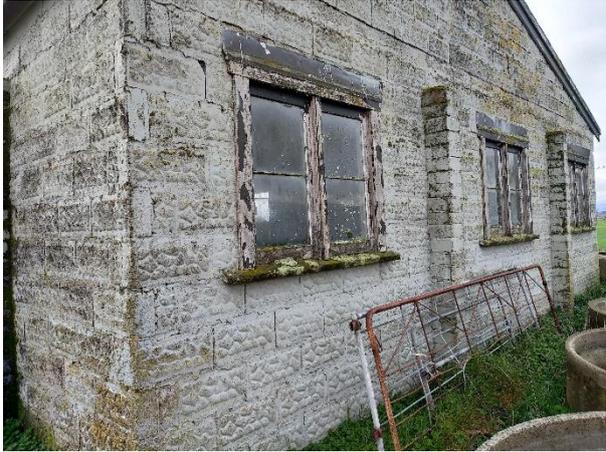
- Further northeast is an empty workshop (feature 8) constructed of stone blocks, with wood skirtings and a corrugate roof, with a solid concrete floor in good condition. Paint on the exterior of the building appears to be weathered/deteriorated. A number of water troughs are stored to the west;

Photo 23: Workshop (feature 8) with paint in deteriorated condition

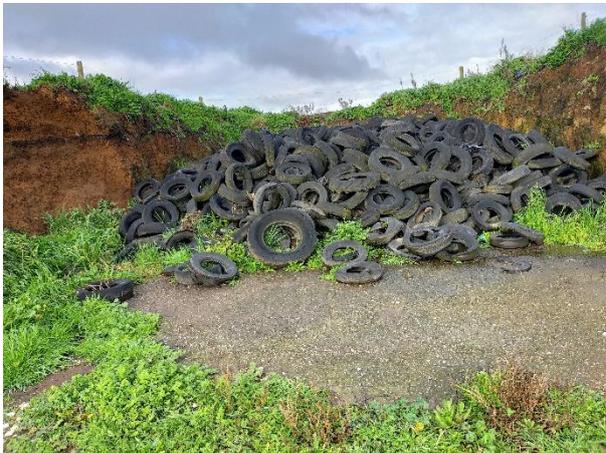
Photo 25: Silage storage pit (feature 9) showing tyre storage

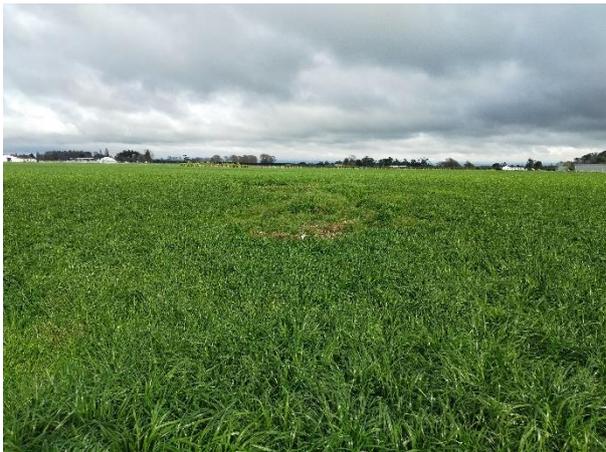
Photo 27: Farm dump/burial pit location in the south of the Site (feature 11)

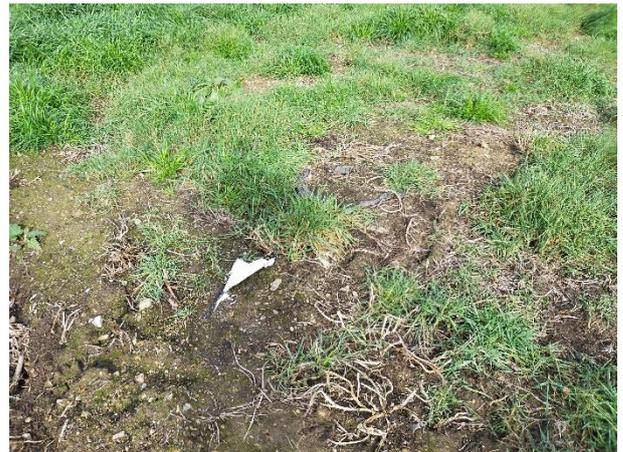
Photo 28: Plastic in the farm dump/burial pit

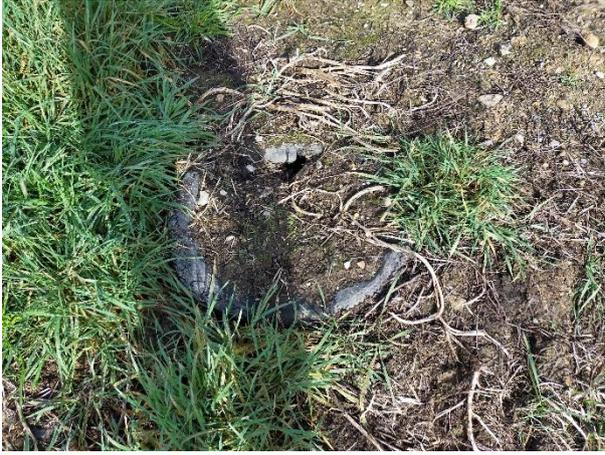
Photo 29: Buried tyre

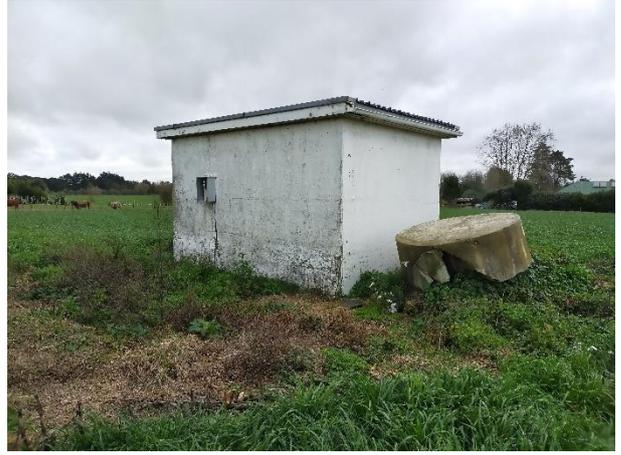
- Near the western boundary in the southern section of the Site is a concrete shed (feature 11) that contains approximately 20 tyres. The power board on the outside of the shed contains potential ACM, the board was in good condition; and

Photo 30: Concrete shed (feature 11)
