**401  
RACECOURSE  
ROAD,  
TE AWAMUTU**

**PRELIMINARY  
GEOTECHNICAL  
REPORT**

PROJECT NO: HD2090  
GLOBAL CONTRACTING  
SOLUTIONS LTD  
REFERENCE: PGR REV 3  
30 NOVEMBER 2021

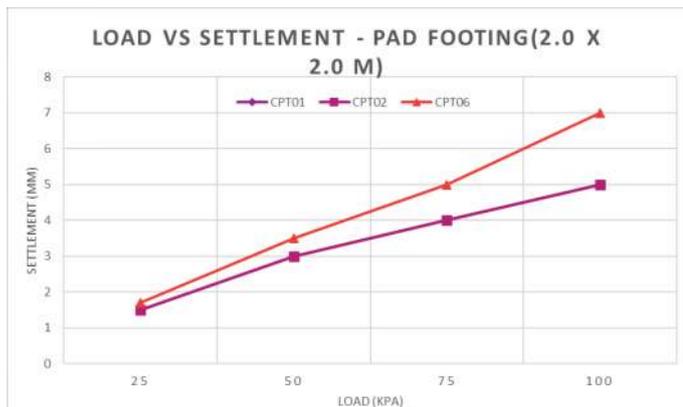
Figure 1: Settlement vs load for a small pad type foundation.

Pad footings are typically affecting only the upper soils, which are generally more sandy. That means that pad footings are relatively stiff and settlement is low for loads up to 100 kPa. For wider spread loads, deeper, softer soils are affected and settlement is much higher. Widespread loads could be from earthworks (filling) or from widespread dead or live loads. The results of our assessment are shown in Figure 1 and Figure 2.

The results indicate there is a high risk of static settlement for large and widespread loads from both foundations and the placement of bulk fill. Settlement is occurring in the clay and silt layers at depth with settlement expected to extend to 18 m below the ground level below 'area 1' and 12 to 13 m below 'area 2'.

The actual amount of settlement and depth of influence will be governed by the loaded dimensions and by the load. A detailed settlement assessment will be needed during the detailed design stage of the project. To refine the settlement assessment, we recommend further geotechnical investigation to obtain samples of the susceptible soils for laboratory testing.

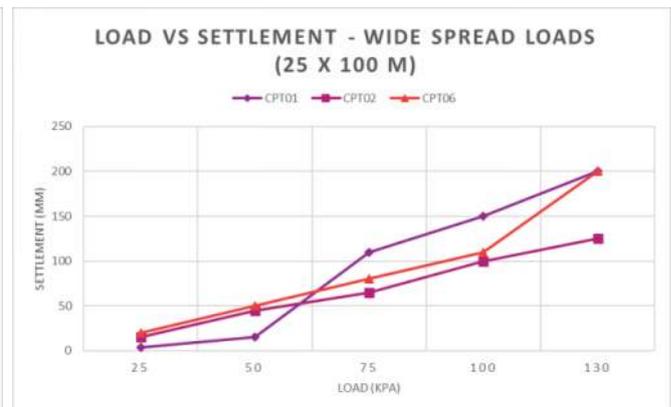
Figure 2: Settlement vs load for a wide-spread load.

The preliminary civil plans<sup>12</sup> for the development indicate that earth fill from <1 m up to 6 m will be required to create the levels for construction. This is equivalent to about 20 kPa up to 120 kPa which could cause widespread and large settlements over the site (as indicated above).

for an accurate assessment, we recommend a detailed settlement assessment. This will include additional subsurface testing including CPTs and boreholes, in situ samples of the compressible material, lab testing and quantitative assessment. The results of this additional assessment will provide better guidance on the expected settlement and timeframes.
