Archaeological assessment of effects

Proposed development: Titanium Park

Hamilton Airport

April 2021

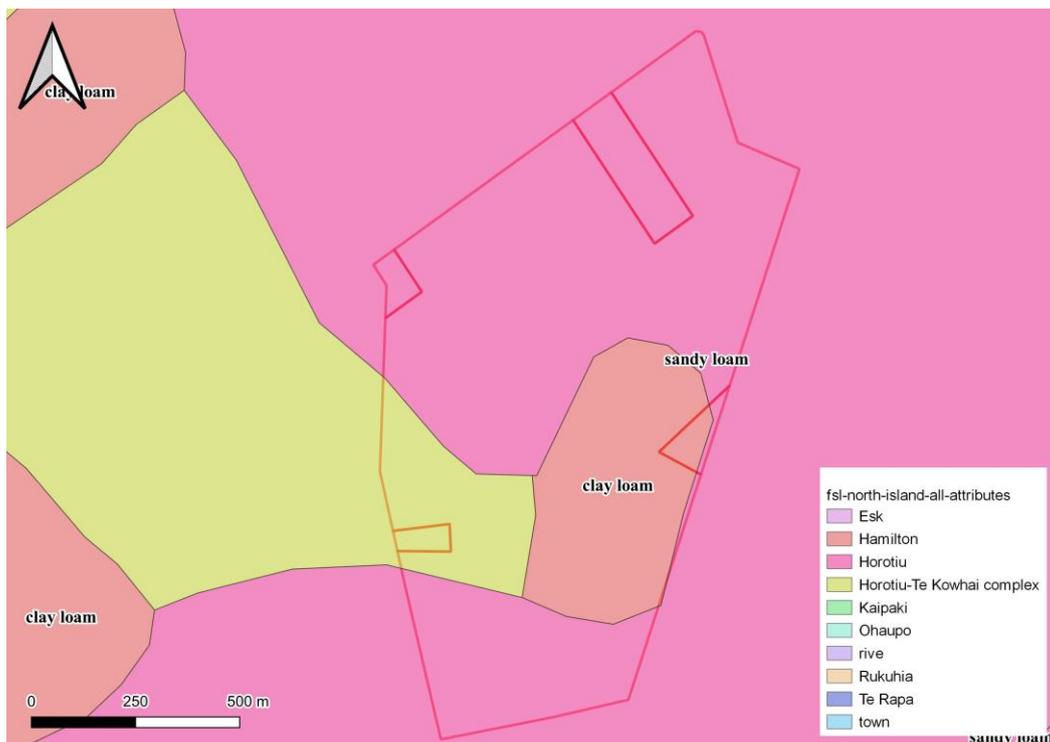
The area affected by the proposed development is mainly low lying flat land that surrounds two hillocks. These hillocks are dominant features within the landscape. Soils within the development are a mixture of Horotiu silt loam, Te Kowhai silt loam and Horotiu sandy loam on the lower lying areas and Hamilton clay loam on the hills (Figure 3).

Figure 3. Soil map of the development area.

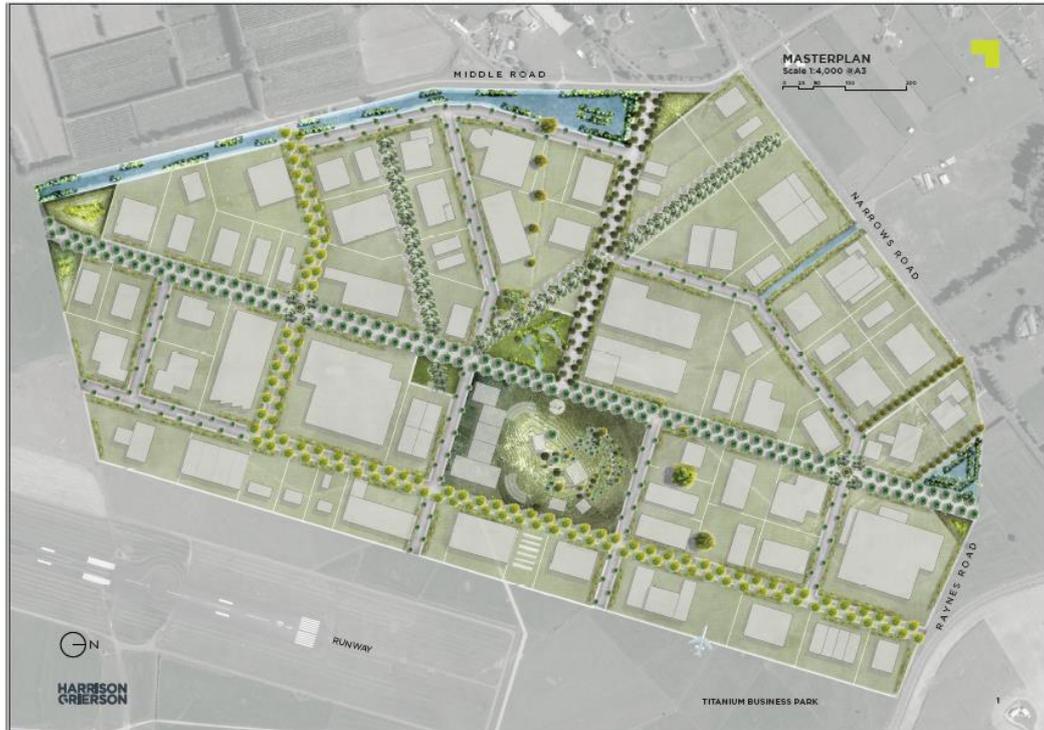
Based on communications with Robert Dol from the Greenstone Group and Dion Merson from Hamilton Airport the proposed works will modify the entire proposed area of works. The larger of the two hills will be entirely removed the smaller hill will be landscaped/modified, flat areas will also be developed according to the plans below (Figures 4-5).

Figure 4. Overview of Titanium Park (Source: Harrison Grierson).

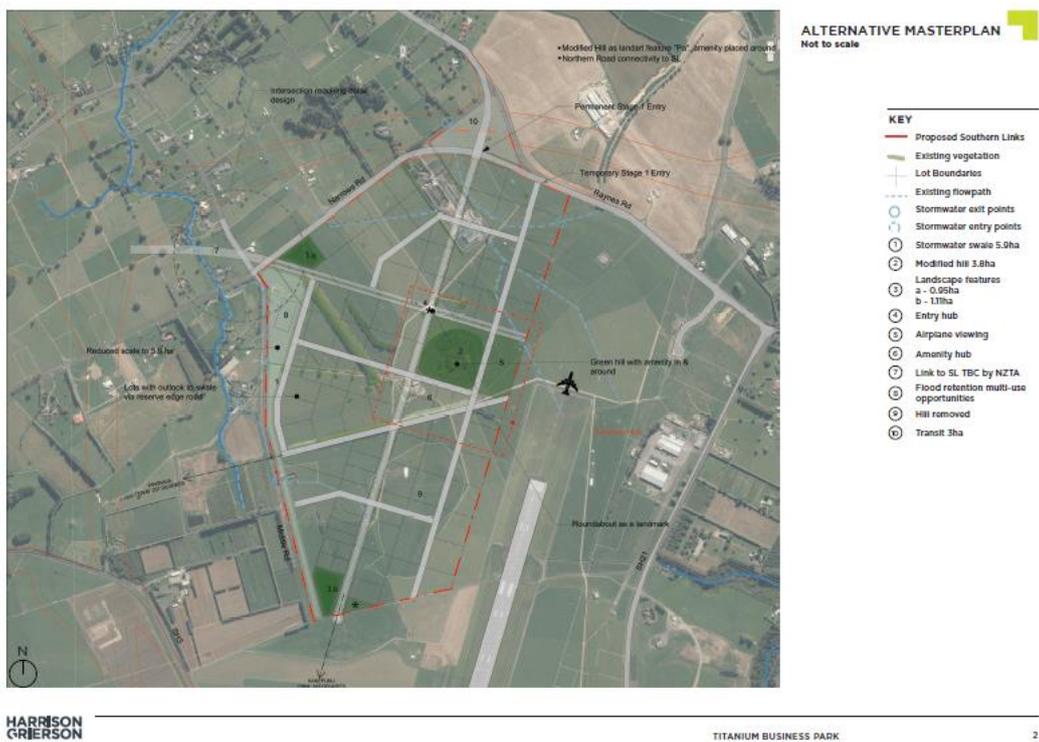
Figure 5. Titanium Park key (Source: Harrison Grierson).

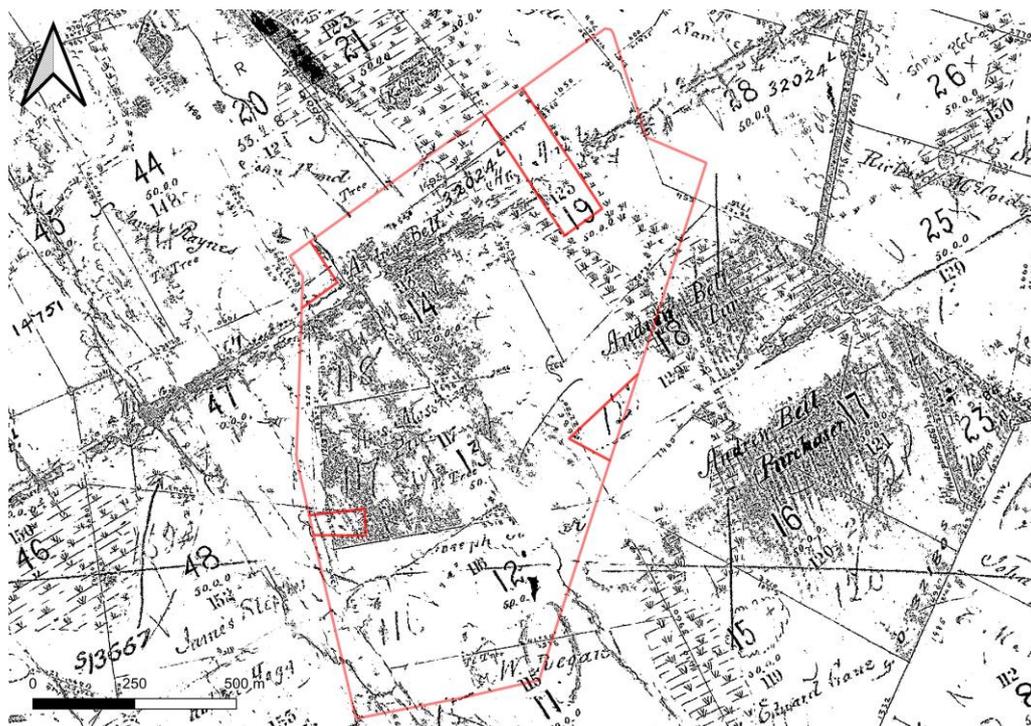
Figure 7. Survey plan from 1885 depicting land parcels and ownership (HN_SO_1385_C_1_1) (Source: Quickmap).

The area within lots 12 and 13 is labelled Ti Tree whilst lots 18 and 19 have a significant amount of swamp land; this land has subsequently been cleared and drained and now is either part of the airport or used for pastoral grazing and maize production.

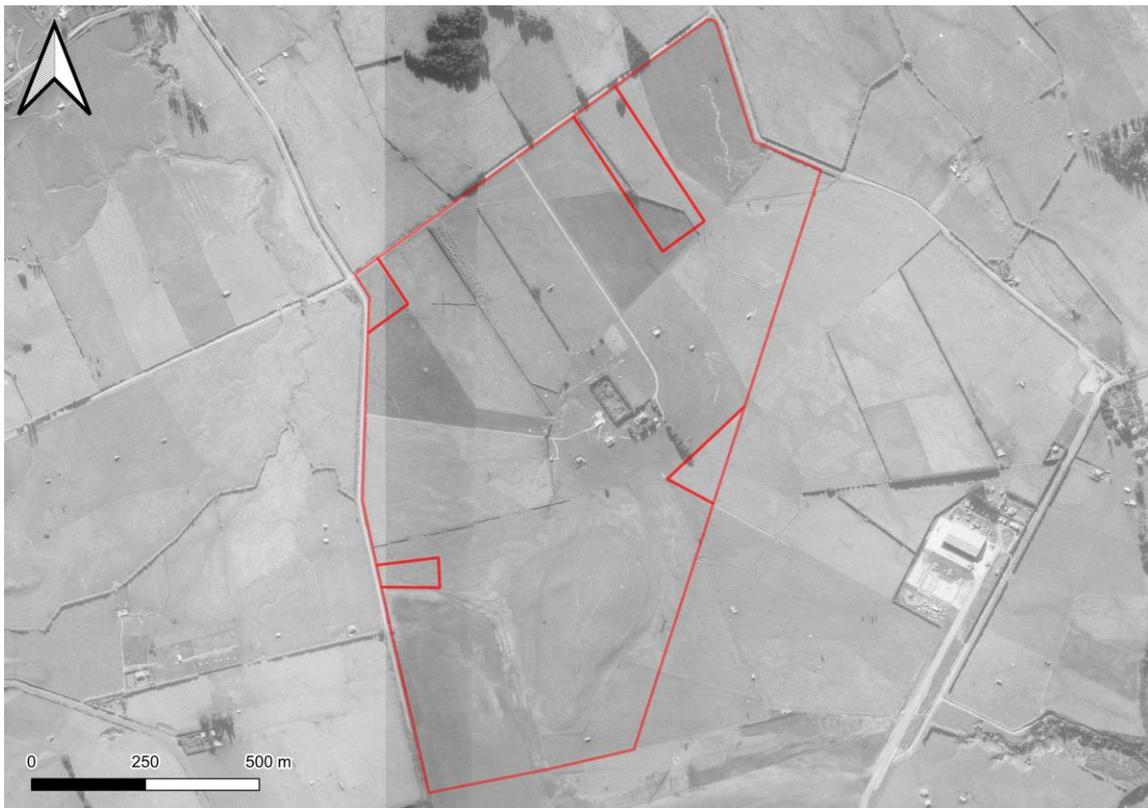
Aerial photographs below were sourced from Retrolens and depict the landscape surrounding Archaeological background. It is apparent in the 1940s aerials (below) that the land is likely in use for pastoral grazing. The smaller hillock is built upon but the rest of the area is free from structures. The larger hill seems to be in a natural state and does not appear to be flat although it is difficult to see in the imagery (Figure 7).

Figure 8. Excerpt from aerial photographs from 1943 series (SN1943_833-48 & 50) (Source: Retrolens).

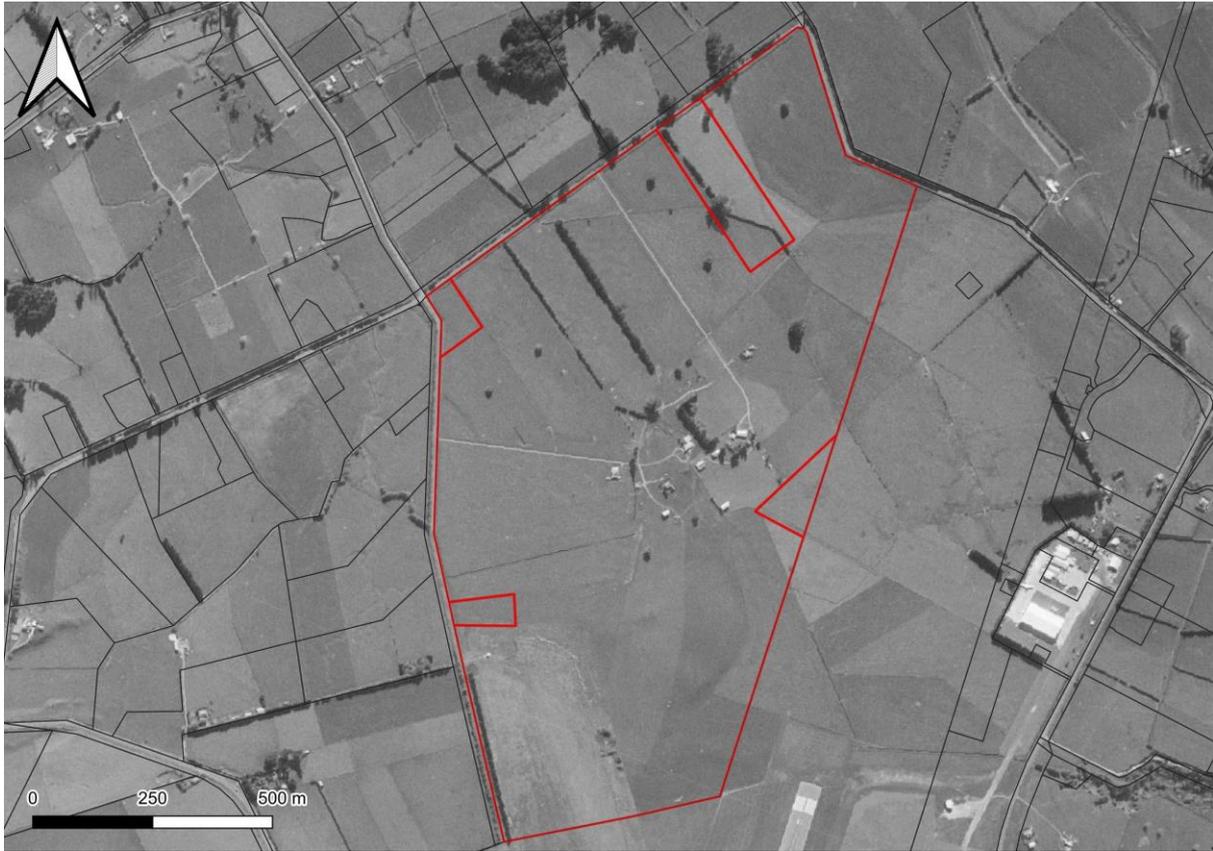
As shown in the 1967 aerial imagery (below) nothing much has changed within the proposed area since the 1940s. The major change is that the airport has been established south east of the area but the runway does not extend up parallel it yet. The land use appears to be consistent with earlier imagery.

Modern aerial imagery is relatively consistent with the historic imagery. There has however been some modification to the larger hill but this is difficult to determine when this was undertaken. It is likely that it has occurred within the last two decades.

Figure 9. Excerpt from aerial an aerial photograph from the 1967 series (SN1889_5057-12) (Source: Retrolens).

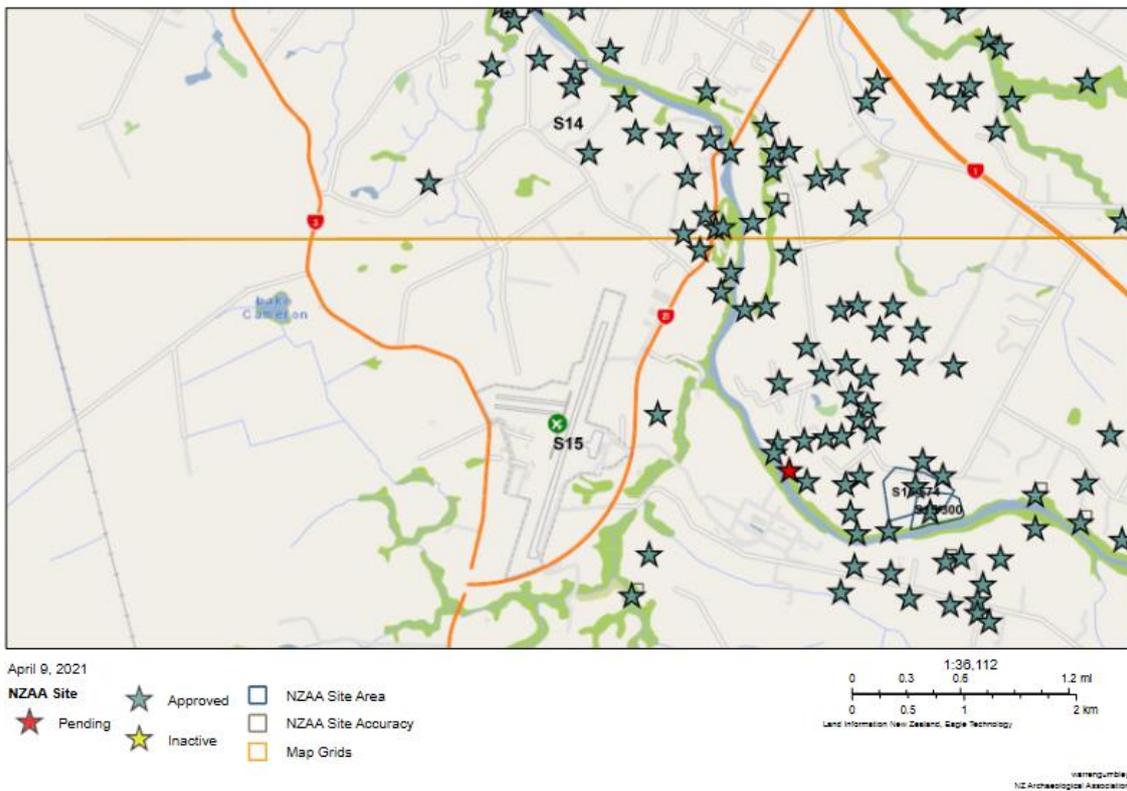
Figure 10. Excerpt from Archsite showing archaeological sites in proximity to area of works (Source: Archsite).

As seen in the above excerpt from Archsite there are no recorded archaeological sites within two kilometres of the proposed development area.

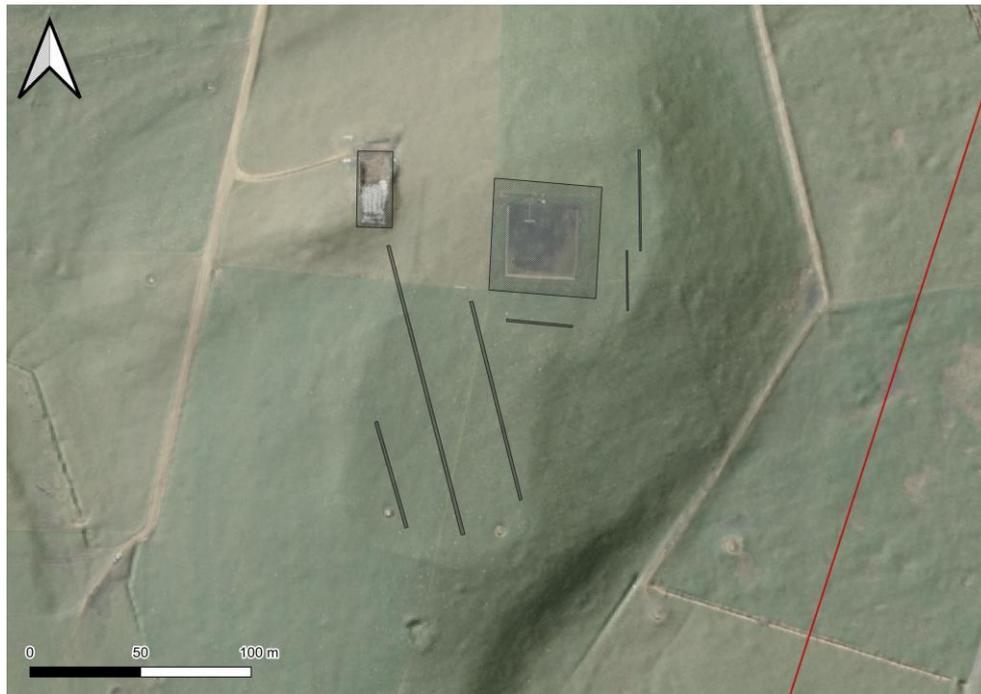
To determine the likelihood of archaeology on the two hills test trenches were excavated with a 3-tonne excavator. These were excavated on the flattened top of the larger hill around the recently established effluent pond and on a small unbuilt flat area on the smaller hill. A total of seven trenches were excavated: six on the larger and one on the smaller.

Figure 11. Test trenches on the larger hill (Source: LINZ).

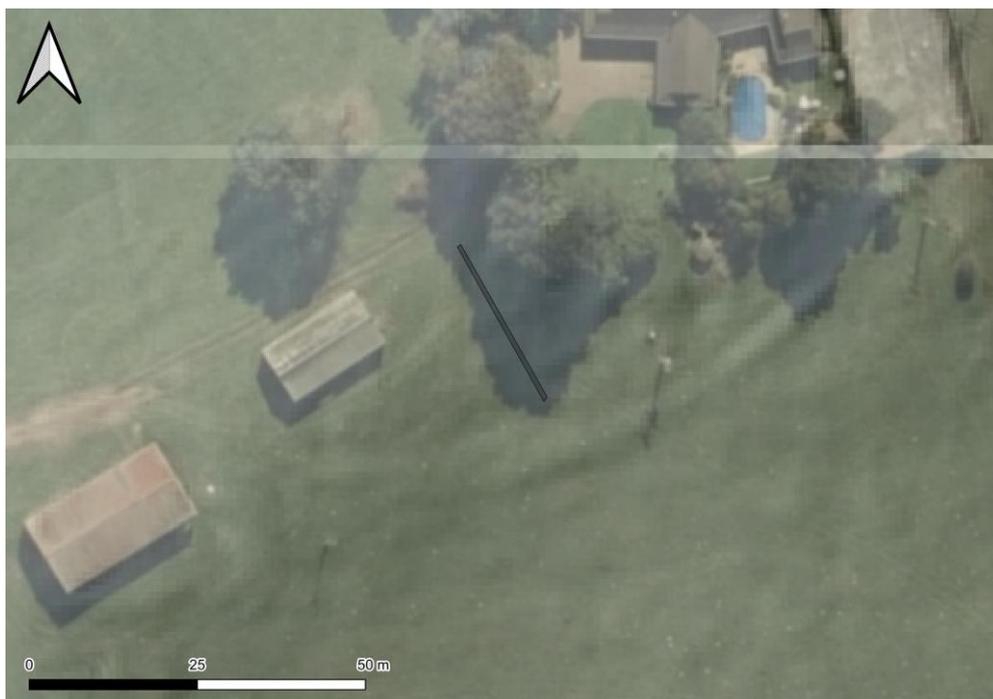
Figure 12. Test trench on the only open area on the smaller hill. This hill has been largely modified (Source: LINZ).

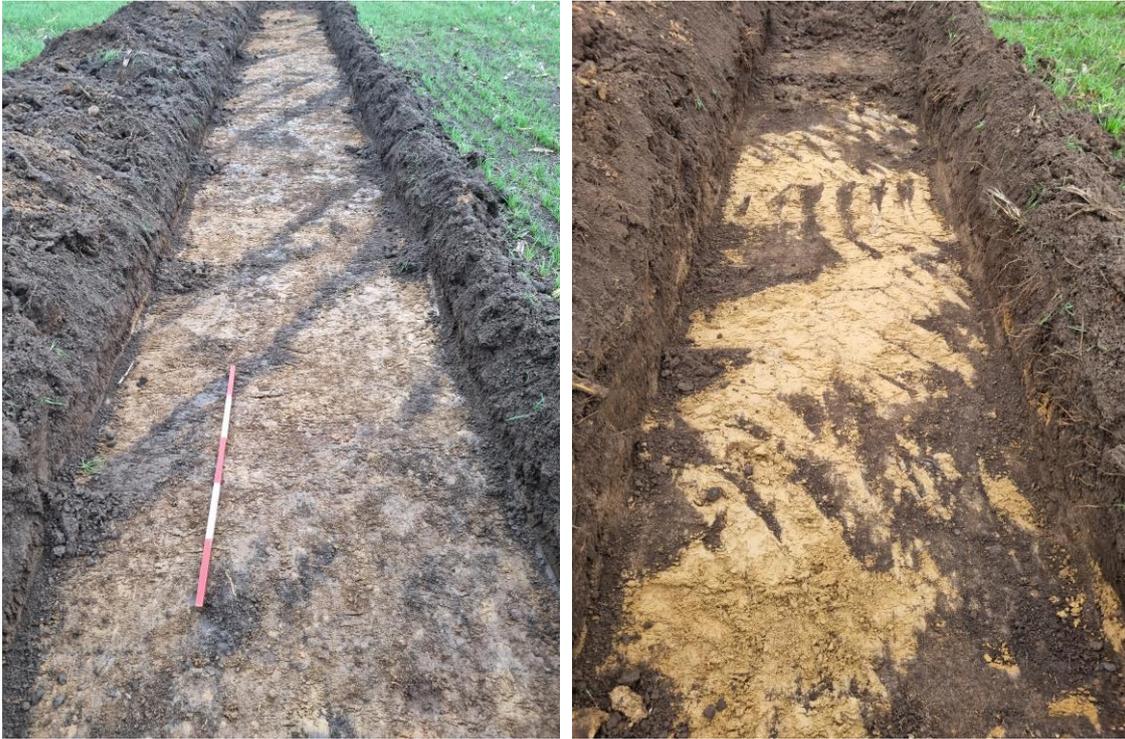
Test trenches revealed that the larger hill has been modified, probably within the last decade. Also, a recent effluent pond has been constructed that occupies approximately one quarter of the total flat area. Modification to the hill was evident through intensive ploughing and a variable subsoil layer. It appeared that the hill has been flattened filling in depressions and removing raised areas. Bulldozer tracks were also identified at a depth of circa 50 centimetres north of the effluent pond. It is likely that the creation of the pond contributed to the modification of the hilltop (Figure 13).

Figure 13. Modification of the soil through ploughing (left) and topsoil/subsoil redistribution. Probably a result of the effluent pond creation (right).

Aside from soil redistribution modern modification is evident through maize planting. Across the larger hill and surrounding landscape to the east and south maize has been planted for harvesting. Maize that was planted on the larger hill had been harvested prior to excavation (Figure 13).

No archaeological features, deposits or sites were identified on either hill. There was no charcoal in the topsoil or subsoil or evidence of forest clearance burning.

Since there is no evidence for any archaeology W. Gumbley Ltd does not recommend that the client apply for an archaeological authority.
