Genetic Technologies Ltd/
Philip Yates Family Holdings Ltd
PO Box 105303
Auckland 1143

05 August 2021

Contaminated Land Summary - Yates-Genetics Rukuhia Property, 3463 Ohaupo Road

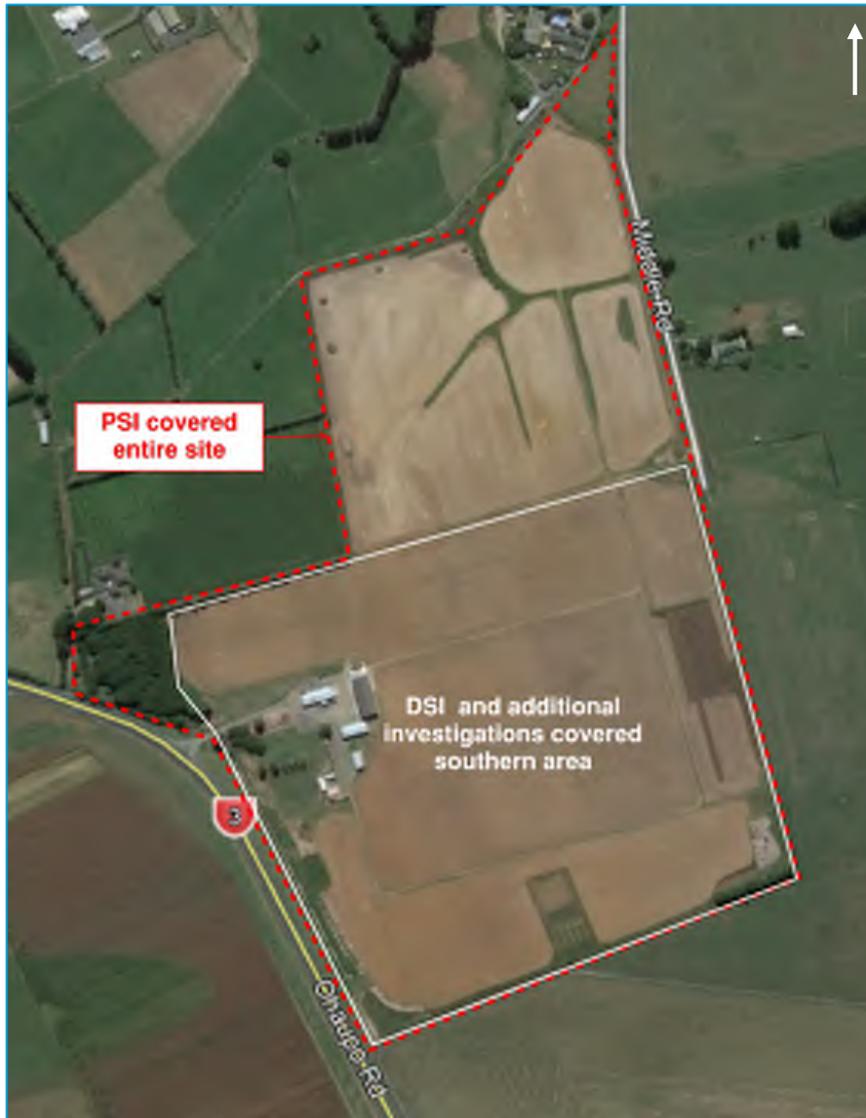
**Figure 2. Extent of PSI and DSI (including supplementary) investigations
(base image source: Google Earth)**

The property has had a number of investigations undertaken between 2011 - 2015. A PSI was undertaken for the entire property, covering the full extent of the site. Various soil sampling assessments have been restricted to the footprint of the proposed Research Hub in the southern half of the site (**Figure 2**).

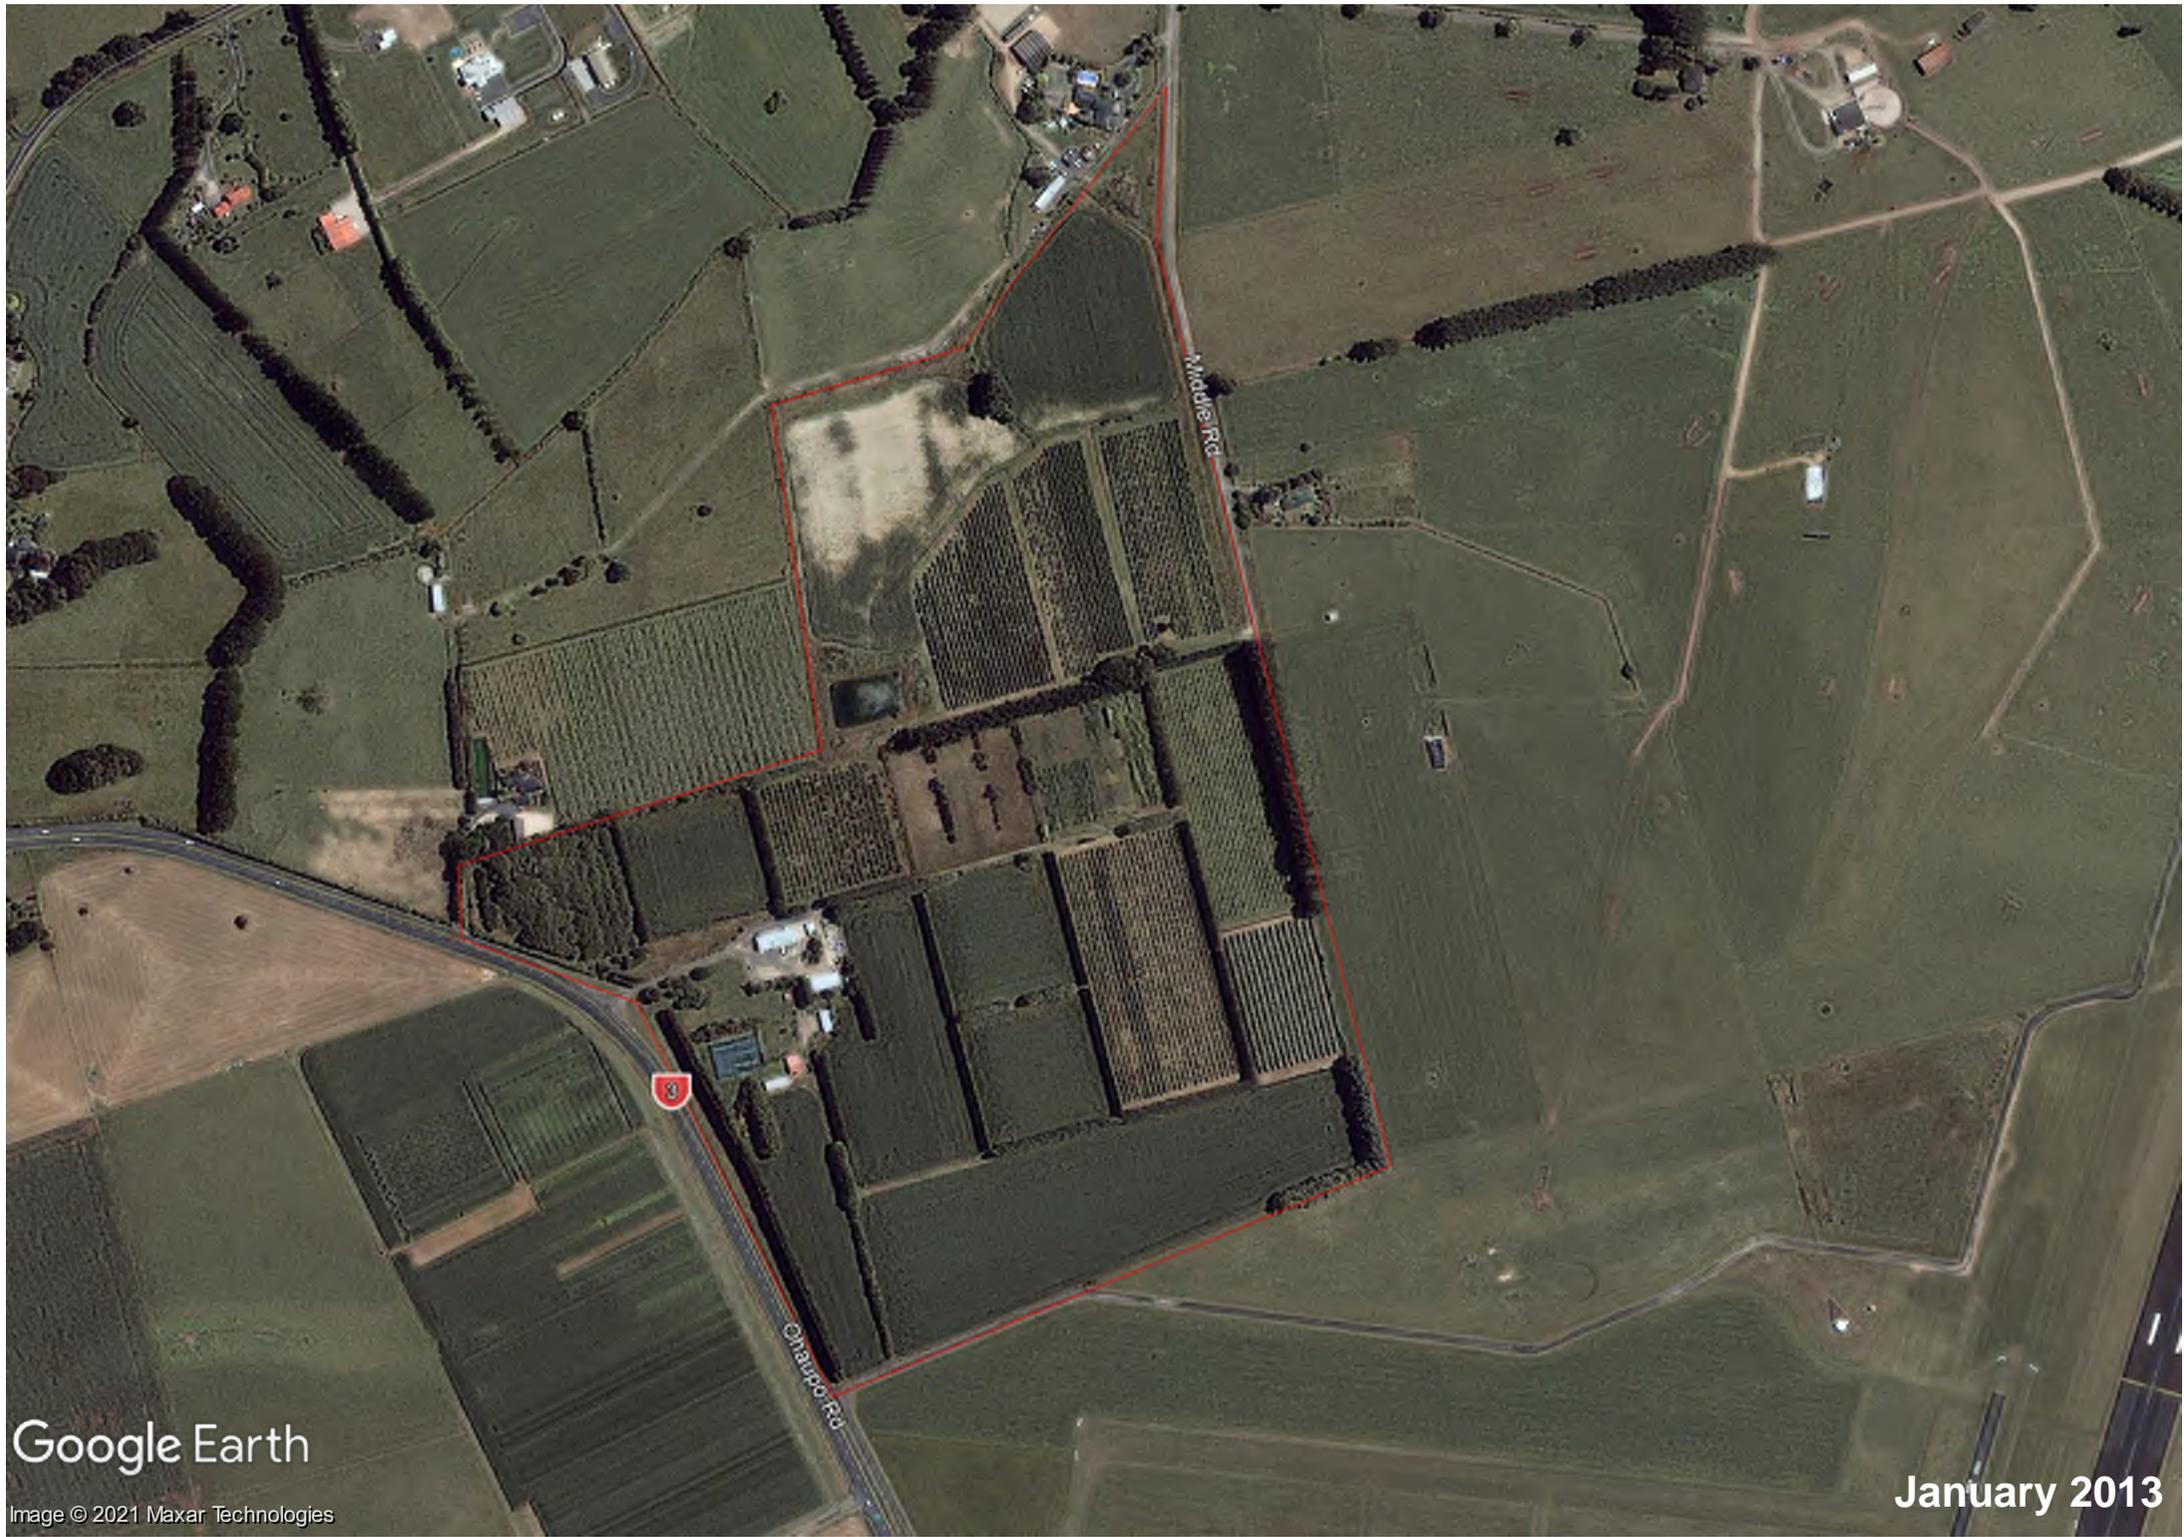
- January 2013 – The entire site appears to be used for mixed horticultural purposes with what appears to be different types of produce planted in rows (identified in the previous assessments as including apples, berries, chestnuts, kiwifruit and potatoes). Surrounding land use is predominantly agricultural with some cropping bordering the site.

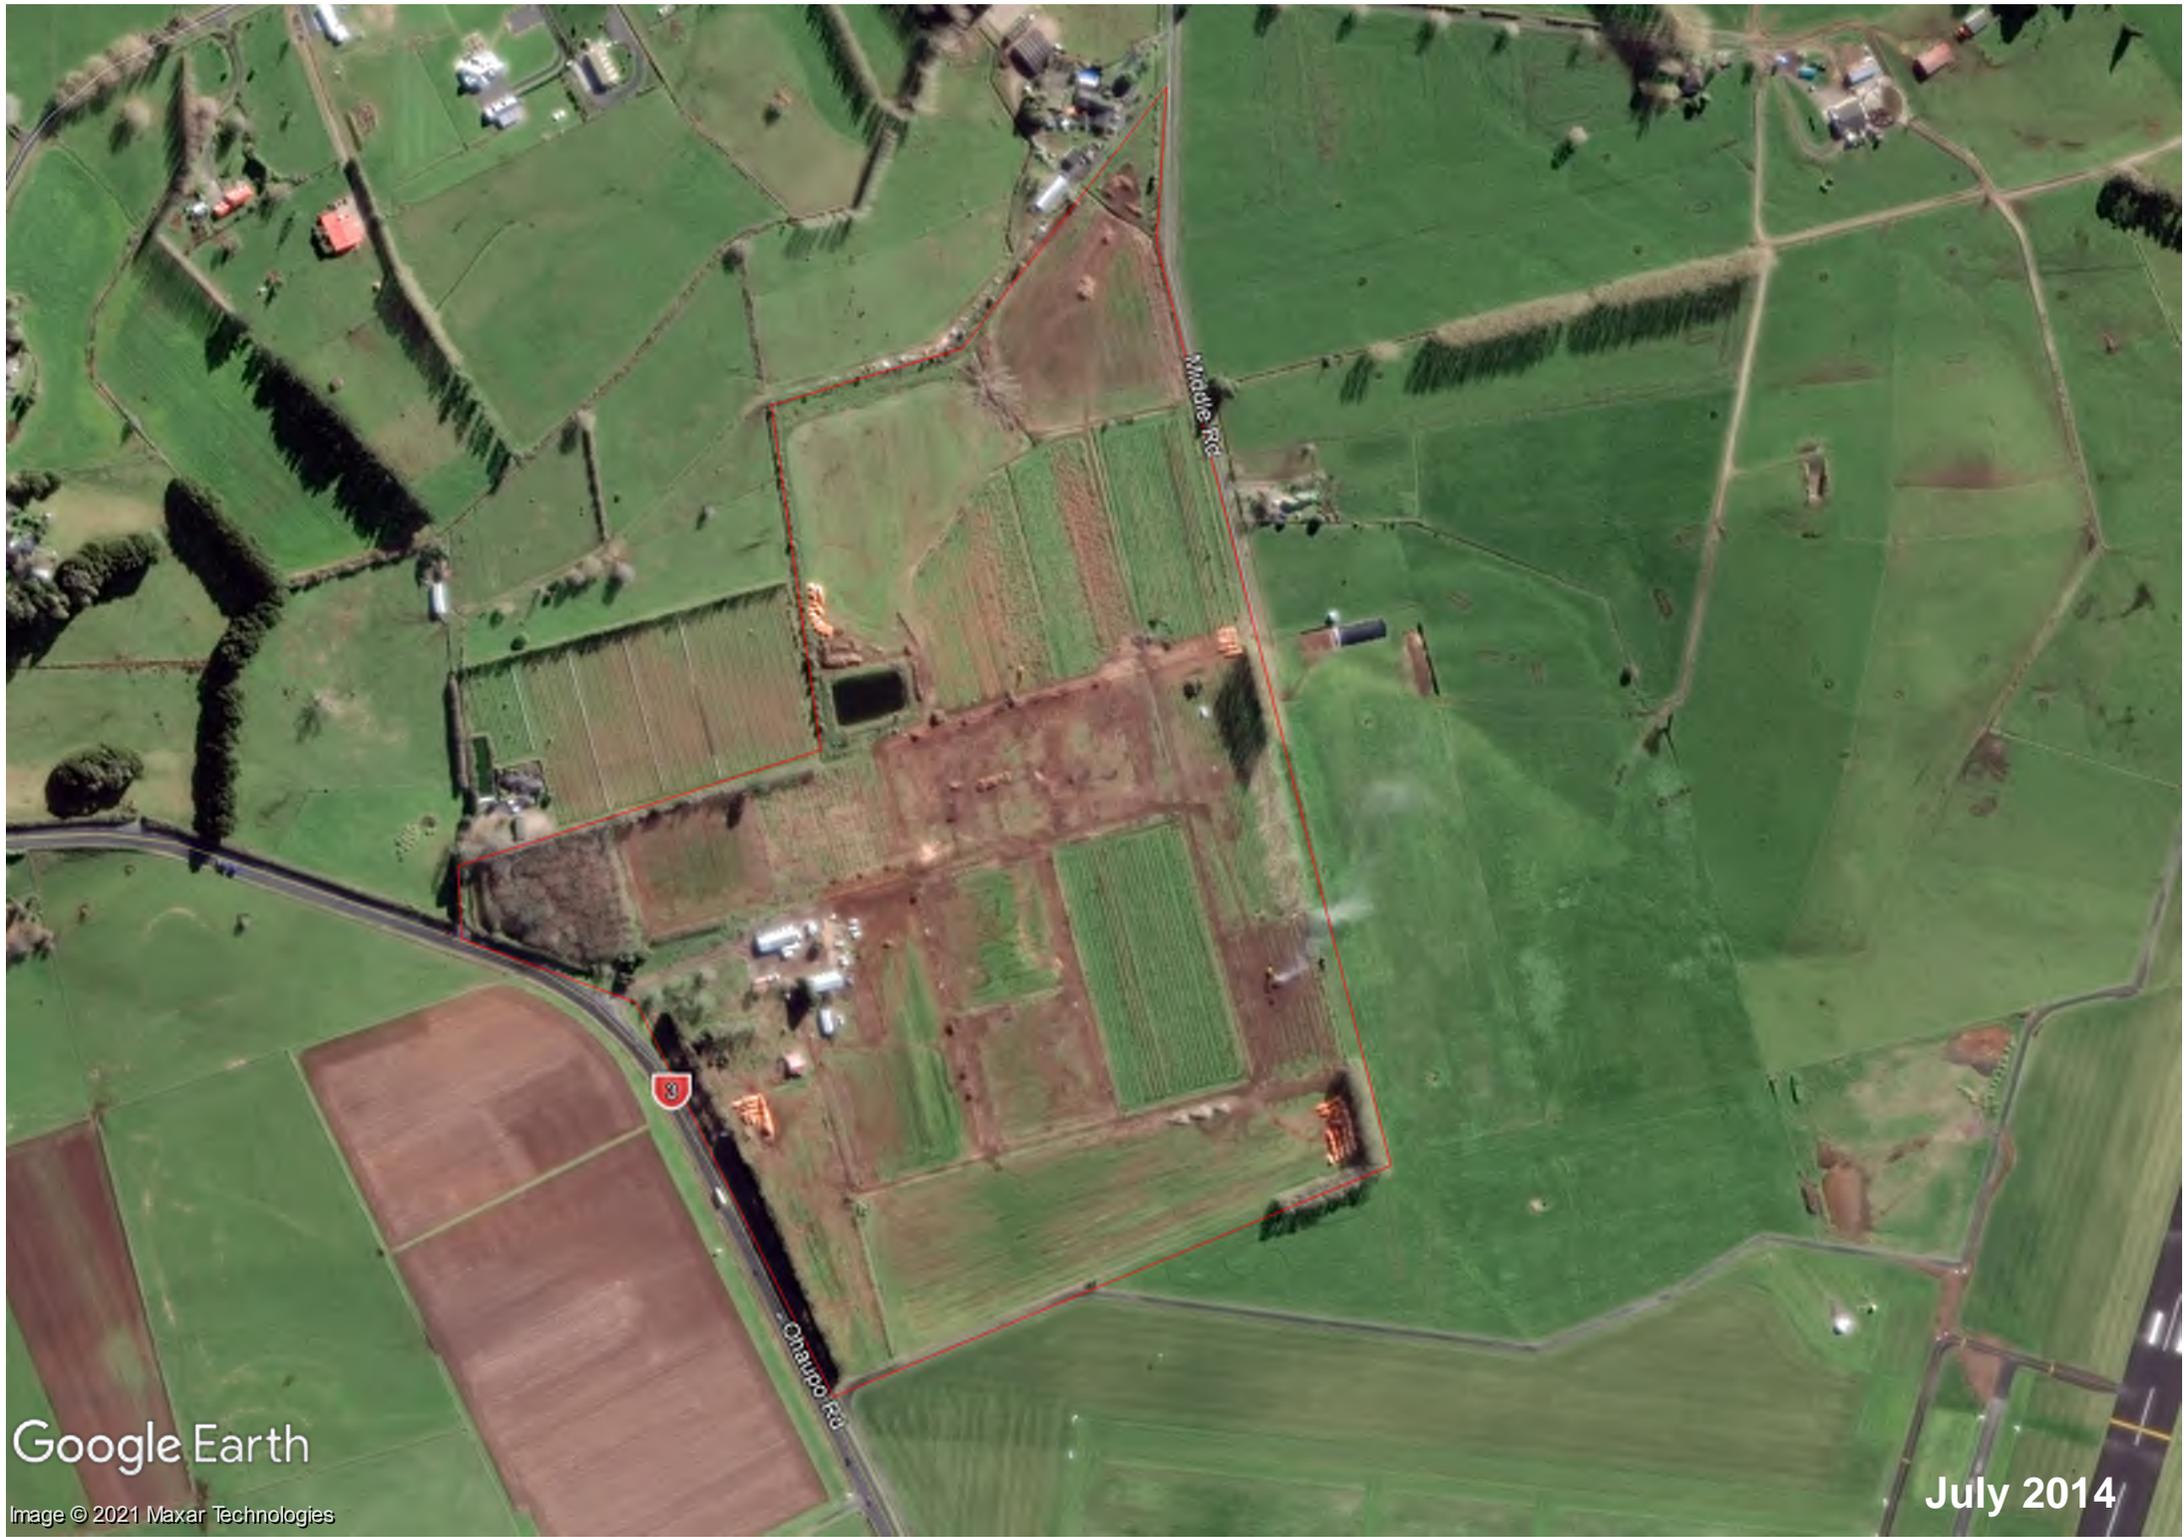
- July 2014 – Clearance operations of the site are underway, with multiple blocks of vegetation throughout the site being cleared and chipped. Several blocks of horticulture remain. No changes have occurred to surrounding land uses.

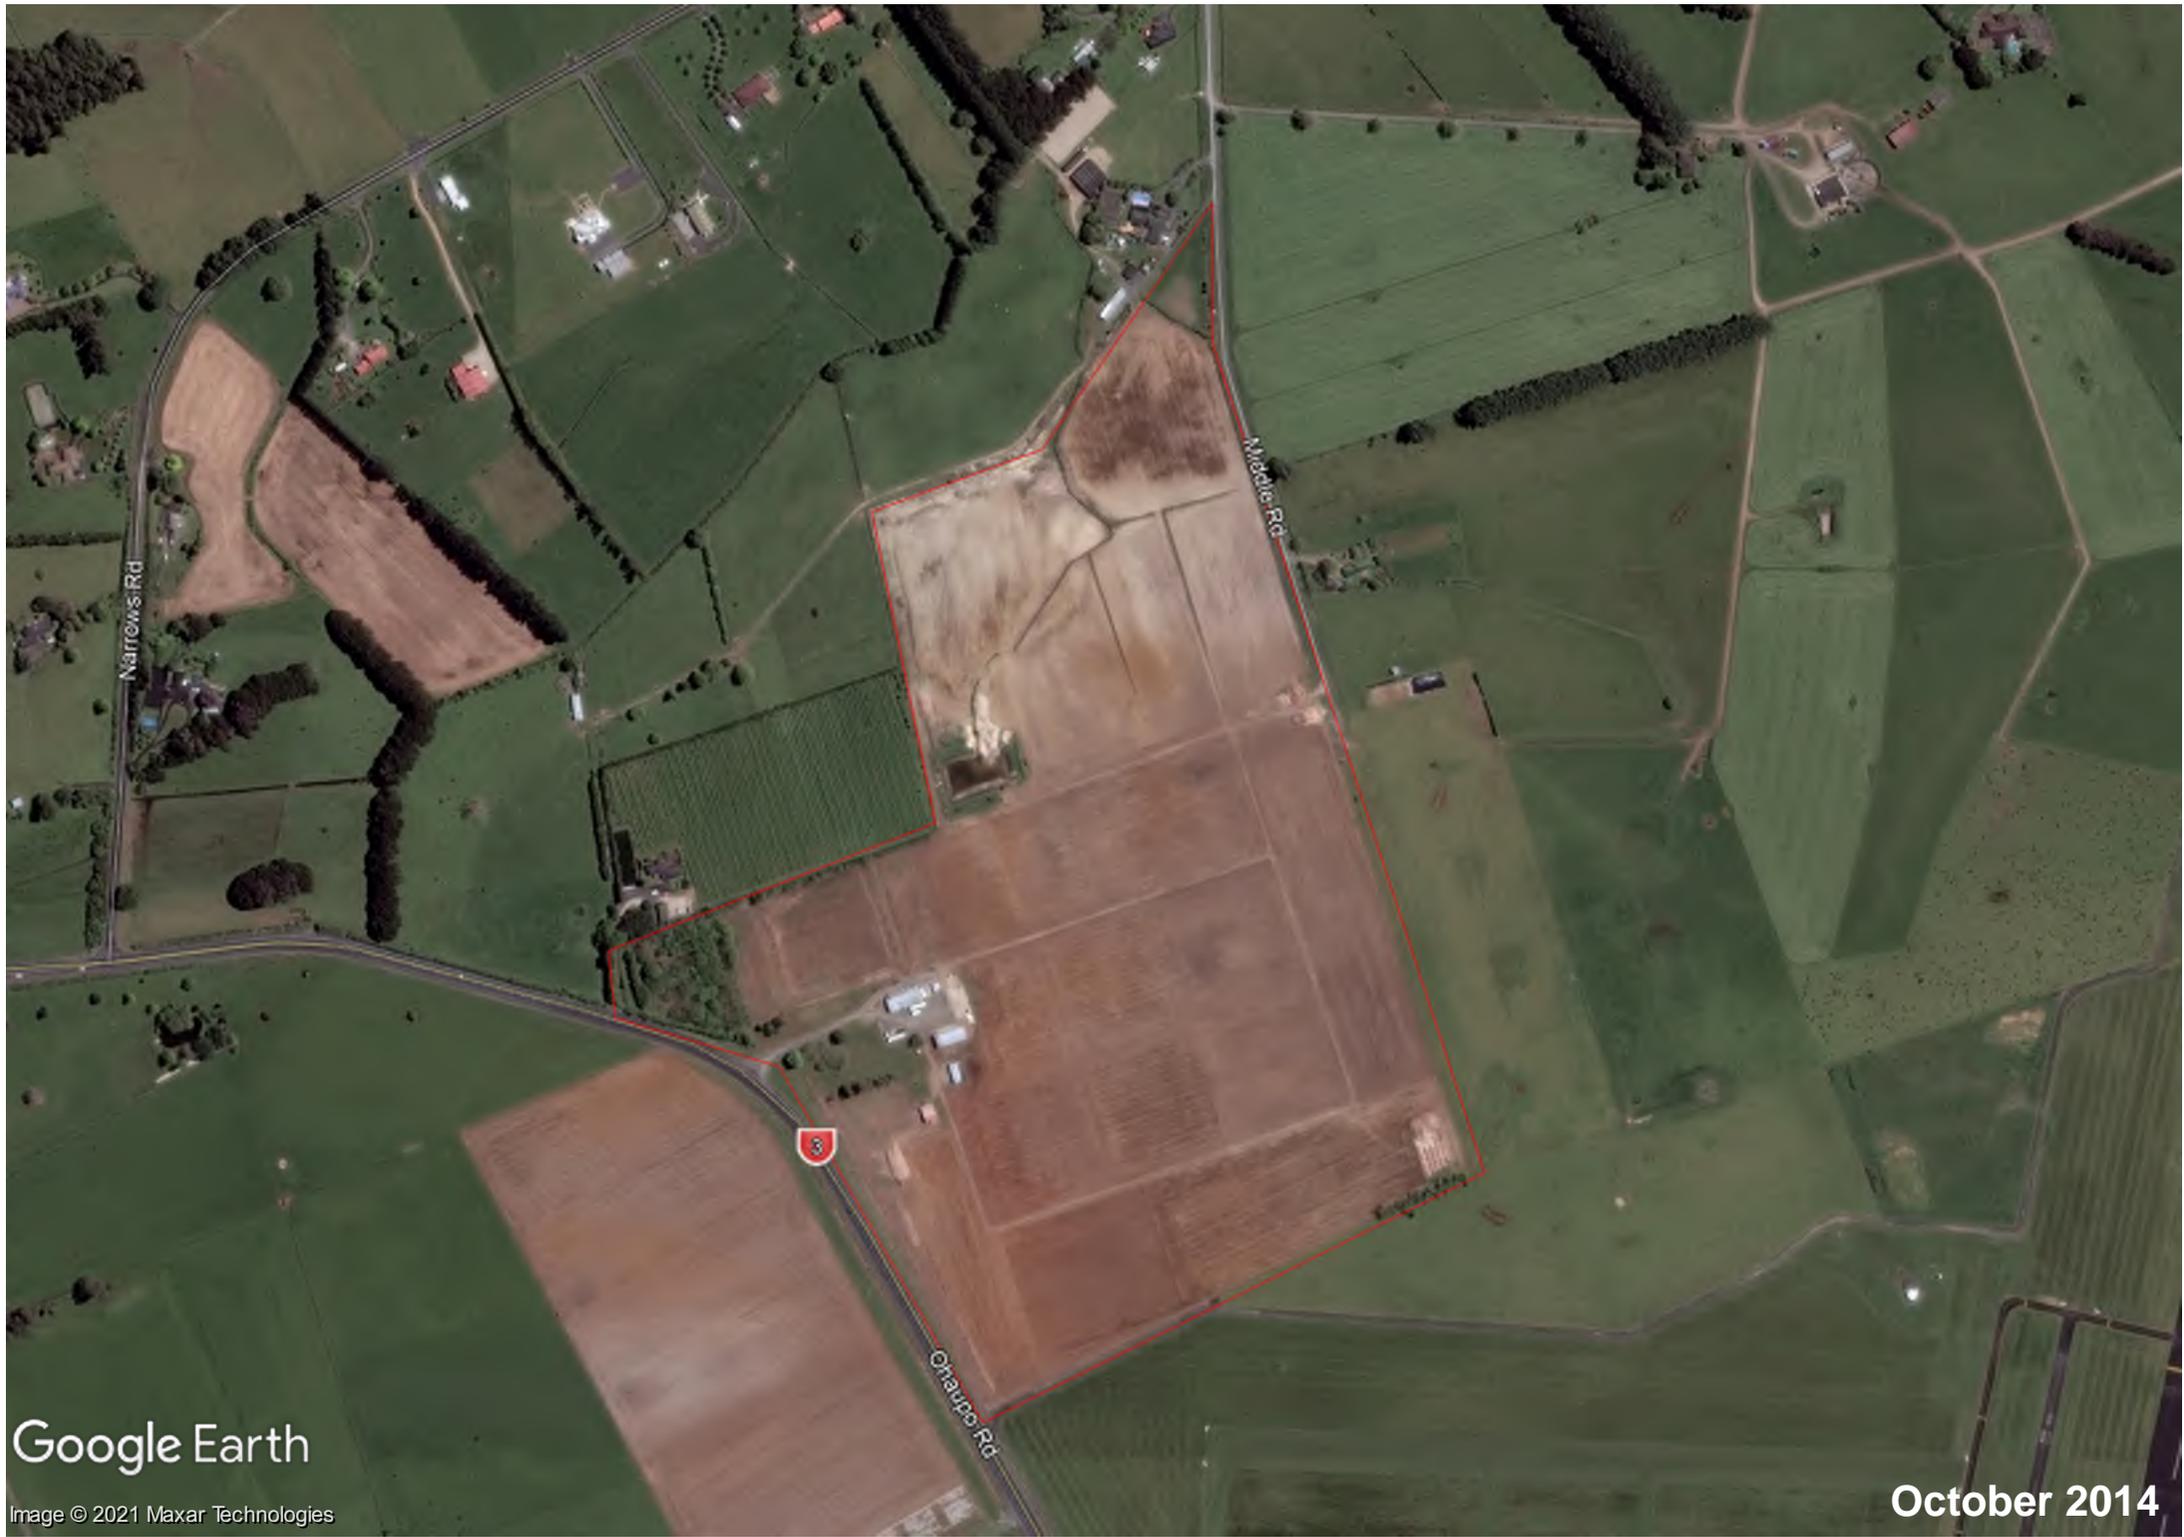
- October 2014 – The entire site has now been cleared with only the implement shed area remaining and a small grove of chestnut trees in the western corner bordering Ohaupo Road. Several stockpiles of what appear to be vegetation chip/mulch remain onsite. A linear pattern across the paddocks appears to reflect the statement that the site was seeded in maize immediately after the vegetation clearance. The water storage pond near the centre of the site also appears to be getting filled in. No changes have occurred to surrounding land uses.

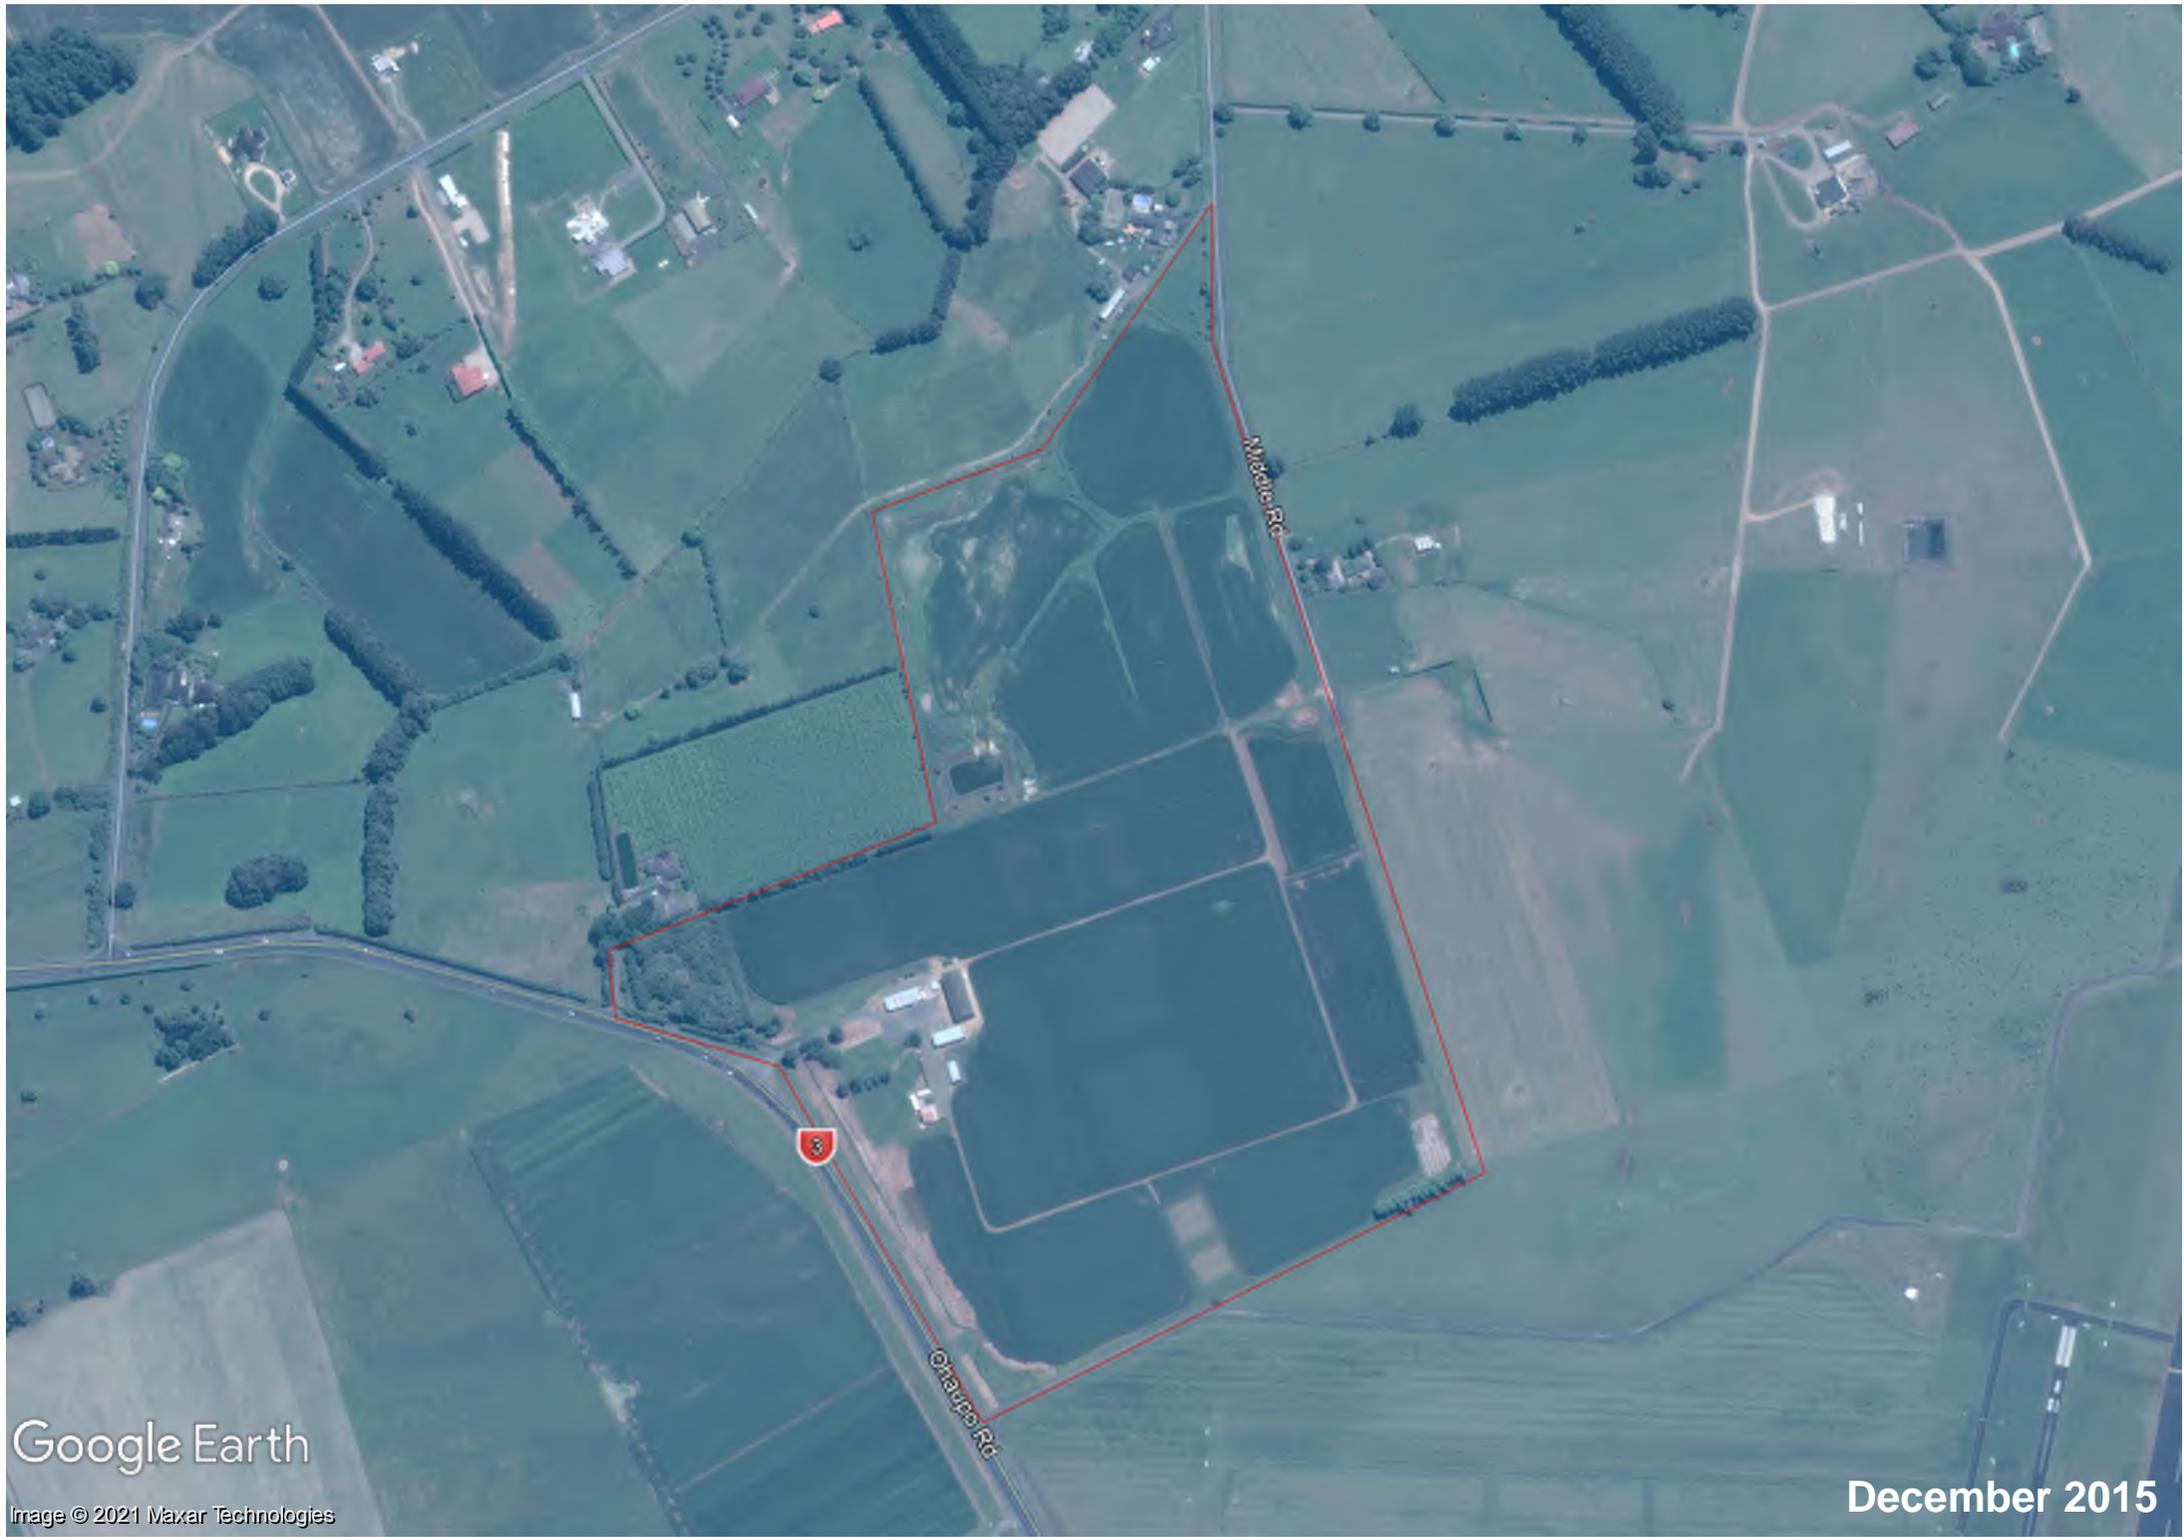
- December 2015 – The entire site appears to be maize cropping. A new shed has now been built adjacent the existing implement shed area, reflecting the statement provided by Mr Yates above. The water storage pond still remains. No changes have occurred to surrounding land uses.

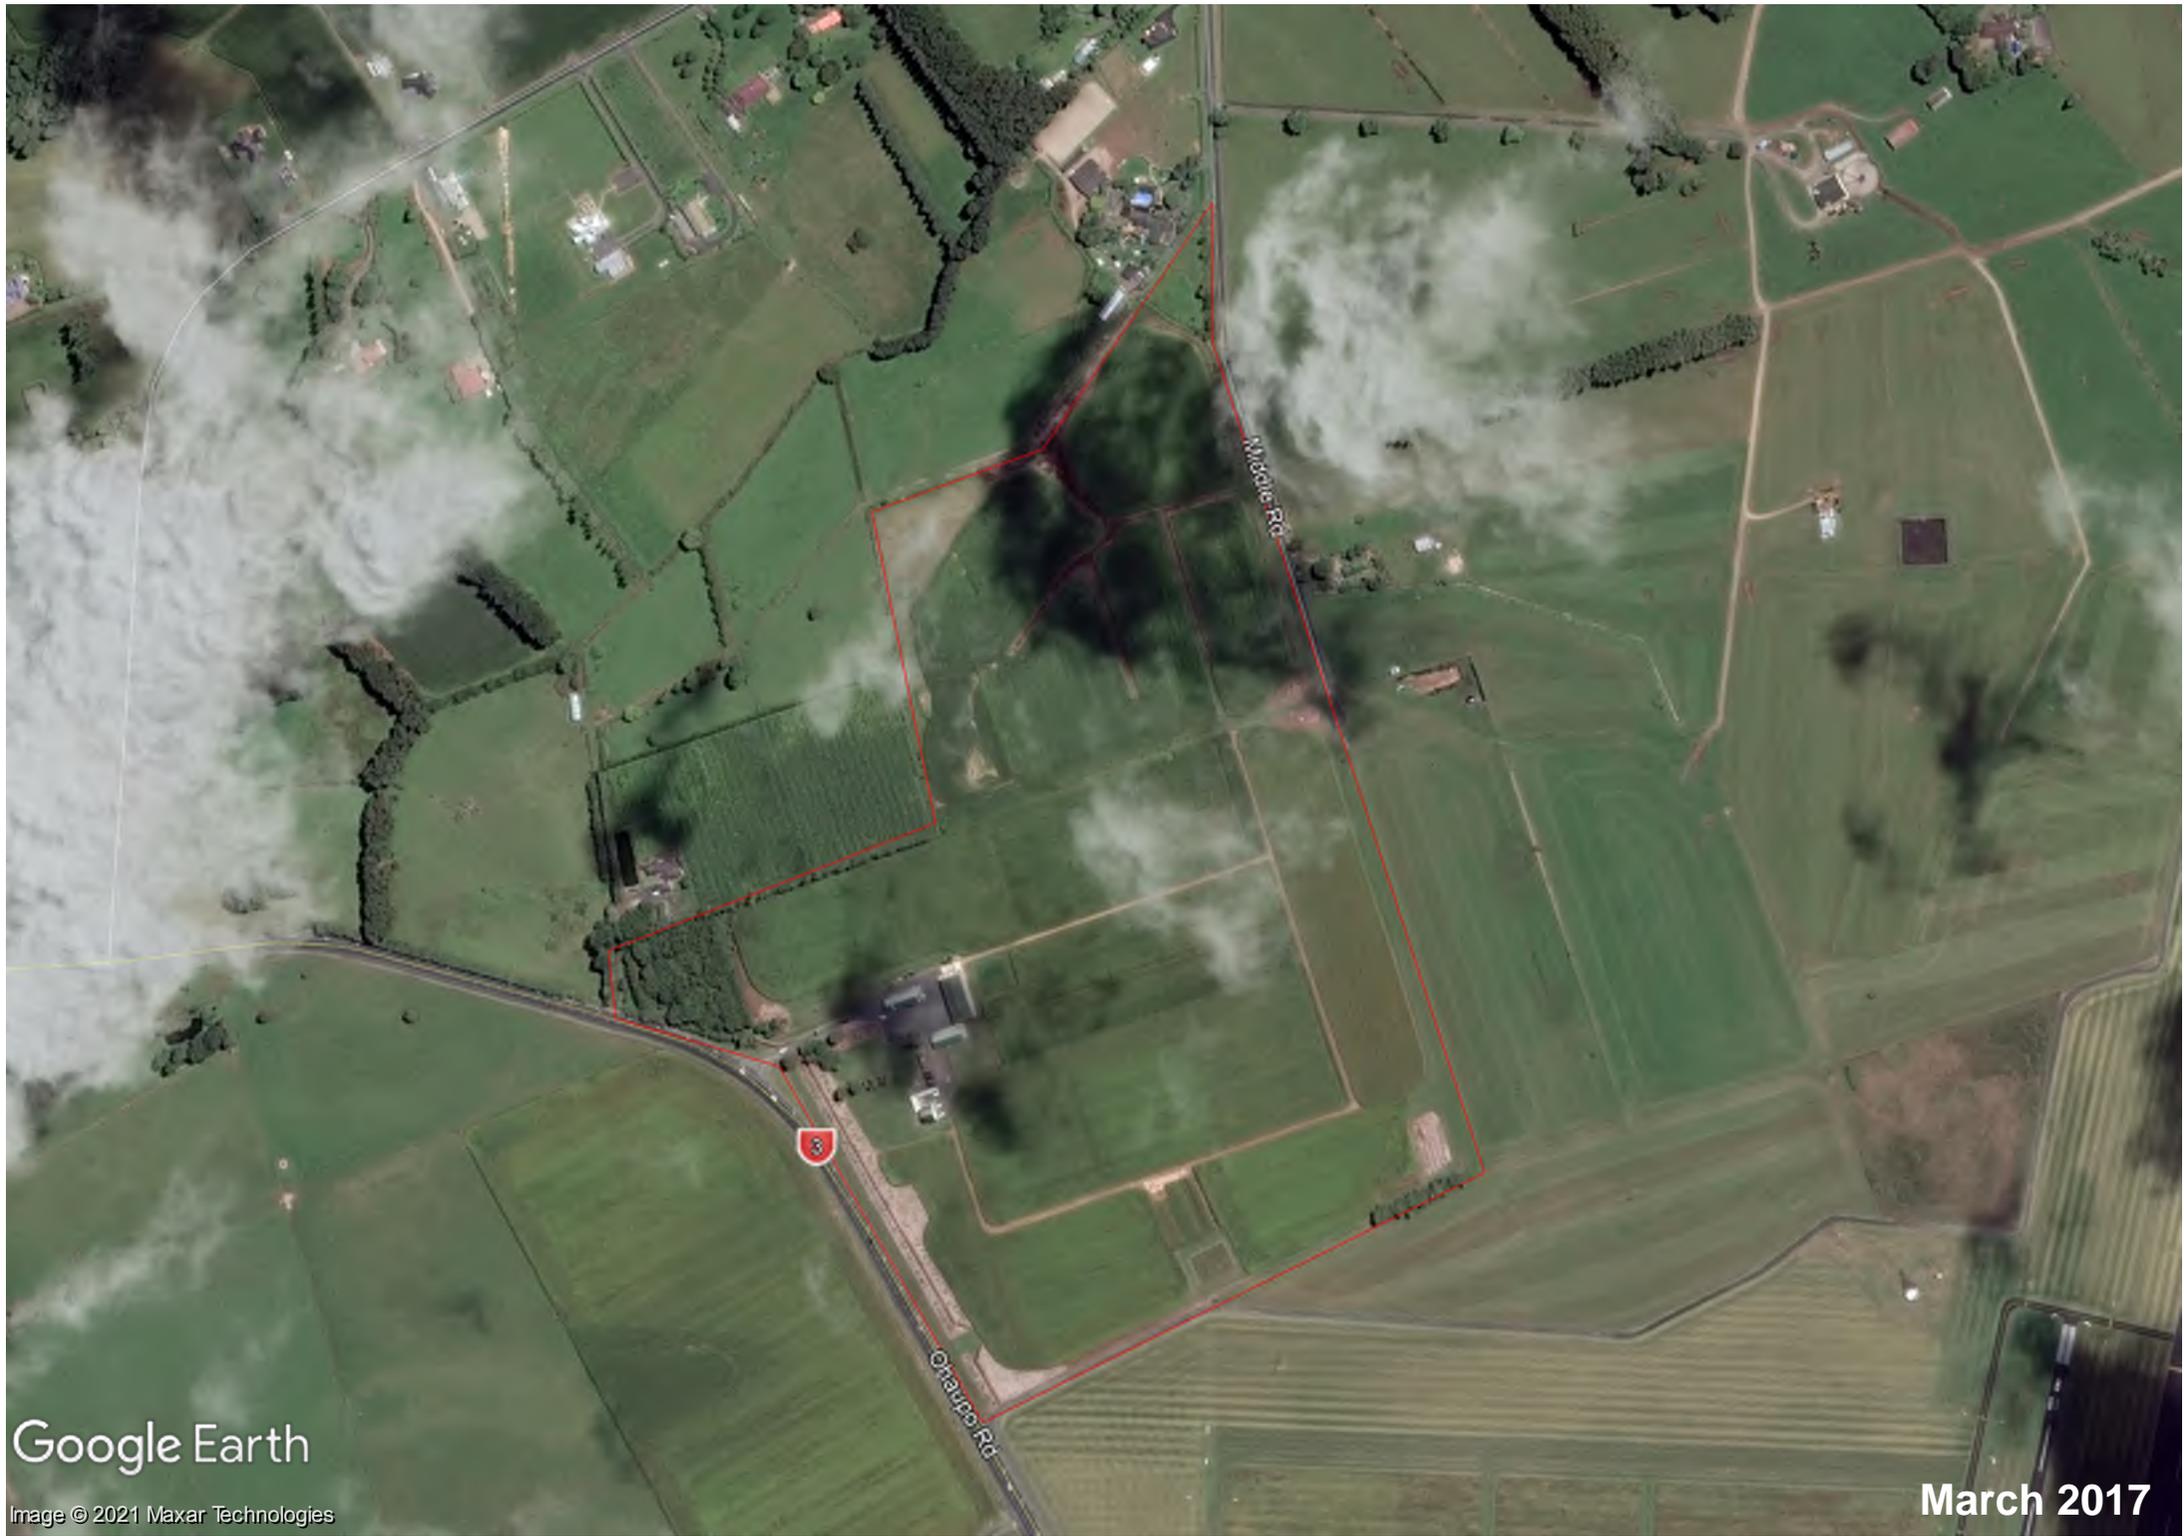
- March 2017 – No changes have occurred to the majority of the site used for maize cropping. The irrigation water storage pond has now been backfilled and is now cropped like the rest of the site. Landscape planting has occurred along the boundary of Ohaupo Road. No changes have occurred to surrounding land uses.

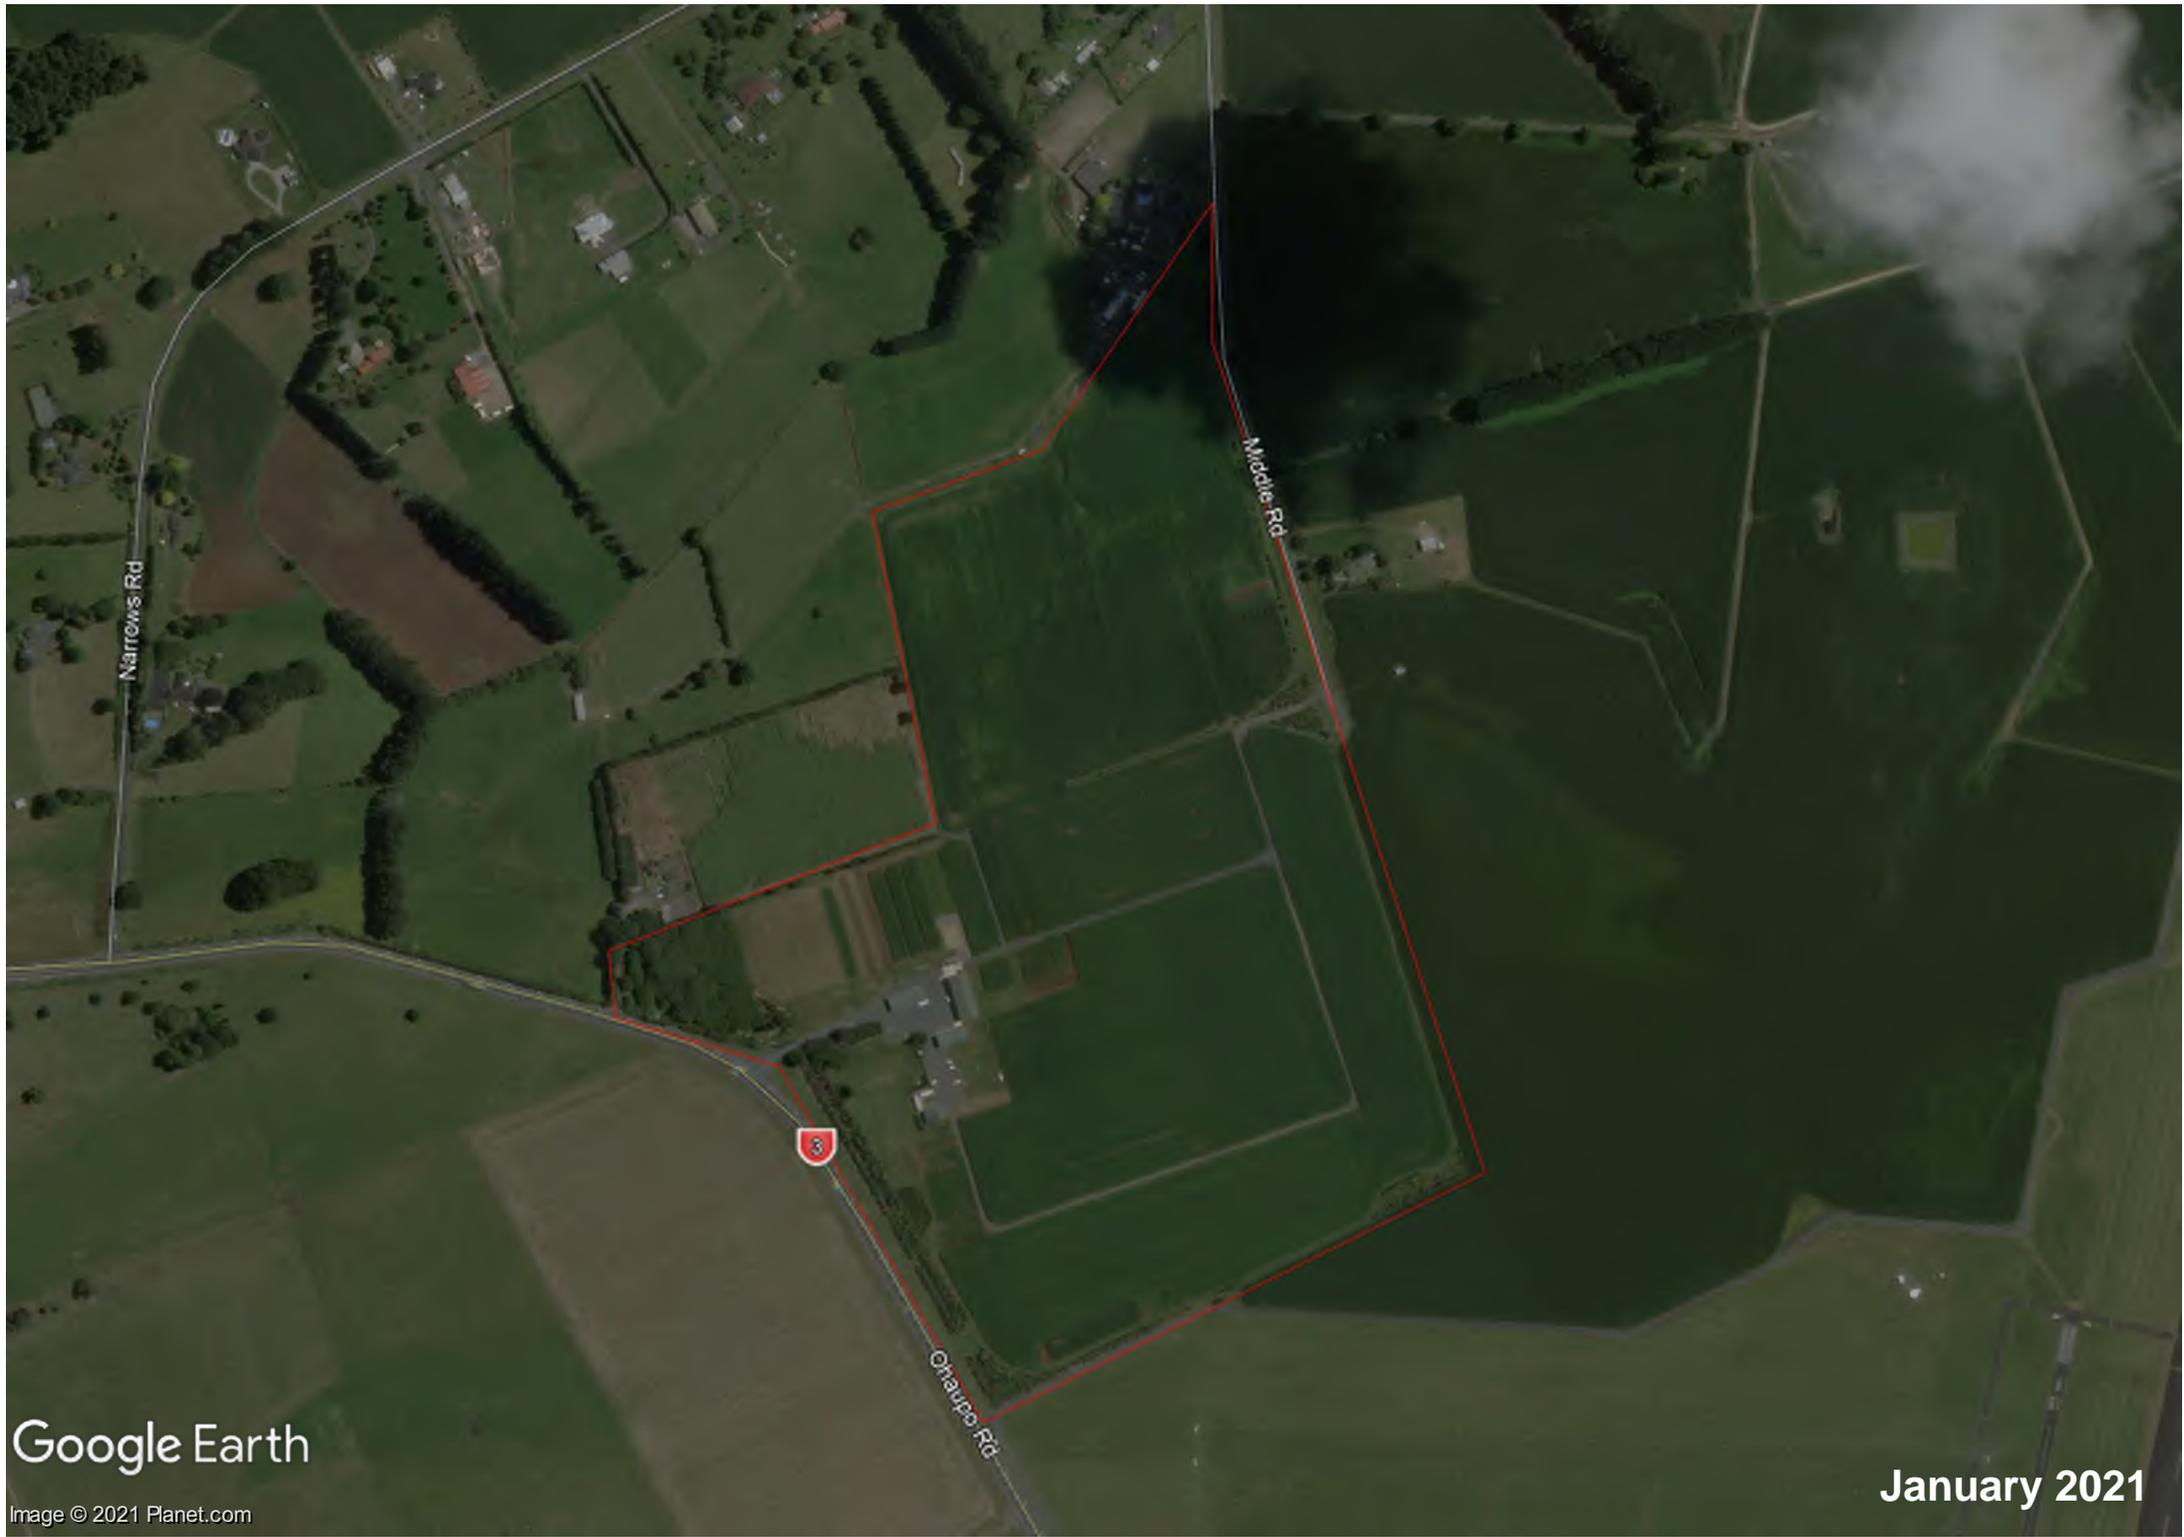
- January 2021 - No significant changes have occurred to site operations or surrounding land uses.
