**638 Cambridge Road, Te Awamutu**

# **General Civils & Three Waters Report**

September 2025

| Project identification | | |
|---|---|---|
| Job name | Mitre 10 Te Awamutu | |

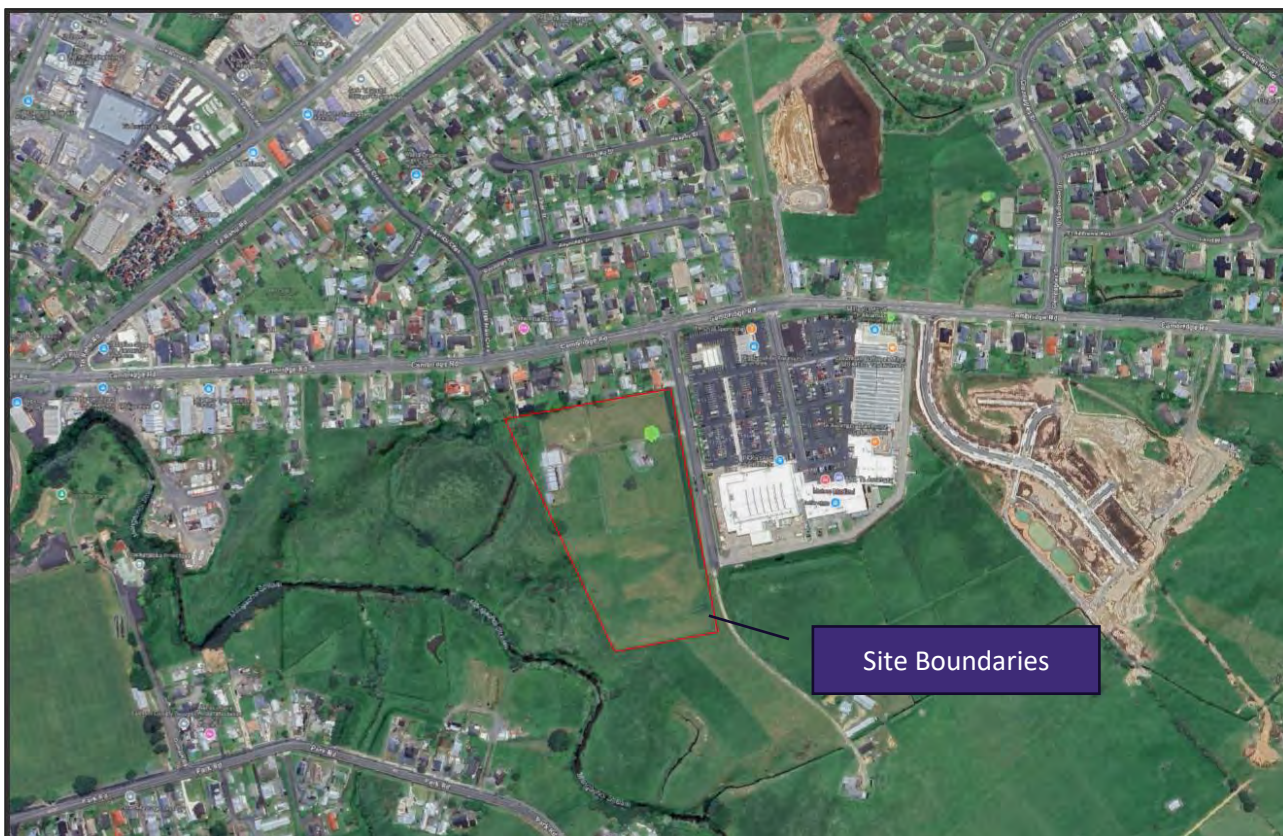
**Figure 2.** Site location

- Northern boundary: Cambridge Road (urban arterial route).
- Southern boundary: Grassland transitioning to the Mangaohoi Stream floodplain.
- Eastern boundary: Commercial.
- Western boundary: Agricultural properties.

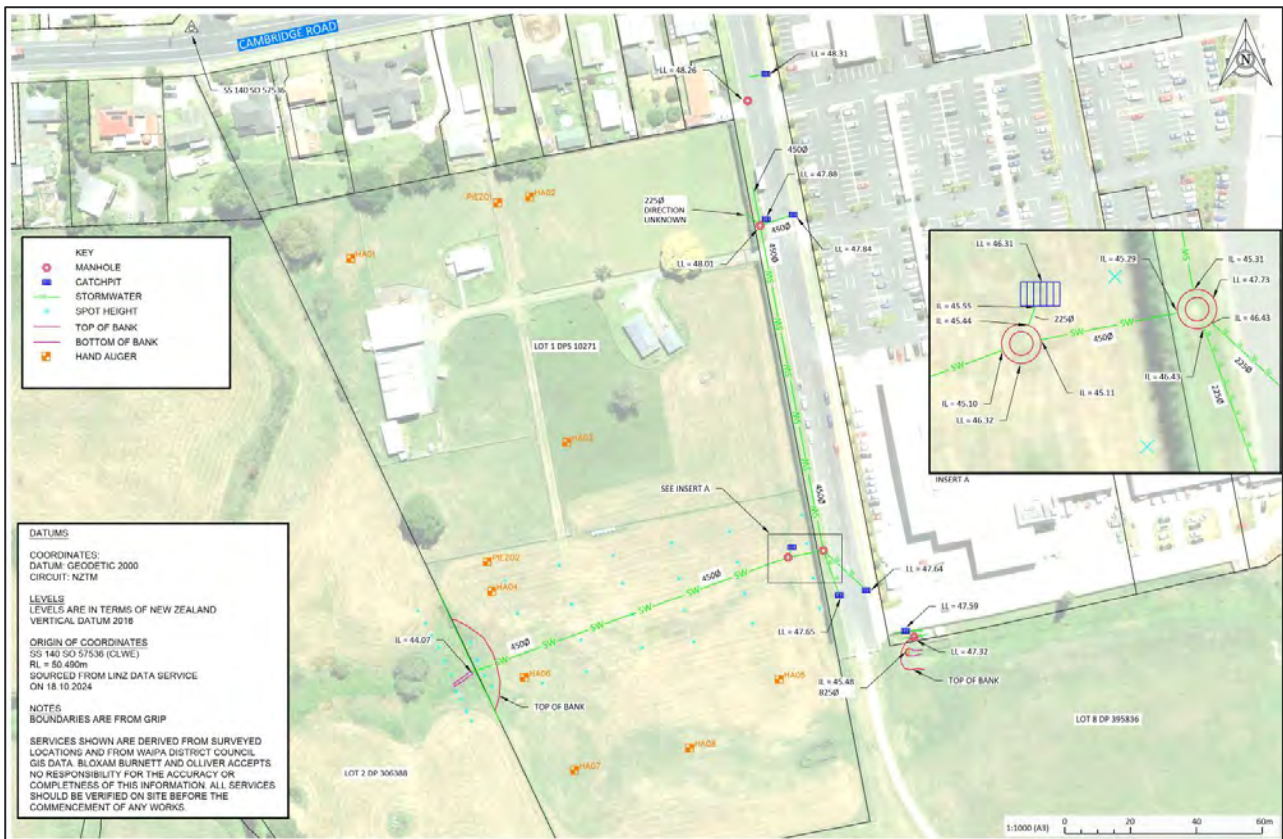
Stormwater infrastructure is limited to the existing 450mm stormwater pipe crossing the site, which conveys intercepted runoff from the eastern access road to the wetland at the western boundary. A field sump within the site drains a local depression point into this pipe.

The proximity of these networks minimizes the need for off-site infrastructure upgrades, simplifying servicing of the development. Further assessments will confirm the adequacy of these utilities to meet the development’s demands and identify any required modifications to integrate with the proposed layout.

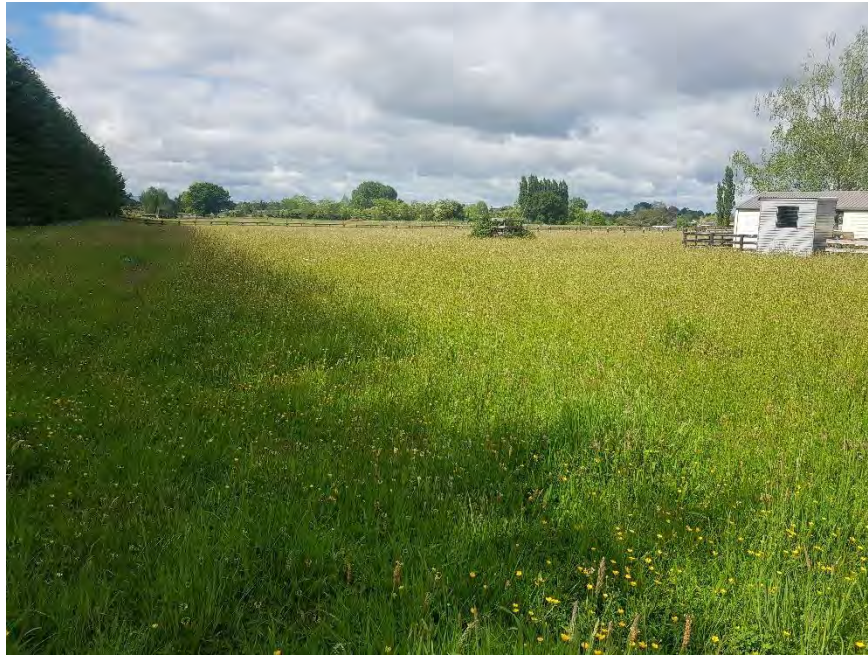
Vegetation across the majority of the site was dominated by exotic pasture species such as Yorkshire fog (*Holcus lanatus*), perennial ryegrass (*Lolium perenne*), sweet vernal grass (*Anthoxanthum odoratum*) creeping buttercup (*Ranunculus repens*) and dock (*Rumex* spp). A c.4m tall leylandii (*Cupressus × leylandii*) hedgerow was present along the eastern boundary of the site and some mature scattered exotic trees including crack willow (*Salix × fragilis*), pin oak (*Quercus palustris*), cherry (*Prunus* sp.) and elm (*Ulmus* spp.) were also present. Terrestrial vegetation across the site is typical of productive pastureland in the Waikato Region and is not representative of any recognised indigenous ecosystem. Overall, the value of terrestrial vegetation on-site is considered to be 'Low' due to the absence of any mature or complex indigenous vegetation and the prevalence of maintained exotic pasture grasses.

*Figure 2: Exotic pasture grasses were the dominant vegetation on site*

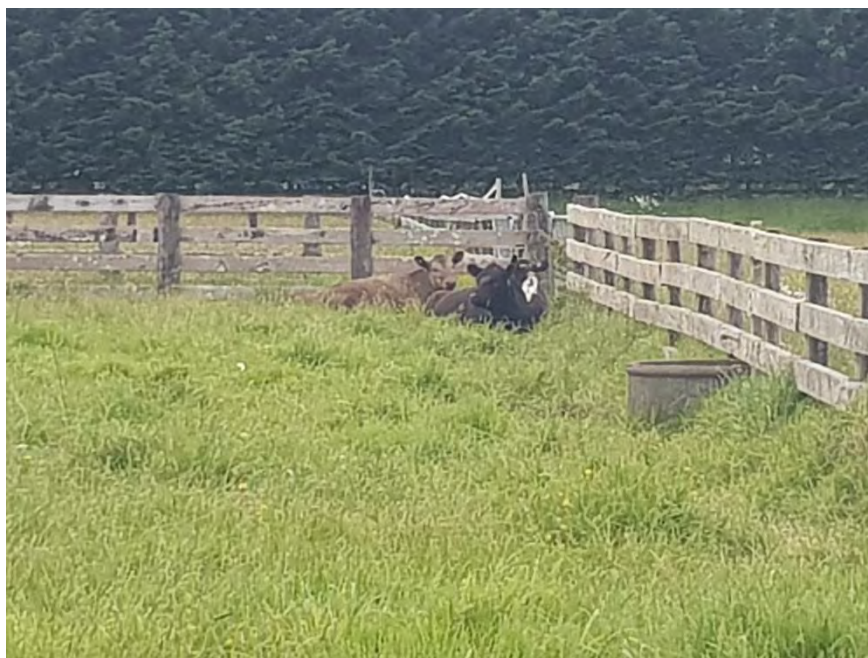
*Figure 3: Evidence of livestock grazing on site*

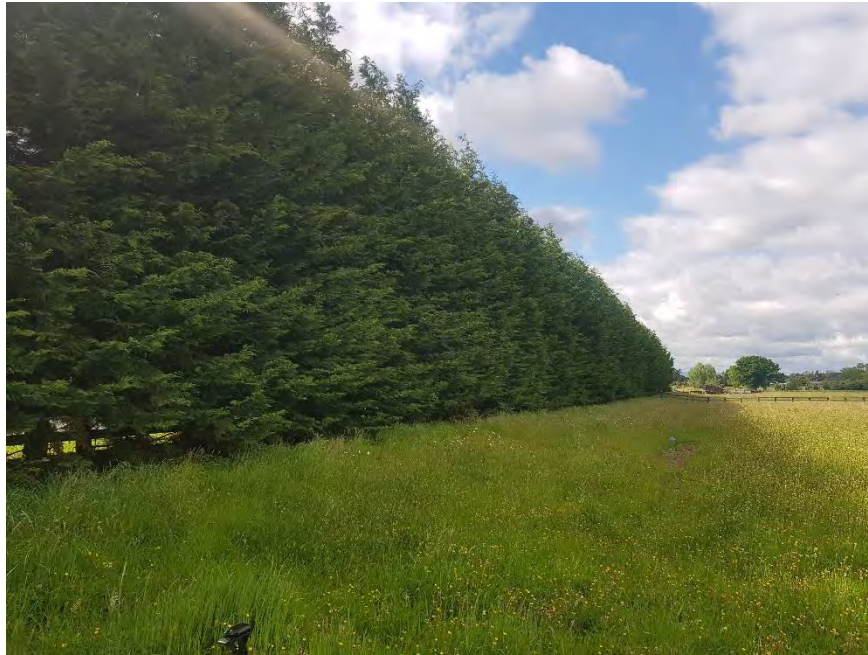
Some limited habitat for copper skinks was identified within areas of rank grass along the fence lines along the northern, west and southern site perimeter, and beneath a hedgerow of Leylandii along the site's eastern boundary (Figure 4). The suitable habitat along perimeter fences and hedgerow base was systematically searched by ENZL ecologists for c. 4 hours and no skinks were observed.

*Figure 4 showing the Leylandii hedgerow with its base identified as potential lizard habitat.*

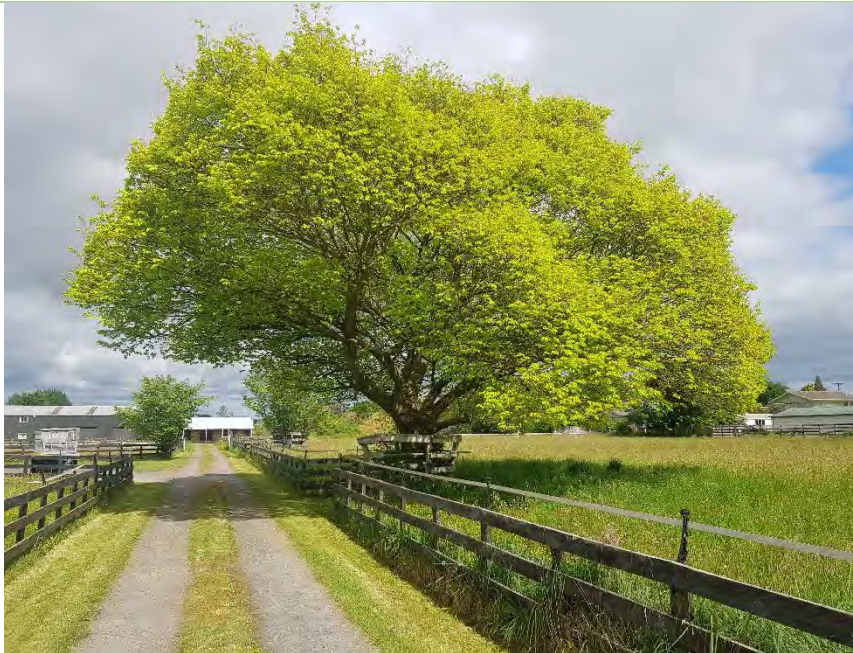
| Risk Rating | Description of bat trees | Photograph of trees with high/low-risk rating for roosting bats |
|---|---|---|
| High | Elm tree with welded leaders forming a potential shelter for bats at c.4m. near to the entrance of the site. | |

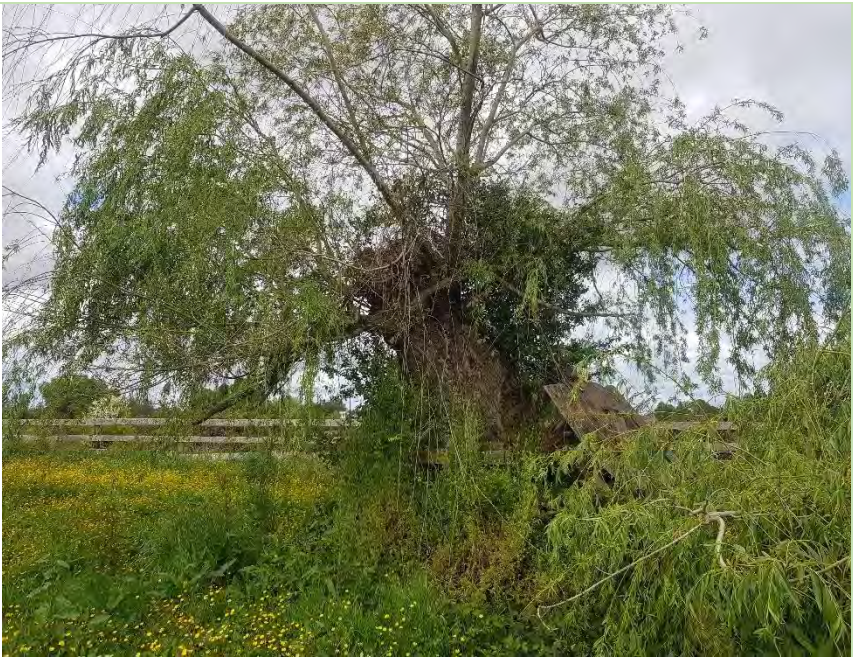
| High | Crack willow tree with multiple failure points creating cavities for bats. Northwest of the site | |

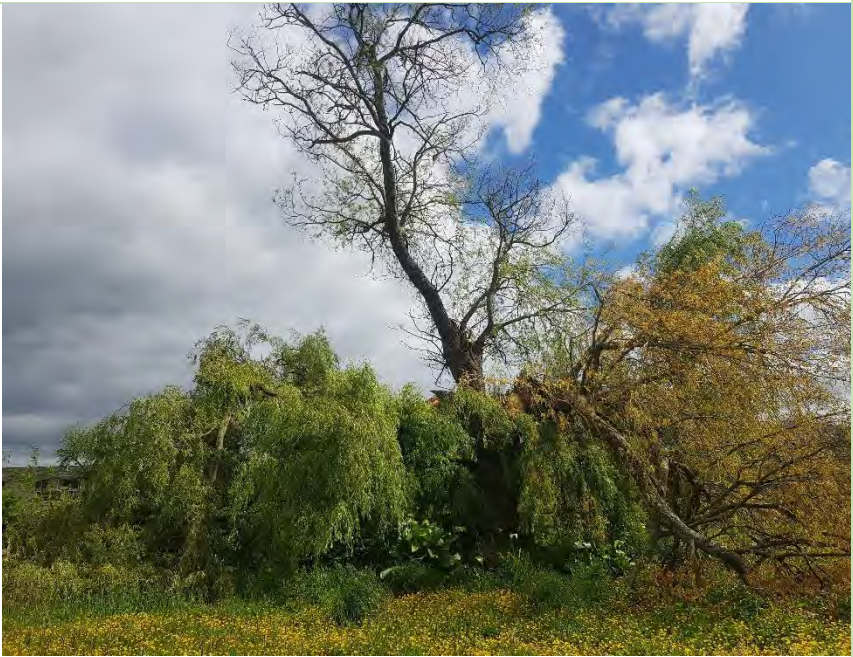
| High | Crack willow tree with multiple failure points creating cavities for bats. The northwestern corner of the site | |

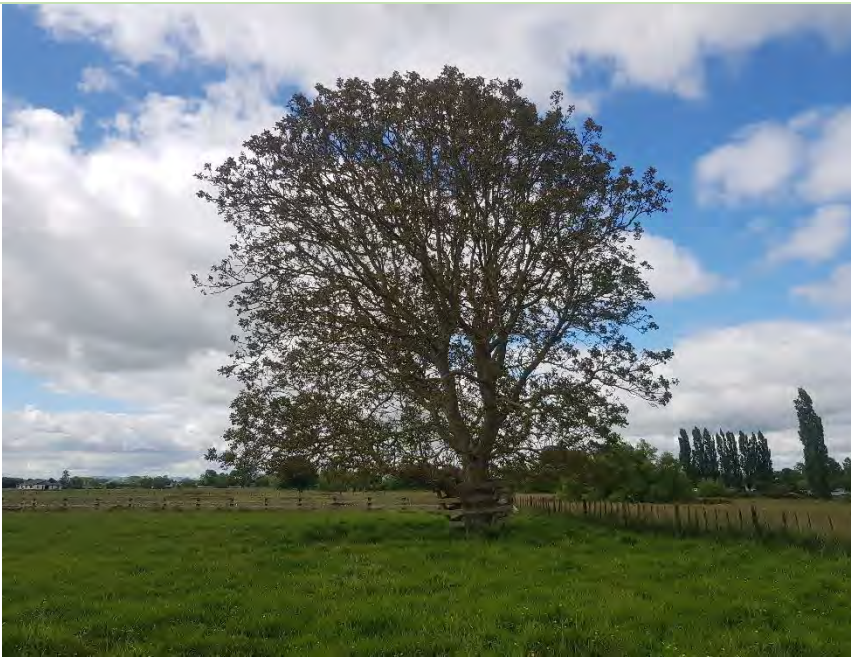
| Moderate | Unidentified tree species with no obvious features but due to its size could present opportunities for sheltering bats in the future | |

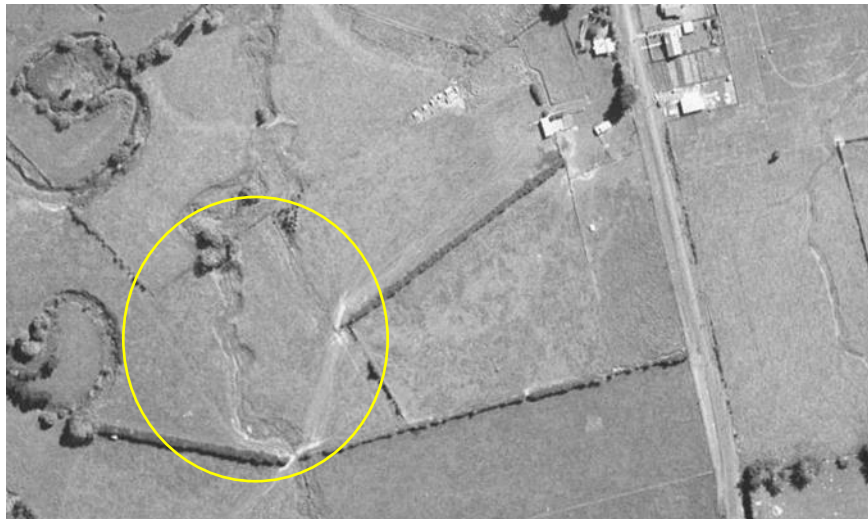
Historic imagery of the site shows that the landscape has changed markedly over time with an increase in the amount of drainage ditches created in the wider landscape. Changes to the drainage regime have likely changed the water table on site. The earliest photograph from aerial imagery shows an overland flow and potential wetland within the areas investigated as part of Potential wetland area 1 (Figure 6). Evidence of draining on site was evident with the presence of a manhole cover and drain within the potential wetland area. The presence of the historic wetland and flow path has likely left behind geomorphological variations compared to their surroundings making the Potential Wetland 1 Area stand out when compared to the rest of the site when observed on more recent imagery. The actual area of wetland habitat appears to have been greatly reduced from its historical extent and now only encroached c.2m over the western boundary of the site as shown in Appendix D.

Figure 6 Yellow area indicates the approximate location of Potential Wetland Area 1 in a historical context

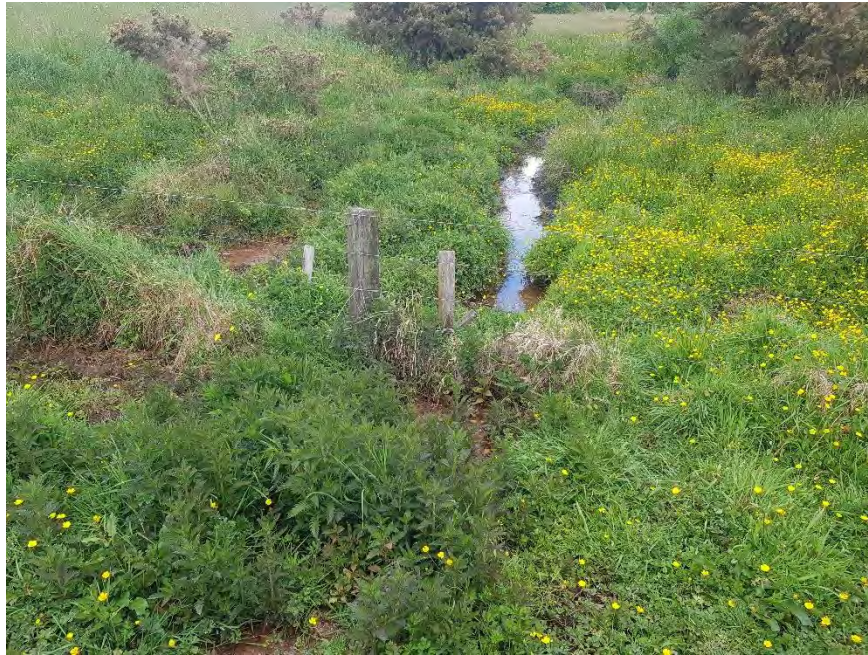
During the on-site investigation, it was clear that wetland habitat was present on the neighbouring property to the west of the site (Figure 7). Water was visibly pooling on the surface and vegetation was dominated by soft rush (*Juncus effusus* var. *effusus*), spearwort (*Ranunculus flammula*) and creeping bent grass (*Agrostis stolonifera*) which are facultative wetland species and fairly reliable indicators of wetland habitat.

*Figure 7: Image showing the wetland area on the neighbouring property to the west of the Site.*

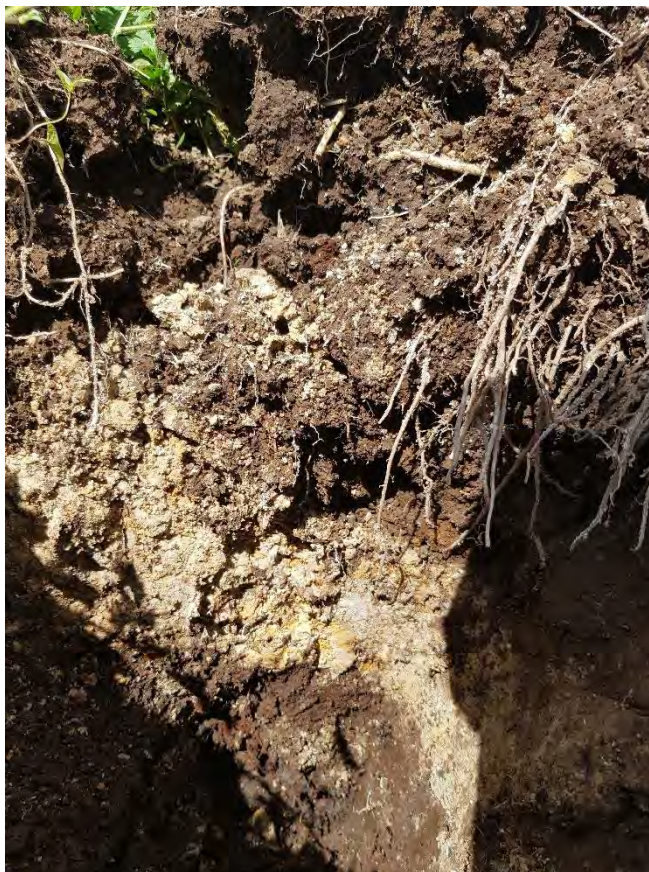
#### Plot 1 hydric soil test

Evidence of hydric soils was identified within the vicinity of Plot 1. There was clear evidence of gleyed soil with a pale low chroma 5/1\* and reddish mottling at a depth of c.200-300mm within the soil plot a restricting layer was observed below the gleyed horizon. The presence of the above soil features indicated that the soil is saturated for at-least part of the year and therefore passes the hydric soil test.
