Document Ref: HAM2023-0058AD | Rev 2

## **RE: PRELIMINARY GEOTECHNICAL REPORT – MITRE 10** **638 CAMBRIDGE ROAD, TE AWAMUTU**

### **1.0 INTRODUCTION**

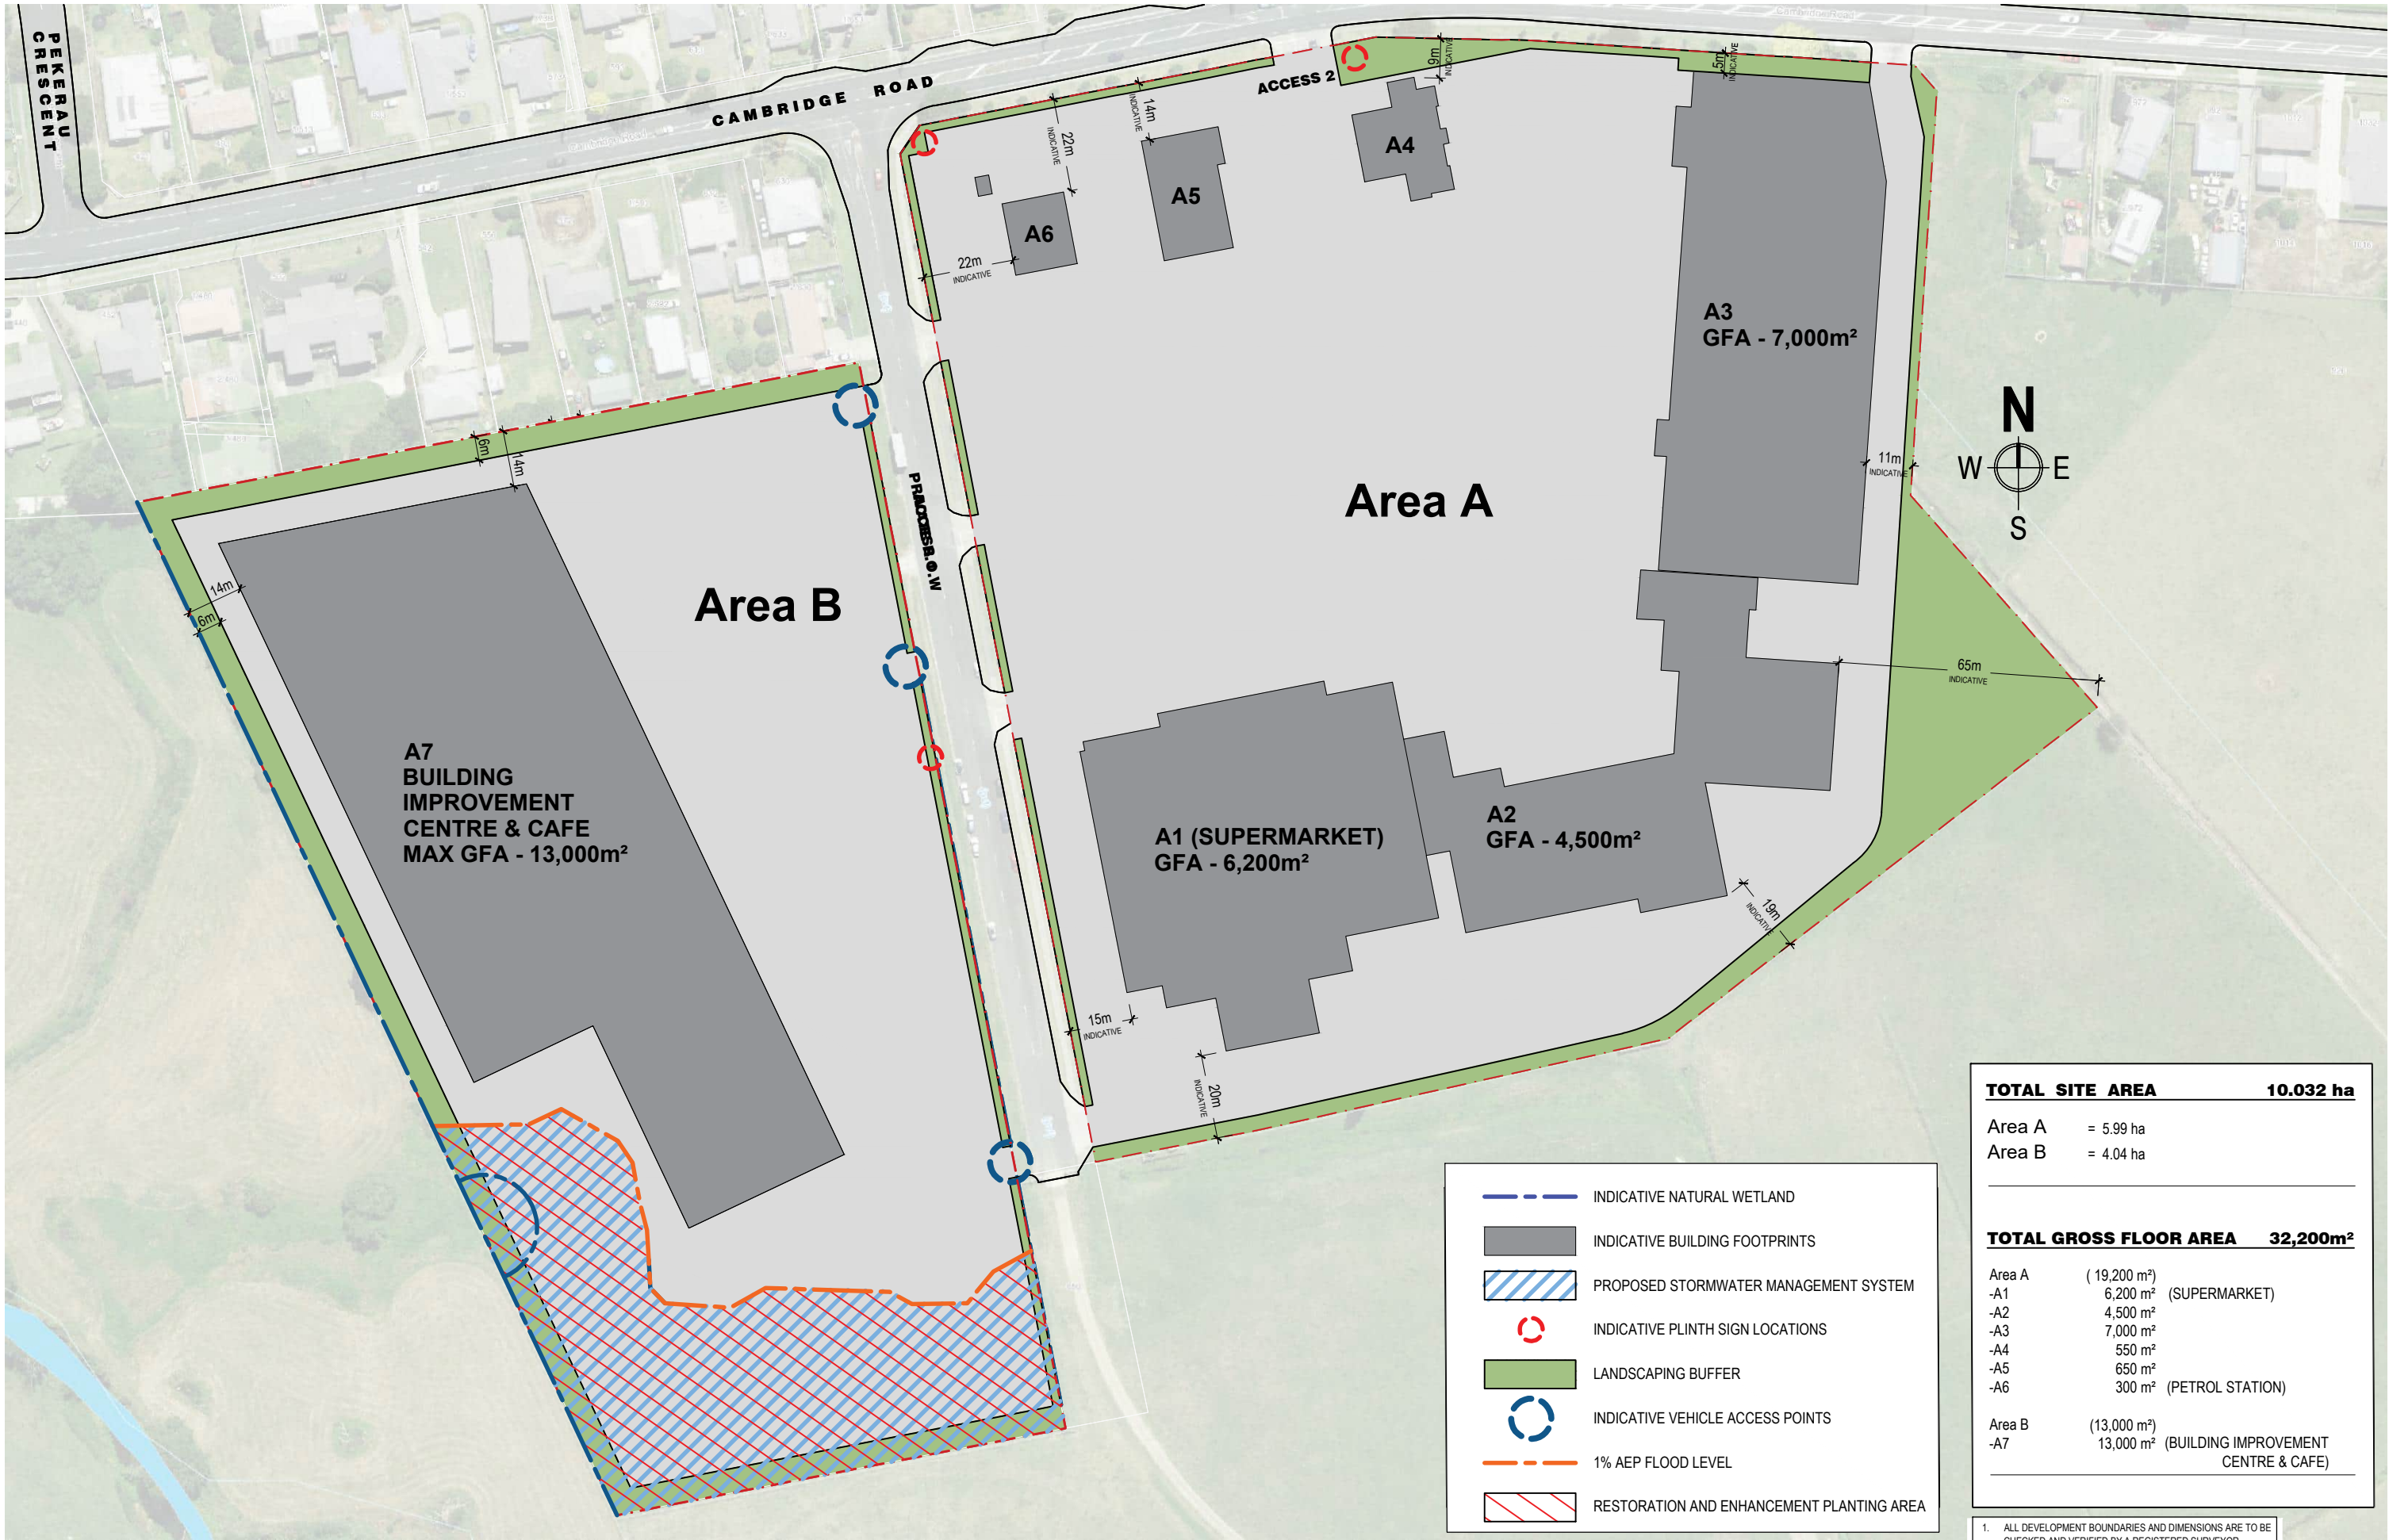
SITE PLAN Scale 1:750 @ A1, 1:1500 @ A3

The site plan by Woodhams Meikle Zhan Architects (***Appendix B***) shows a building with a 13,000m<sup>2</sup> floor area covering the western side of the Site, which we assume will be a single-story warehouse building, similar to other Mitre 10 stores.

The proposed building is shown to be offset approximately 14m from the western boundary and 7m from the northern boundary. A 6m wide landscape strip is shown along the north, south, and west boundaries. It is assumed that the remainder of the site will comprise hardstand and car parking.
