Environmental Contamination Report

Detailed Site Investigation (DSI)

Client: Waipa District Council

Job No.: 60343891

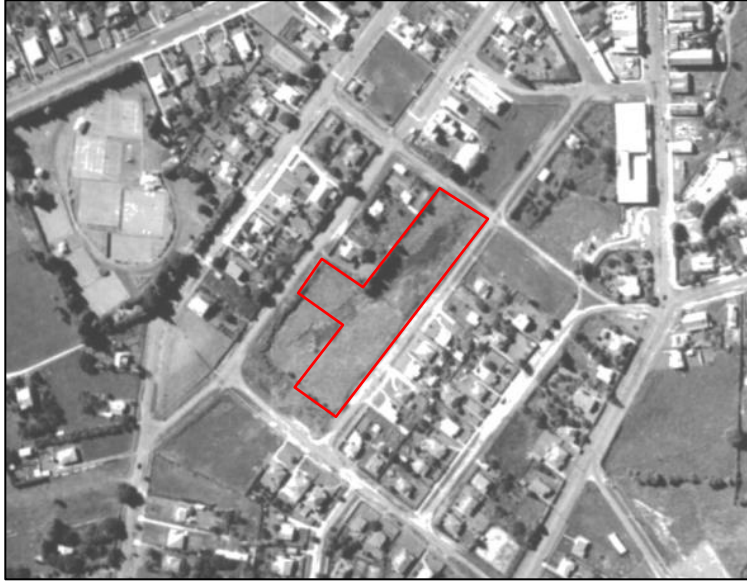
Year & Historical Photograph	Review
<p data-bbox="183 414 239 443">1944</p>

<p data-bbox="414 1048 702 1070">Source: Waikato Regional Council</p>	<p data-bbox="957 459 1404 705">The Site is undeveloped and grassed. A gully traverses the Site in a south-west to north-east direction; a small watercourse is potentially present here. Residential landuse development is evident in the areas adjacent to the Site. Vacant or undeveloped land is noted to the south-west and north-east is partially vacant.</p>
<p data-bbox="183 1086 239 1115">1957</p>

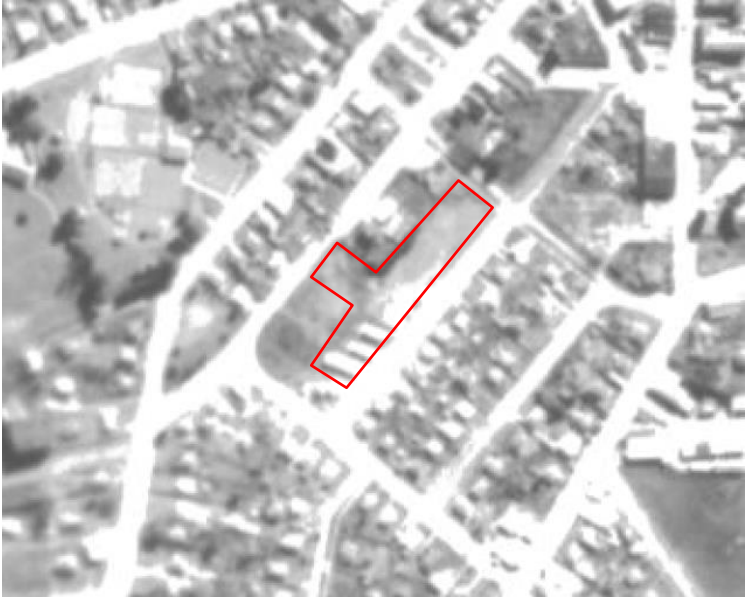
<p data-bbox="414 1731 702 1753">Source: Waikato Regional Council</p>	<p data-bbox="957 1131 1404 1310">Some pensioner houses have been constructed on the southern portion of the Site. The gully is now less visible. The previously undeveloped areas to the south-west of the Site have been developed for residential landuse.</p>

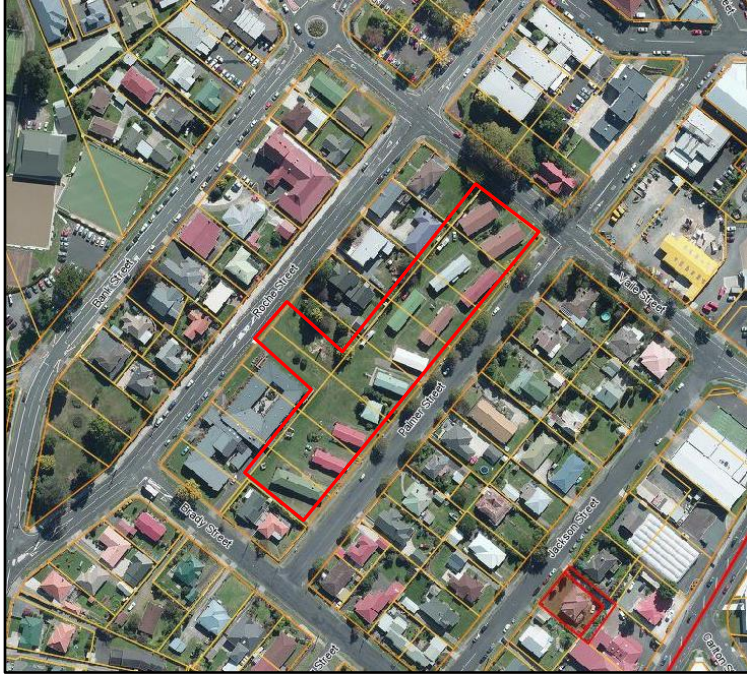
Year & Historical Photograph	Review
2006

<p data-bbox="432 1104 687 1122">Source: Waipa District Council</p>	Current Site layout.

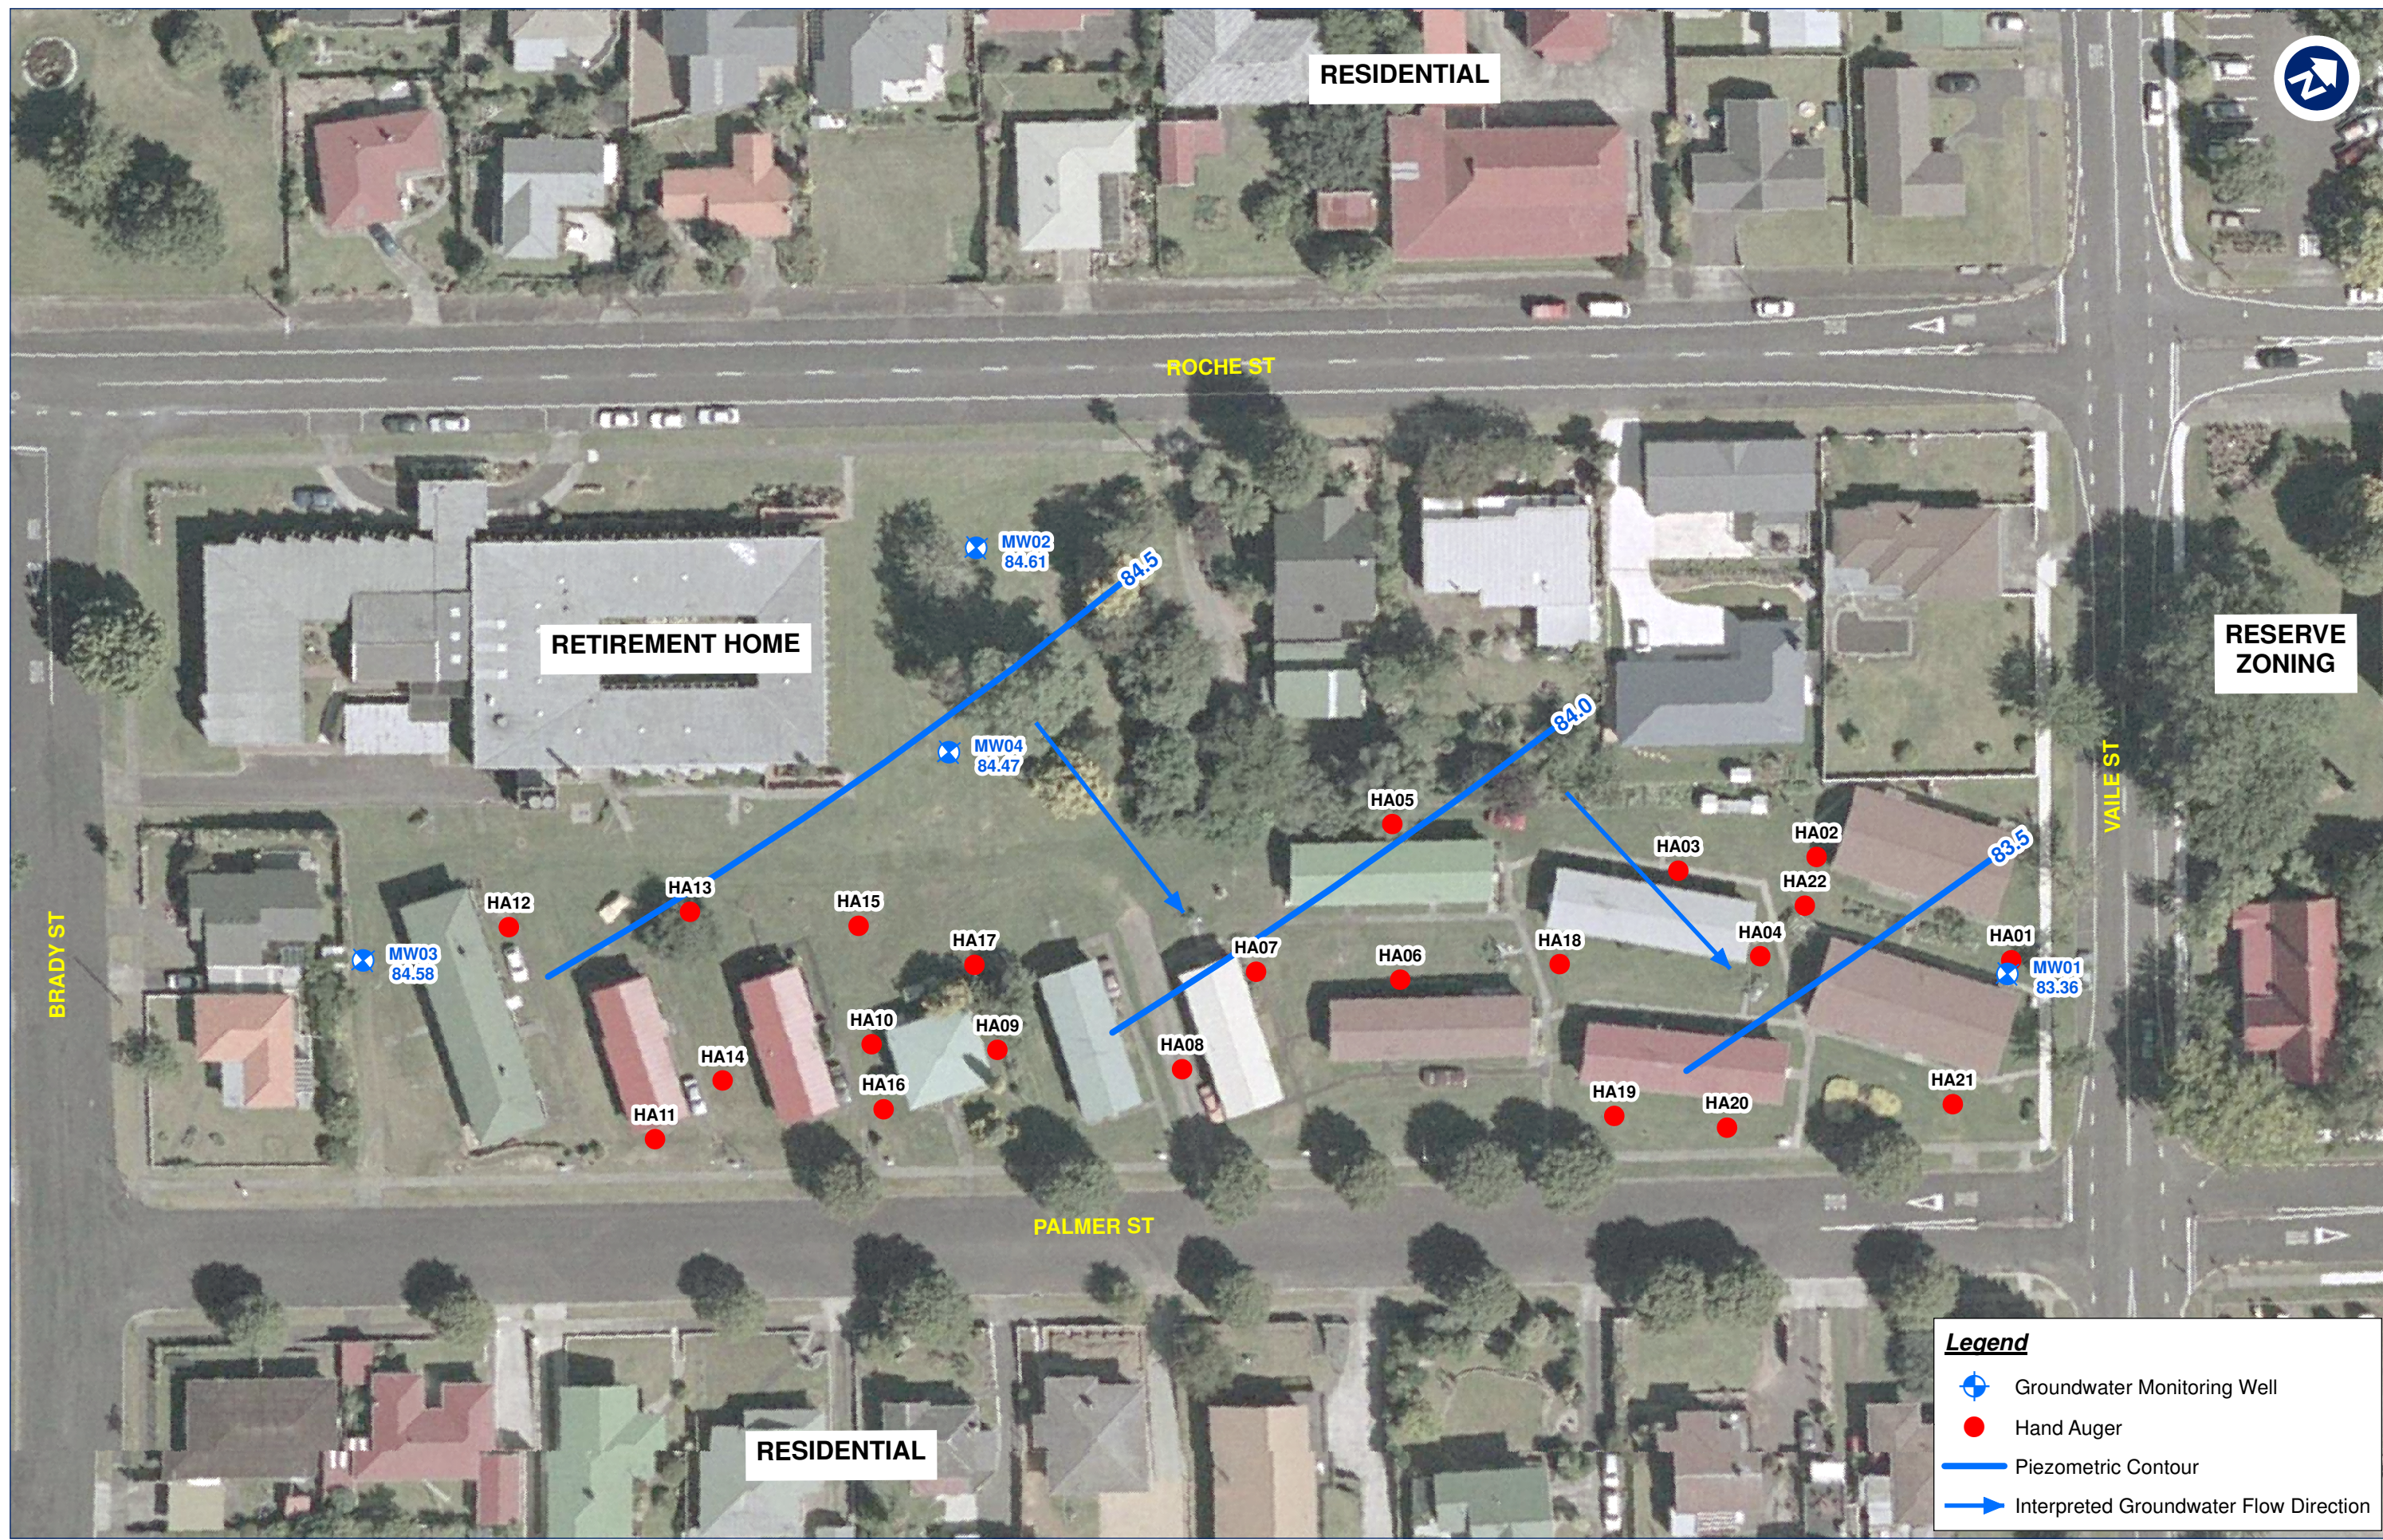
The piezometric contour plan based on the May 2015 data is presented in **Figure A4** in **Appendix A**, with groundwater interpreted to flow in an easterly to north-easterly direction, towards the Mangaohoi Stream. No significant vertical hydraulic gradients were noted between leachate and the surrounding groundwater, suggesting that groundwater is in close hydraulic connection with the fill. Approximately 0.6 m of leachate is inferred to be present within the fill, in the former location of the gully.

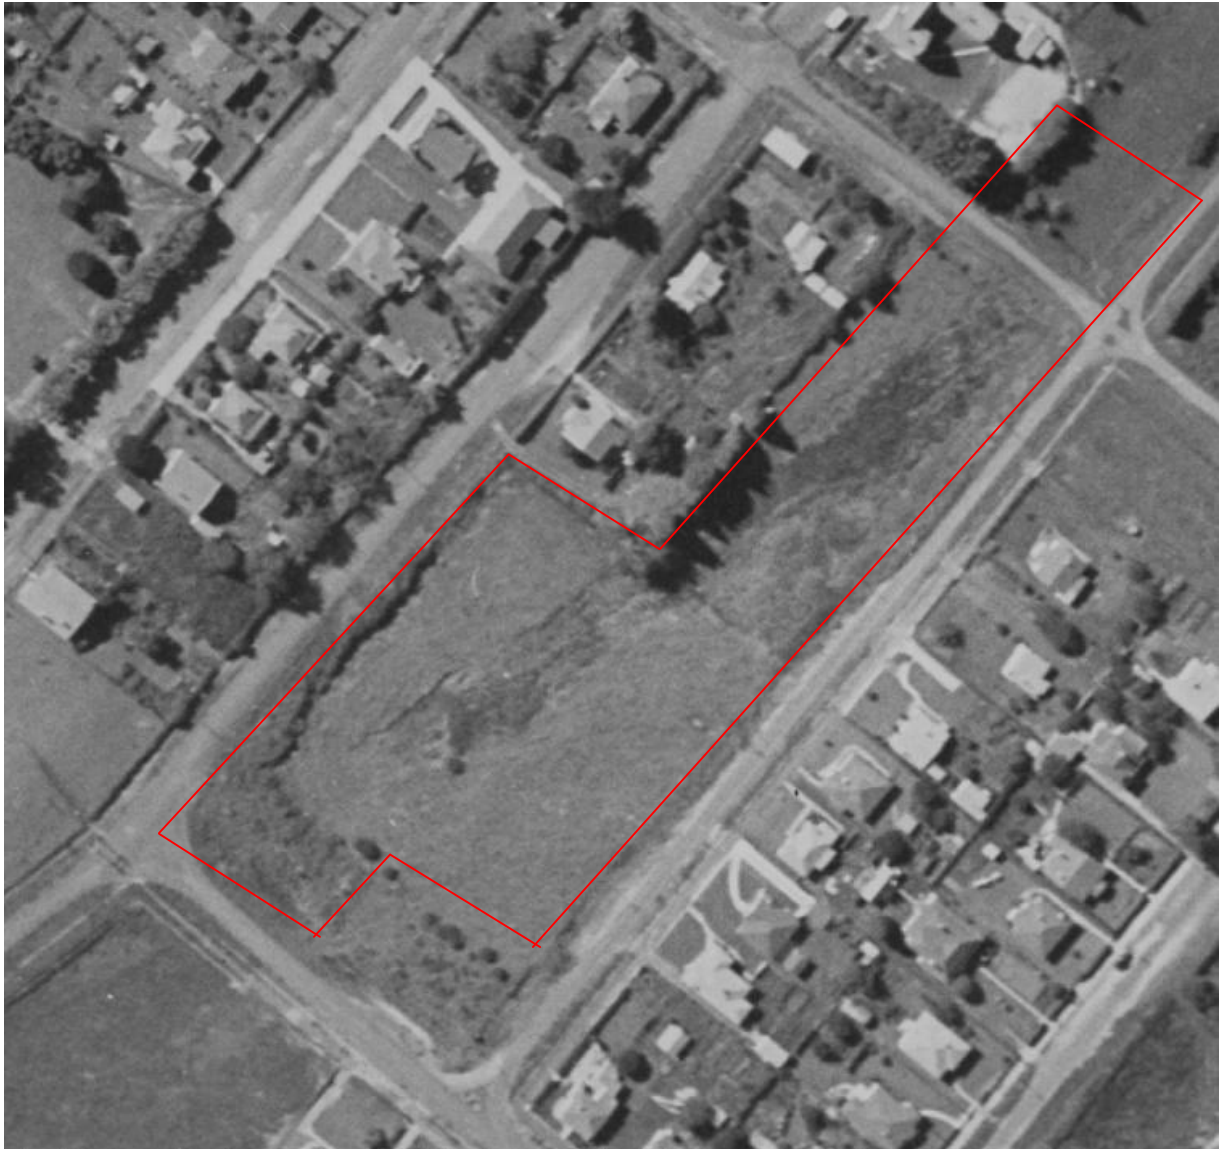
Figure 4 Situation in 1944 (Photo from NZAM). Three residential properties at northern end of the block. The red line indicates the very approximate site boundary. Clear signs of water running diagonally through this section can be seen. Older people in the area remember the site being a very boggy place.

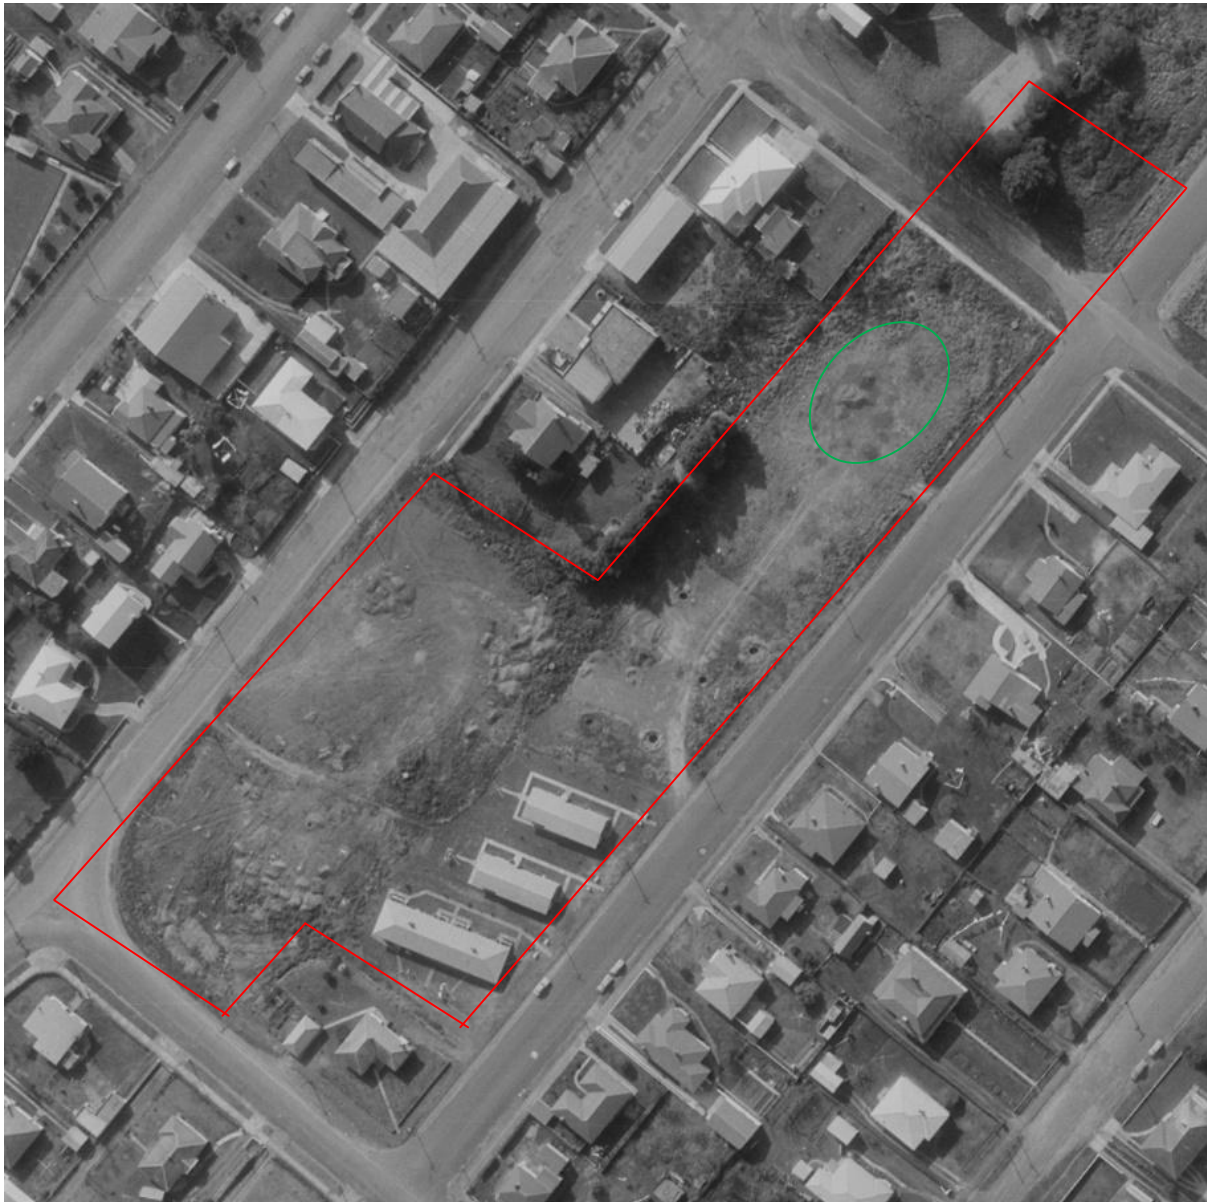
Figure 5 Situation in 1963 (Photo from NZAM). The first 3 retirement homes have been build. All over the site there appear to be stockpiles of materials. Large diameter holes have been drilled north east of the three new buildings. These could have been intended as storm water soak holes. The top NE section seems a natural depression (indicated by the green oval)

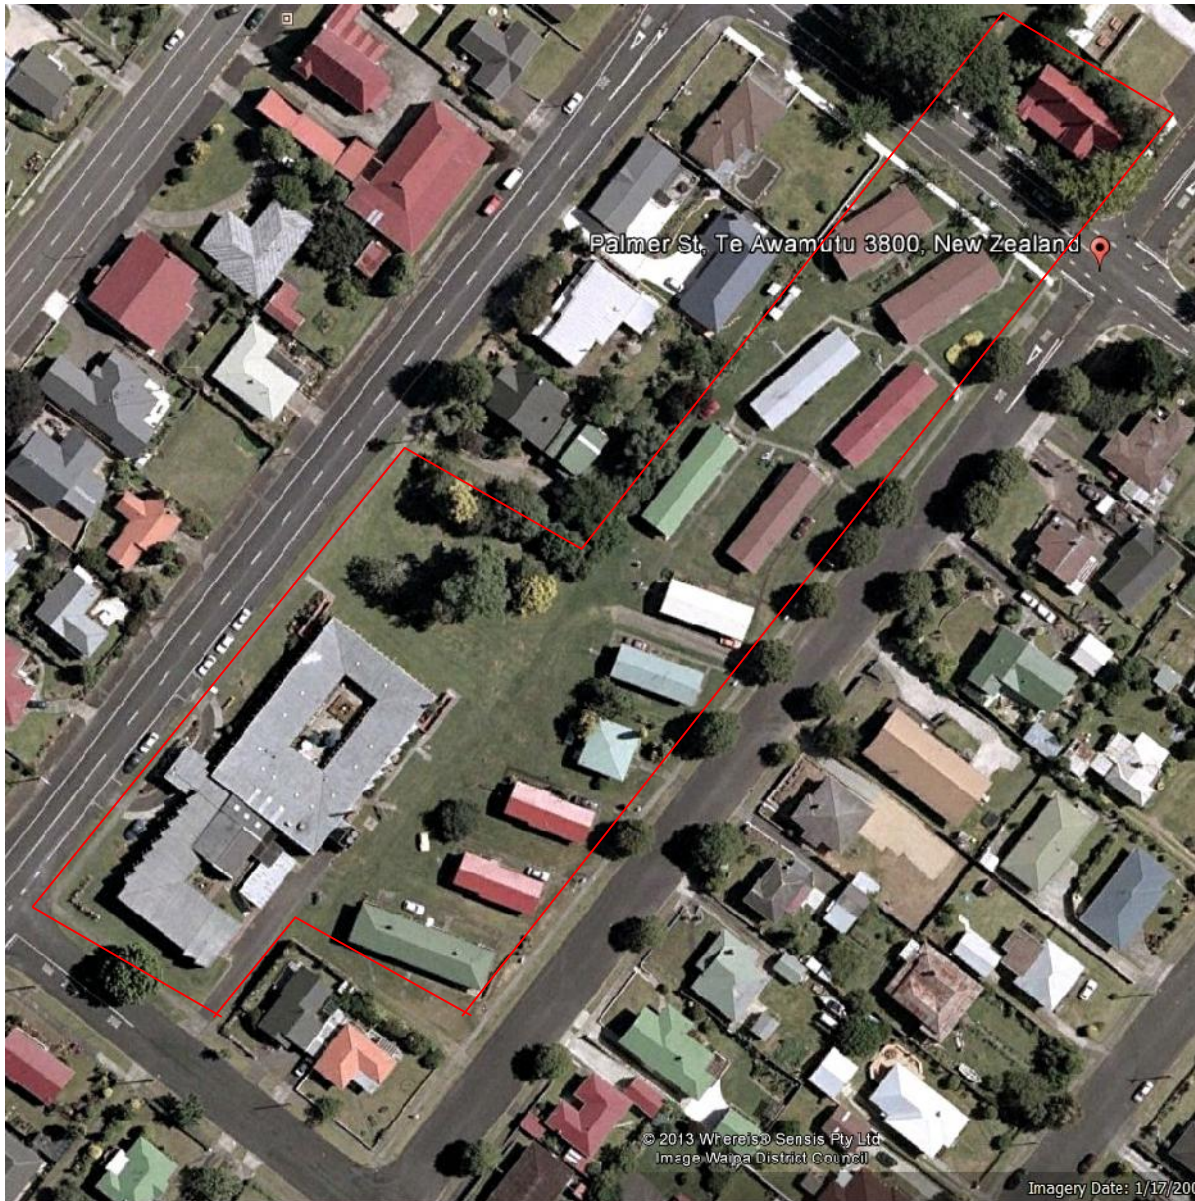
Figure 6 Situation in 2006 Note the community centre (SW corner) is located on a significantly raised area, especially in the NW corner. The building is on a pile foundation and all around the building the ground is subsiding.

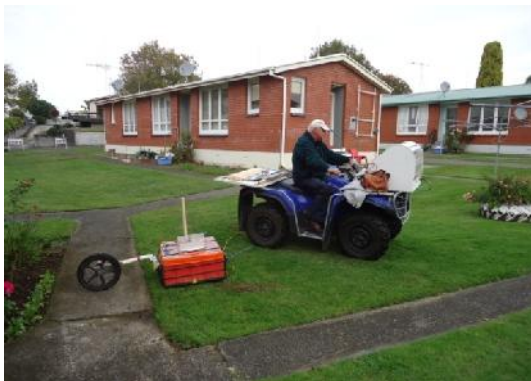
Figure 7 GPR set-up with direct PC readout unit on front of quad

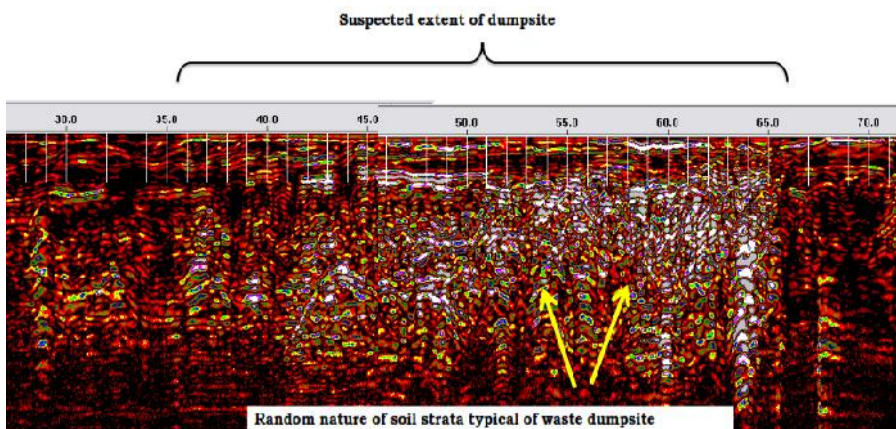
On the left more regular layering of soil can be seen, while on the right all segments are highly disconnected, indicating randomly placed fill. More radargrams are provided in the appendix.

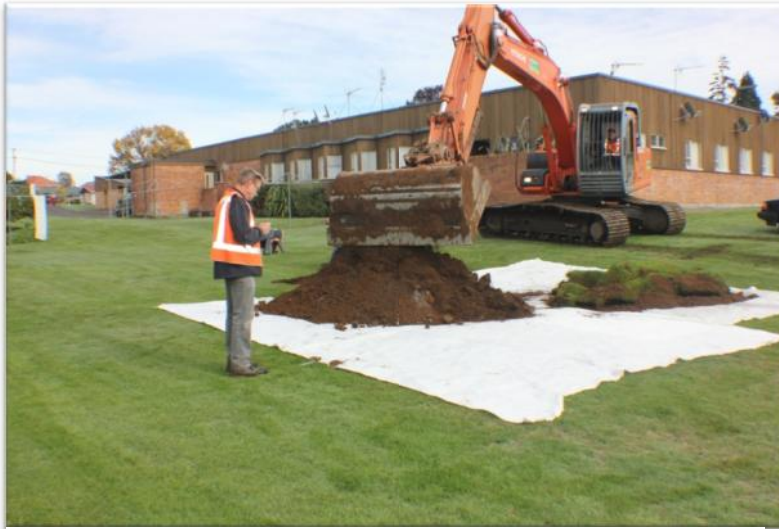
Figure 8 Sampling the anomalies found in the radargrams

All excavations showed a similar pattern, with waste free soil over the first 1 – 2 meters below the surface, after which the material rapidly changes to consisting almost entirely out of waste.

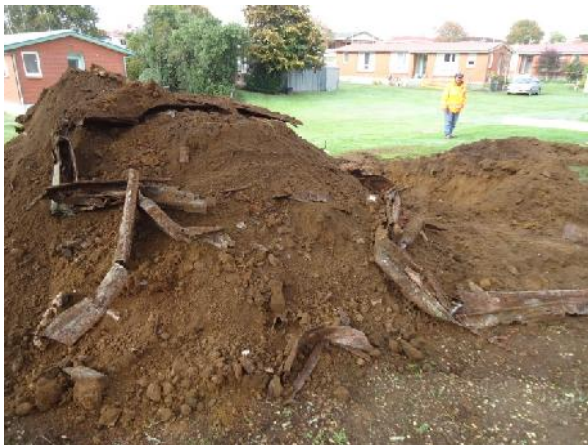
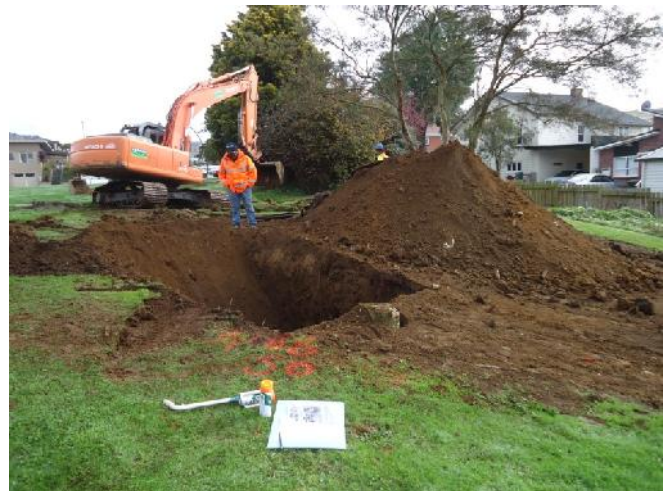
Brown waste, as can be seen on the left, appears to contain a lot of earthy component derived from composted materials in a generally aerobic environment (i.e. above average groundwater table).

Black waste is more fragmented, has far more open pore space and far more individual waste items like glass bottles. Both types of waste can have a large portion of bigger waste pieces, like car axels iron sheeting etc. (see above.).

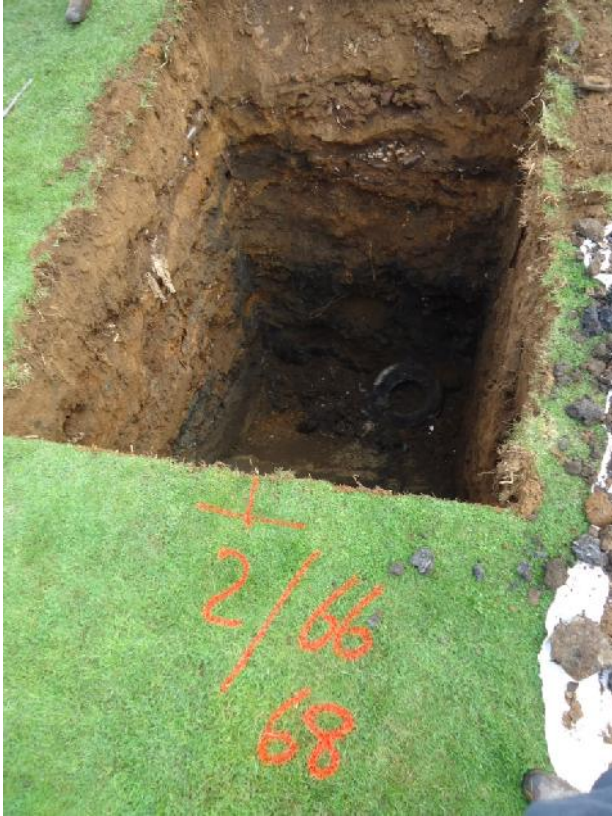
The black waste, especially when located above the water table, seems to have been burned. This has practice has been observed in other excavated landfills and is likely associated with reducing volume as well as limiting the smell from the waste dump.

On the left, an example of black waste with blown waste on top. This pit was dug on radar line no. 2 at 66 – 68 meters from the start of the line.

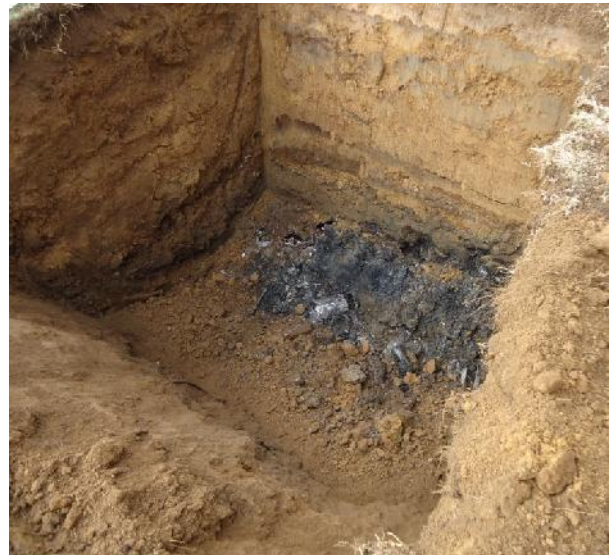
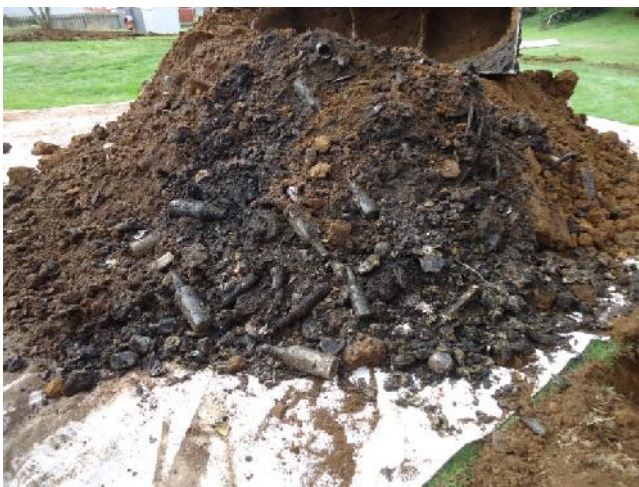
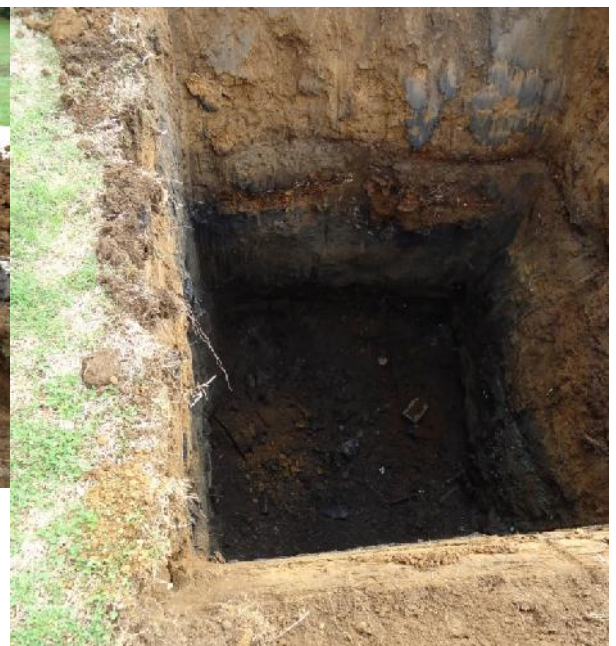
This type of black waste is very 'particle rich' as can be seen in the picture below.

This waste can extend quite deep. The pit shown in bottom right extends to 5.8 meters (pit 2/ 33-36, located at the corner of the community centre building).

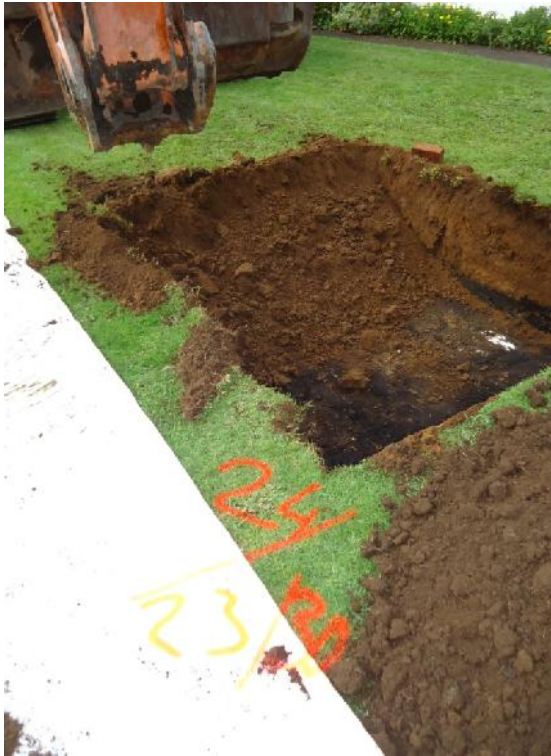
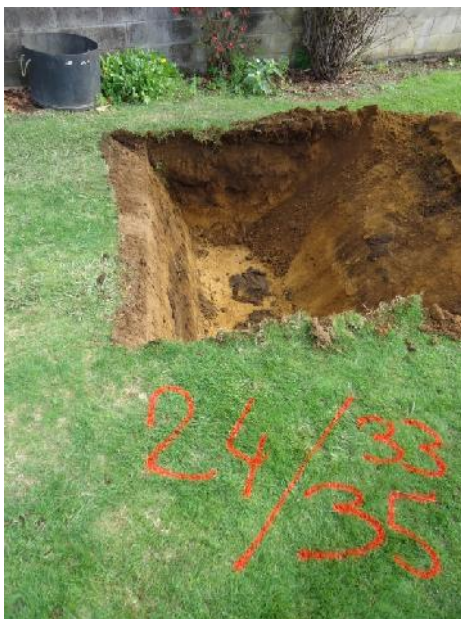
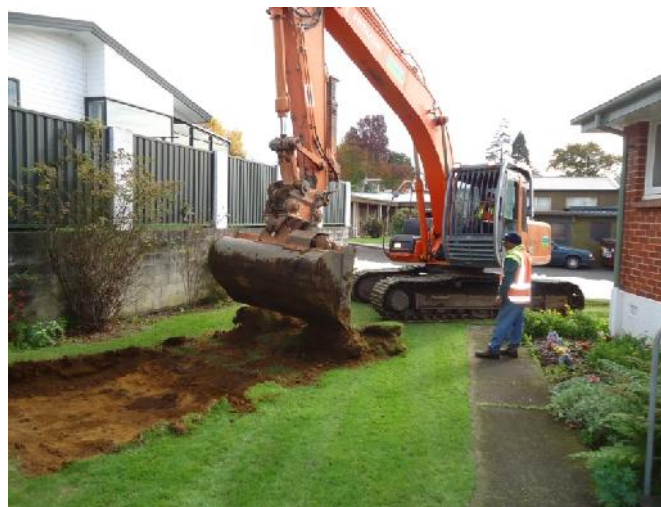
At the edges of the fill areas the 'waste' can be confused with the natural peaty soil common in bogs. On line 24 two pits were dug close together at the SE corner of the site to verify this. On the top is the pit at 23 – 30 m on line 24, showing mainly natural black soil overlain with a brown earth fill. The layer is only about 1 meter thick and contains hardly any waste (3 bottles were found). On the bottom is the pit dug 5 meters to the east (pit 2-33/35) which shows the black soil layer has wedged out and is no longer present.

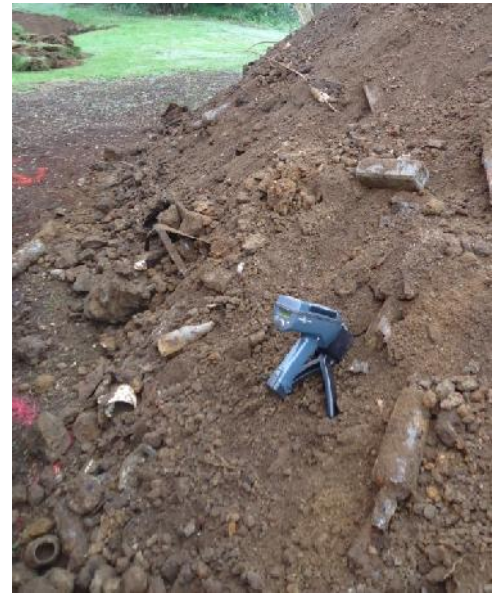
The main difference with lab analysis is that in a laboratory the soil gets sieved first and all particles over 2 mm removed. Then a 2 gram subsample is analysed by acid extraction and the extract injected into the analyser. XRF analyses do not need extraction into a liquid and hence no sieving is required. This does mean larger pieces get analysed which the lab misses, however it also creates a larger variability of results. In this project this is good, as it provides insight into the range of concentrations that exist within the fill. An example is provided below for a sample from a pit on line 4 at 23.5 – 29 m (pictured on the above right).

Sample No.	Ti	Cr	Co	Ni	Cu	Zn	As	Pb	Analysis	Date
	mg/kg d.w.									
pit 4 -23.5-29	548	45	390	22	52	104	7	337	on-site	15-May
pit 4 -23.5-29	96	114	197	15	88	219	3	609	on-site	15-May
pit 4 -23.5-29	2090	169	442	41	14	99	9	57	on-site	15-May
pit 4 -23.5-29	150	32	16	5381	10964	195	5	13	on-site	15-May
pit 4 -23.5-29	150	103	219	199	261722	2782	85	389	on-site	15-May
pit 4 -23.5-29	1122	13	157	11	25	83	8	51	on-site	15-May
pit 4 -23.5-29	530	24	167	13	22	139	24	106	on-site	15-May
pit 4 -23.5-29	3475	81	981	21	31	444	15	686	on-site	15-May

Going over the metals, we see a large variation in Titanium. Around 1000 is natural soil, higher may indicate some paint pigments are added, lower means less natural soil present. The latter can be seen when we jump to Nickel and Copper (Cu) which are high when Ti is low indicating corrosion products of some alloy make up the volume rather than soil. Note 261722 mg/kg copper is 26% copper, with added oxygen copper oxide will make up most of the 'soil' volume in this sample. Chromium and Cobalt are used to detect waste oil and the first also treated wood residues. Zinc (and copper) is benign to people, but highly toxic to the environment, especially in the water phase (rivers etc.). Of main concern on this site is the health of people, for which arsenic and lead (the last two in the list) are indicative. For arsenic the NES soil quality value is 20 mg/kg arsenic and it is 210 mg/kg for lead. Both values are exceeded in many of the analysis results.

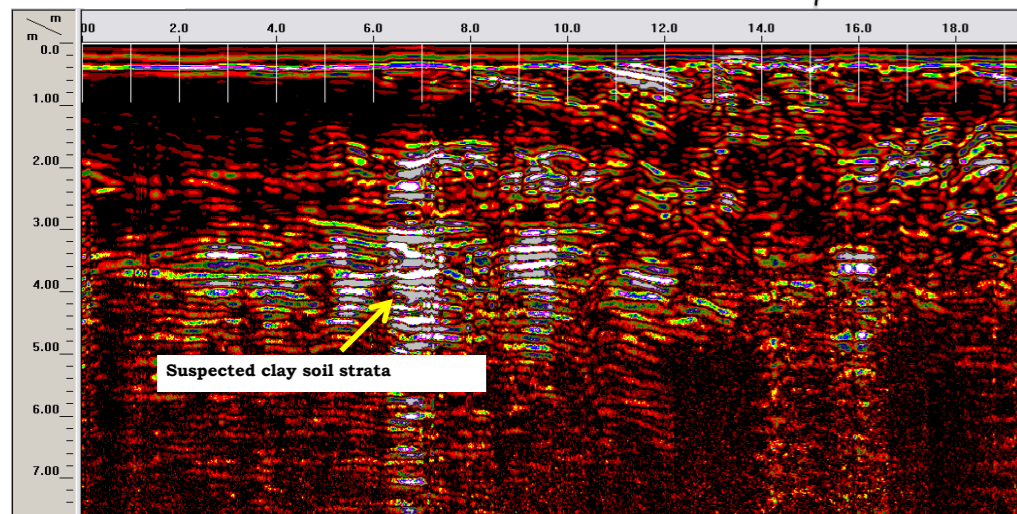
File 10

GPR scan crosses footpath with
suspected underground services
Some small variation in GPR reflections
seen in this area - possible effect of fill
material ?
