## MEMORANDUM

**Subject:** Former Tokanui Hospital – Evaluation of Fish Passage for Proposed Culvert 3 (V4)

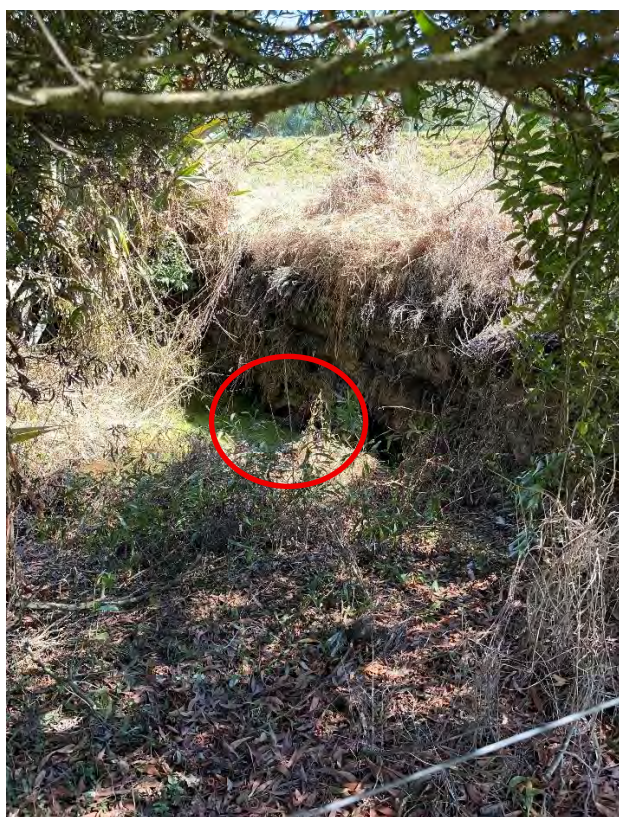
**Figure 1: Culvert 3 Inlet – 29 Feb 2024**

Observations from multiple site visits are that Culvert 3 is typically either fully drowned or almost drowned, under both normal and storm flow conditions. This is shown in Figure 1 below, where the top of culvert 3 at the inlet end is just visible.

It should be noted that the stream bed gradient through this area is relatively flat, with an estimated bed gradient of 0.3%, while water levels at culvert 3 are controlled by existing trees/vegetation within the stream itself below Te Mawhai Road and the Te Mawhai Rd culvert (C1). Removal of culvert C2 between C1 and C3 has been modelled to help reduce stream flood levels upstream of C2 but is unlikely to have an effect on normal stream water levels, due to the stream bed gradient, existing vegetation/trees and C1 all restricting flow, causing water to back up through this area. This is supported by FTL staff who have visited the Tokanui site regularly over the last two years, including during summer, only ever having seen the top of C3 once, with it just visible above the water level, meaning the water depth would have been around 1.-1.1m under low flow conditions, further supporting the above comments (refer photo in Figure 1).
