**TOKANUI HOSPITAL DEMOLITION, REMEDIATION AND LANDFILL  
UPGRADES**

**STATEMENT OF EVIDENCE OF SEAN MATTHEW FINNIGAN (ENGINEERING,  
CONTAMINATED LAND AND ENVIRONMENTAL EFFECTS) ON BEHALF OF  
THE APPLICANT**

Dated:            12 September 2025

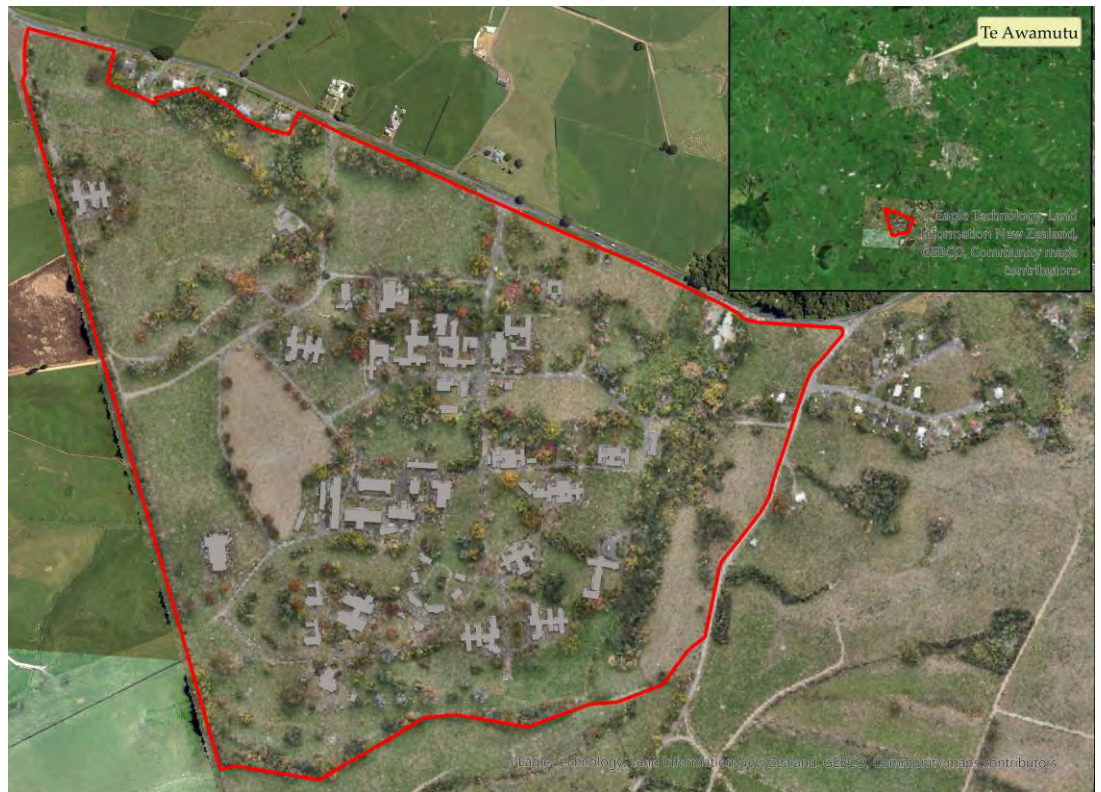
**Figure 1: Site location and extent**

33. The Site is located at 149 Te Mawhai Rd, Tokanui, approximately 14 kilometres southeast of Te Awamutu, Waikato. The Site was developed in 1912, and operated through to 1998. The Site is approximately 79ha in size and contains 84 buildings/structures, a now decommissioned wastewater treatment plant (**WWTP**), a swimming pool, eight substations, substantial underground services, a closed landfill and substantial roading infrastructure. The **Site** is shown in **Figure 1**.

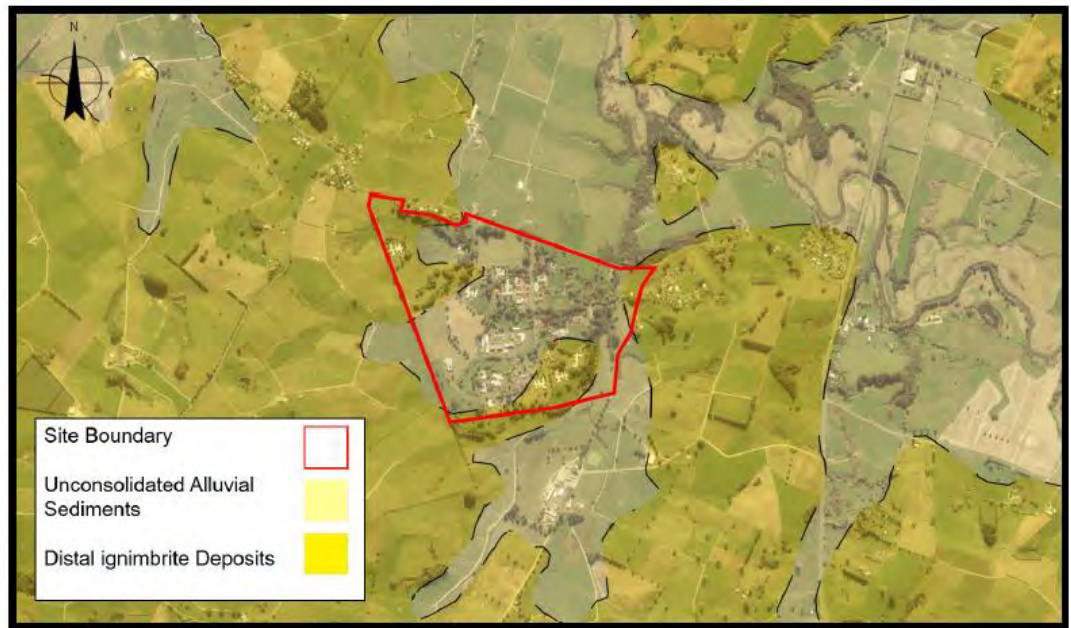
**Figure 5: Published Geology Map (source: GHD, PSI, May 2022)**

42. The Institute of Geological and Nuclear Sciences geological web map (NZ 1:250,000) indicates that the site is predominantly underlain by middle Pleistocene to late Pleistocene River deposits consisting of locally derived pumiceous clays, sandy clays and gravels of the Tauranga Group. A small portion of the Site is underlain by early Pleistocene to middle Pleistocene River and igneous deposits consisting of alluvium dominated by primary and reworked, non-welded ignimbrite of the Walton Subgroup, which is part of the Tauranga Group. **Figure 5** below shows the underlying geology of the area.

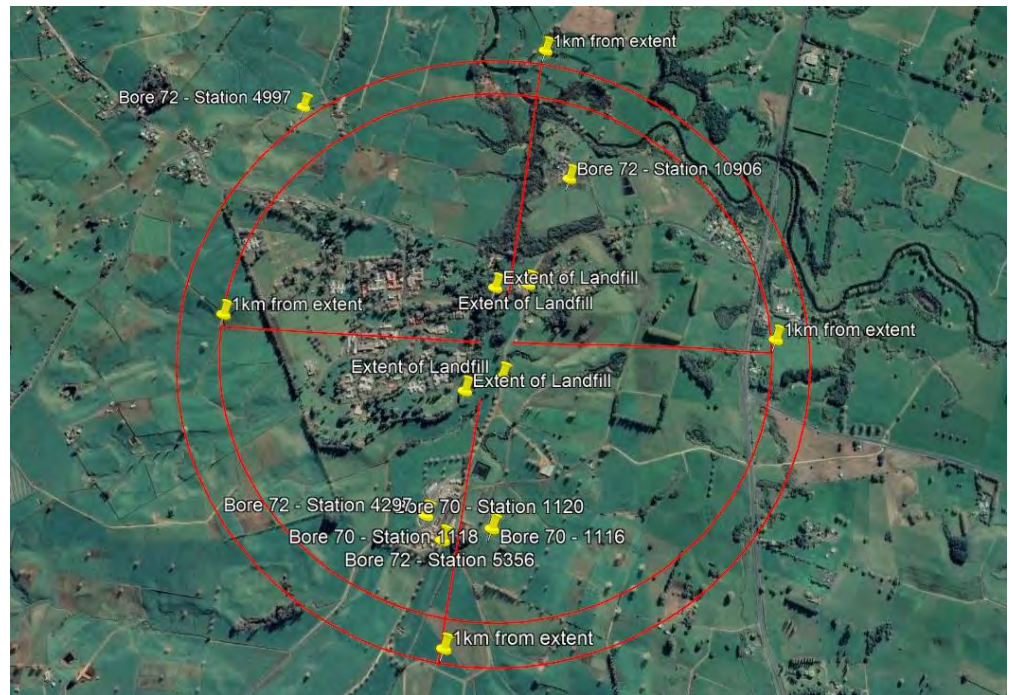
44. An Environment Waikato database search was done for all groundwater bores within 1km radius of the landfilling area, the results of which are shown on **Figure 6**. This search showed there are six groundwater bores within 1km of the site, of which only one is located downgradient (north) of the landfill. This bore (Bore 72, Station 10906) was formerly used by Pūniu River Care for irrigation of their nursery operation, but they have advised by email from Shannon Te Huia (8 August 2024) that they no longer use this bore, but instead have a water surface take from the Wharekōrino Stream as described further below and illustrated in **Figure 10**.

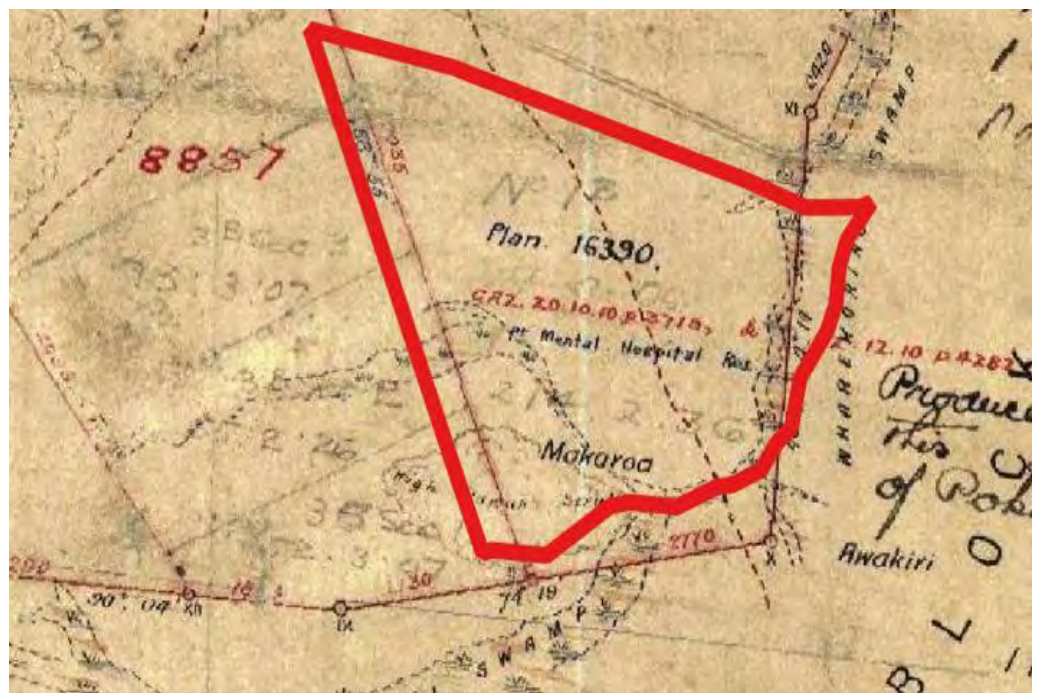
**Figure 7: Tokanui Hospital Site – Historical Plan showing former swamps (from CFG, July 2024)**

45. CFG Heritage Ltd (**CFG**) (July 2024) refer to the Site being located at the junction of three waterways, noted in ML 6748 drawn in 1889 as Makaroa, Tarutahi and Wharekōrino Swamps as shown in **Figure 7**.

46. Of these swamps, the Wharekōrino Stream is still present and flows through the Site from south to north, separating the hospital area from the historical Disposal Site area, which is located on the eastern portion of the Site. This stream includes swamp-like features, while the Tarutahi Swamp appears to be part of the Wharekōrino Stream above the Site, and the Makaroa Swamp is no longer present.

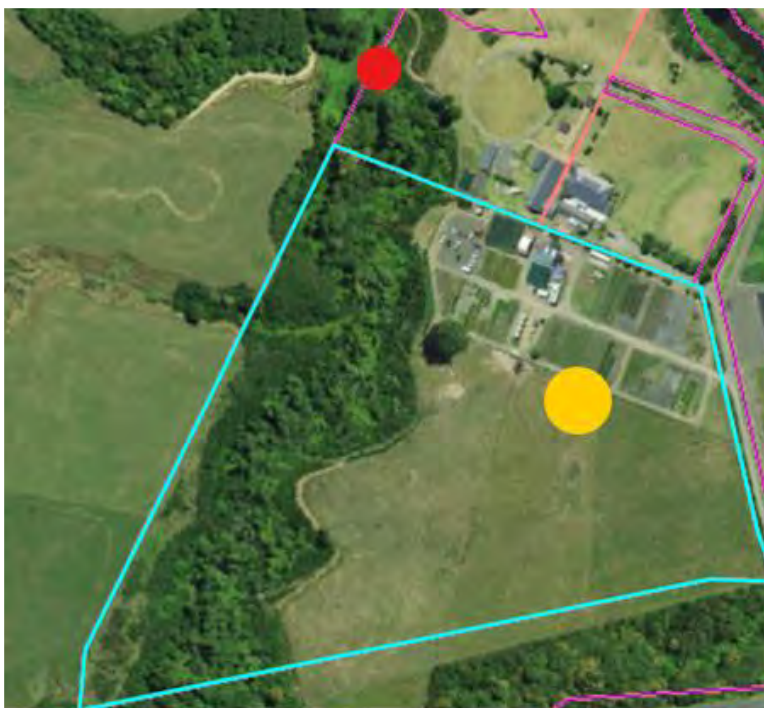
**Figure 10: Pūniu River Care Surface Water Take Inlet Location (red dot) on Wharekōrino Stream; yellow dot is location of their bore which is no longer used**

49. Pūniu River Care holds resource consent AUTH144702.01.01 (valid until October 2037) to take water from the Wharekōrino Stream for irrigation of a 3ha plant nursery during September-March inclusive, based on a daily maximum take of 100m<sup>3</sup> and total annual take of not more than 10,000m<sup>3</sup>. The inlet structure is located on the Wharekōrino Stream at the location of the red dot shown below in **Figure 10**, with the disused groundwater bore (Bore 72, Station 10906) indicated by a yellow dot. The water take location is approximately 550m below the Site's northern boundary.

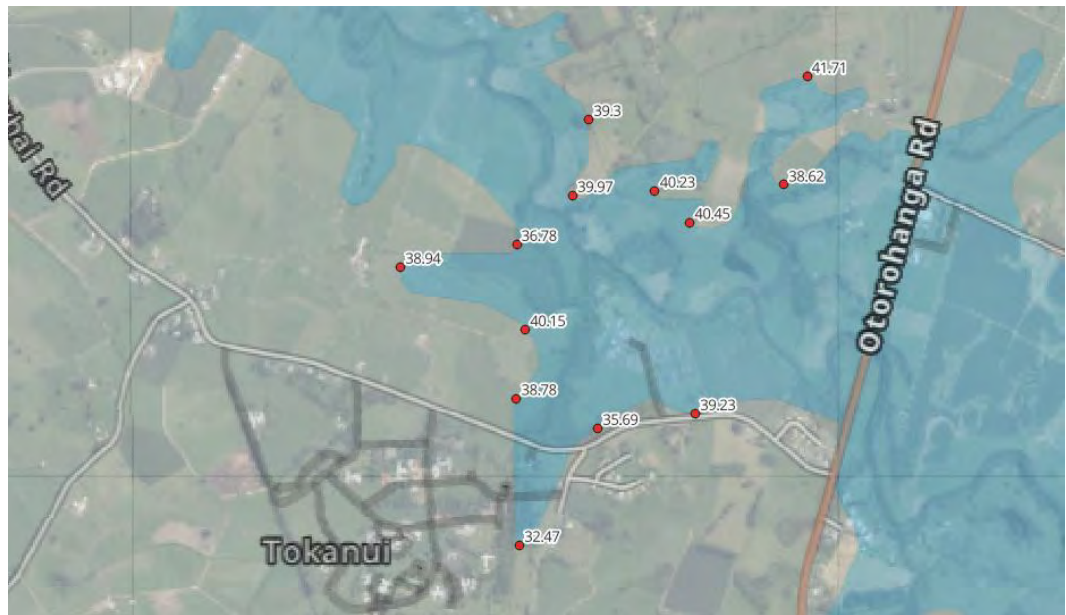
**Figure 17: Flood extent elevation for Regional Scale Flood Hazard – Pūniu River**

148. Our review of available flood modelling information shows that flooding of farm land on the western side of the Wharekōrino Stream is more likely due to flooding from the Pūniu River itself, as this has a relatively extensive floodplain and causes water to flow back up the Wharekōrino Stream and into adjacent farm land on the western side of the Stream. Predicted flooding from the WRC Regional Scale Flood Hazard mapping for the Pūniu River is shown in **Figure 17** below.

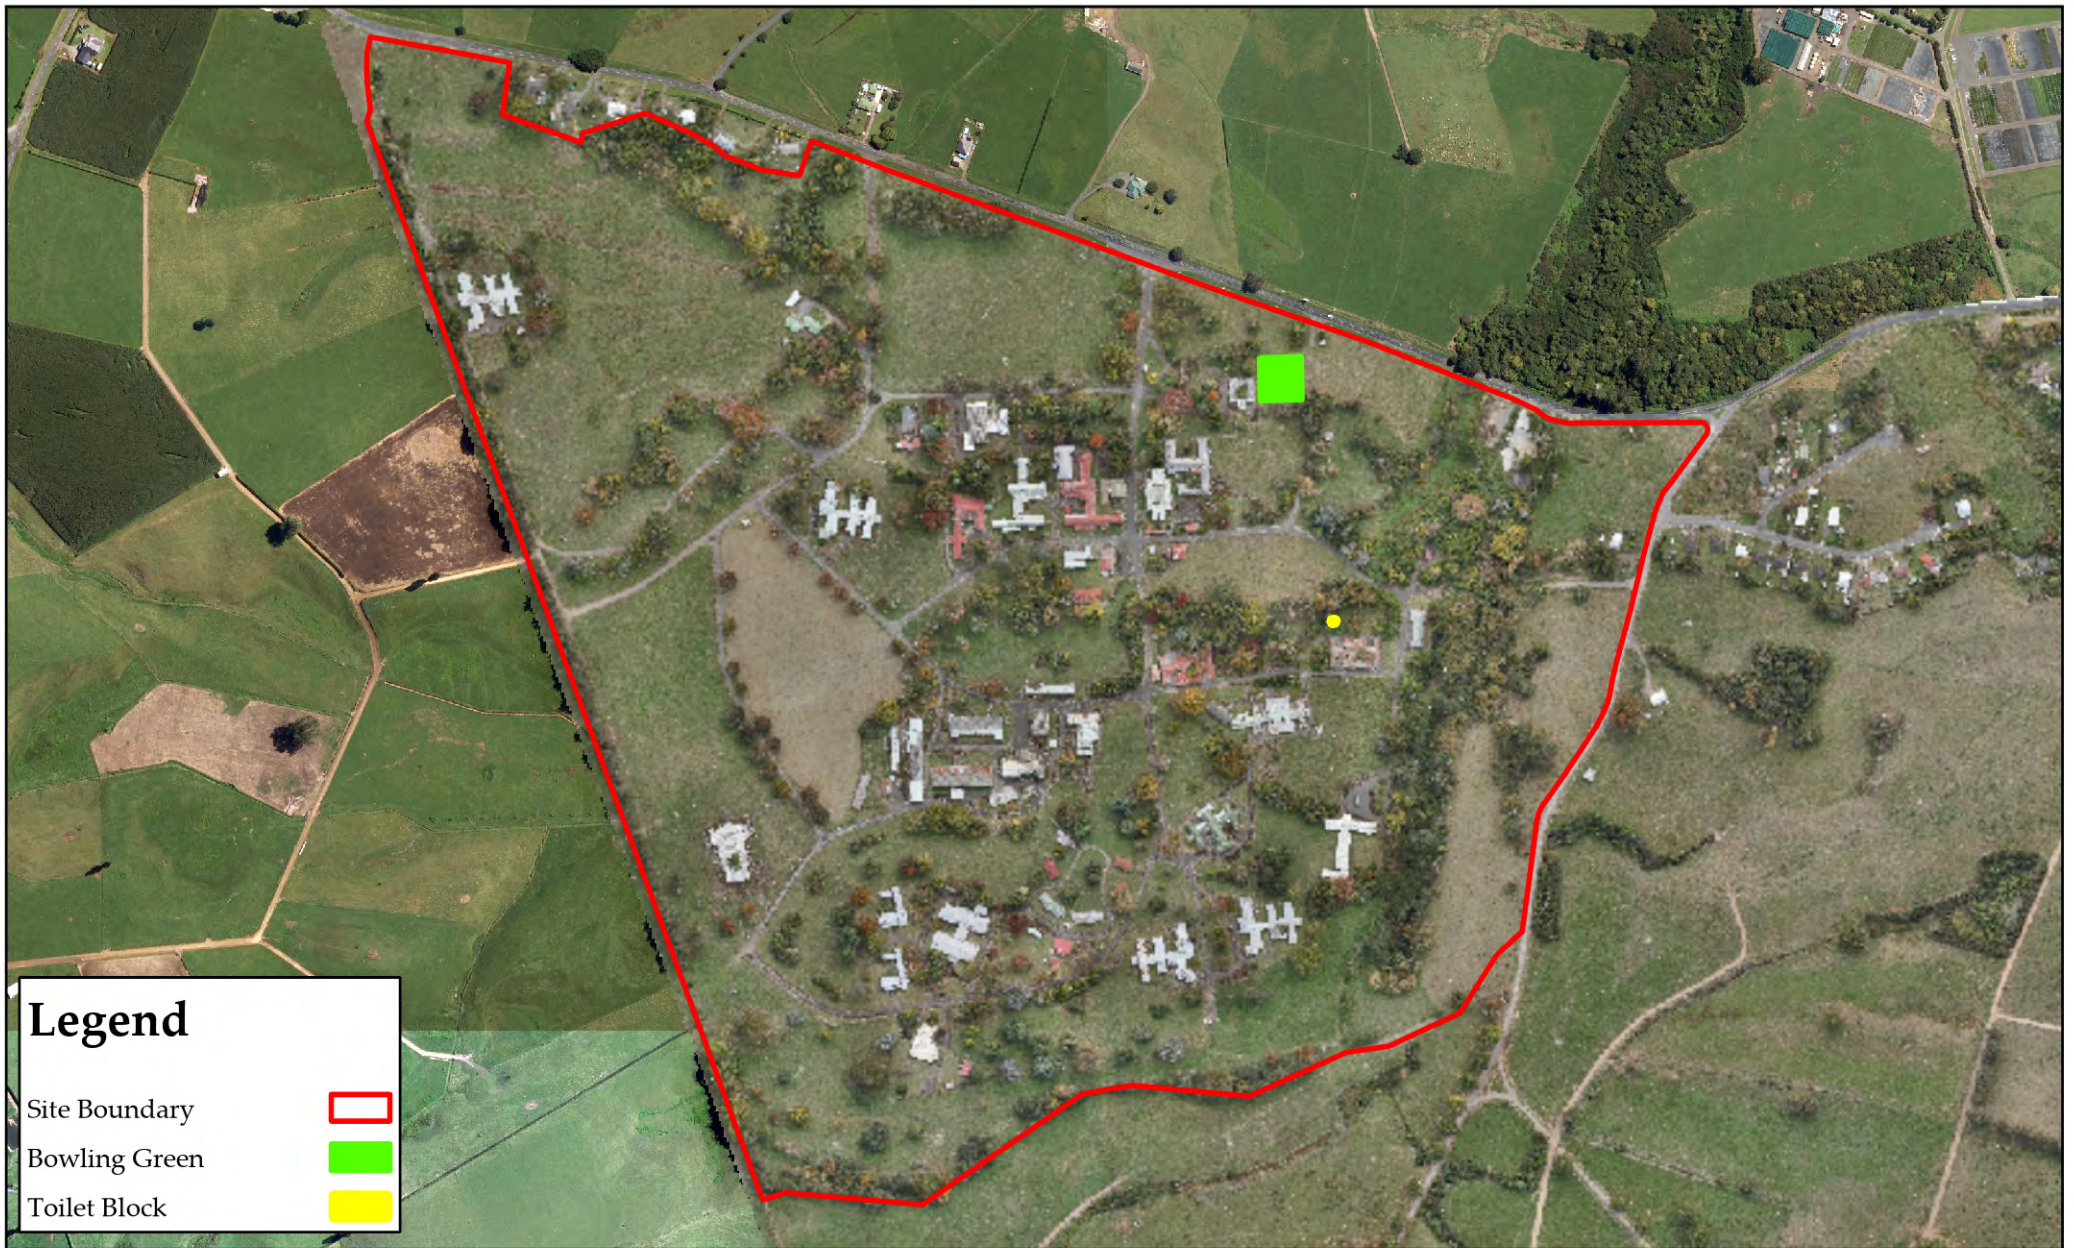
**Figure 1: Site Location Plan**

The additional structures, namely the historical bowling green and toilet block, which were not surveyed or sampled in previous investigations of site infrastructure, are located within the north-east portion of the site (see Figure 1 attached to the report). The objective of this assessment was to determine the contamination status of soils within and surrounding these additional structures, which were not visually identified during the previous investigations listed above.

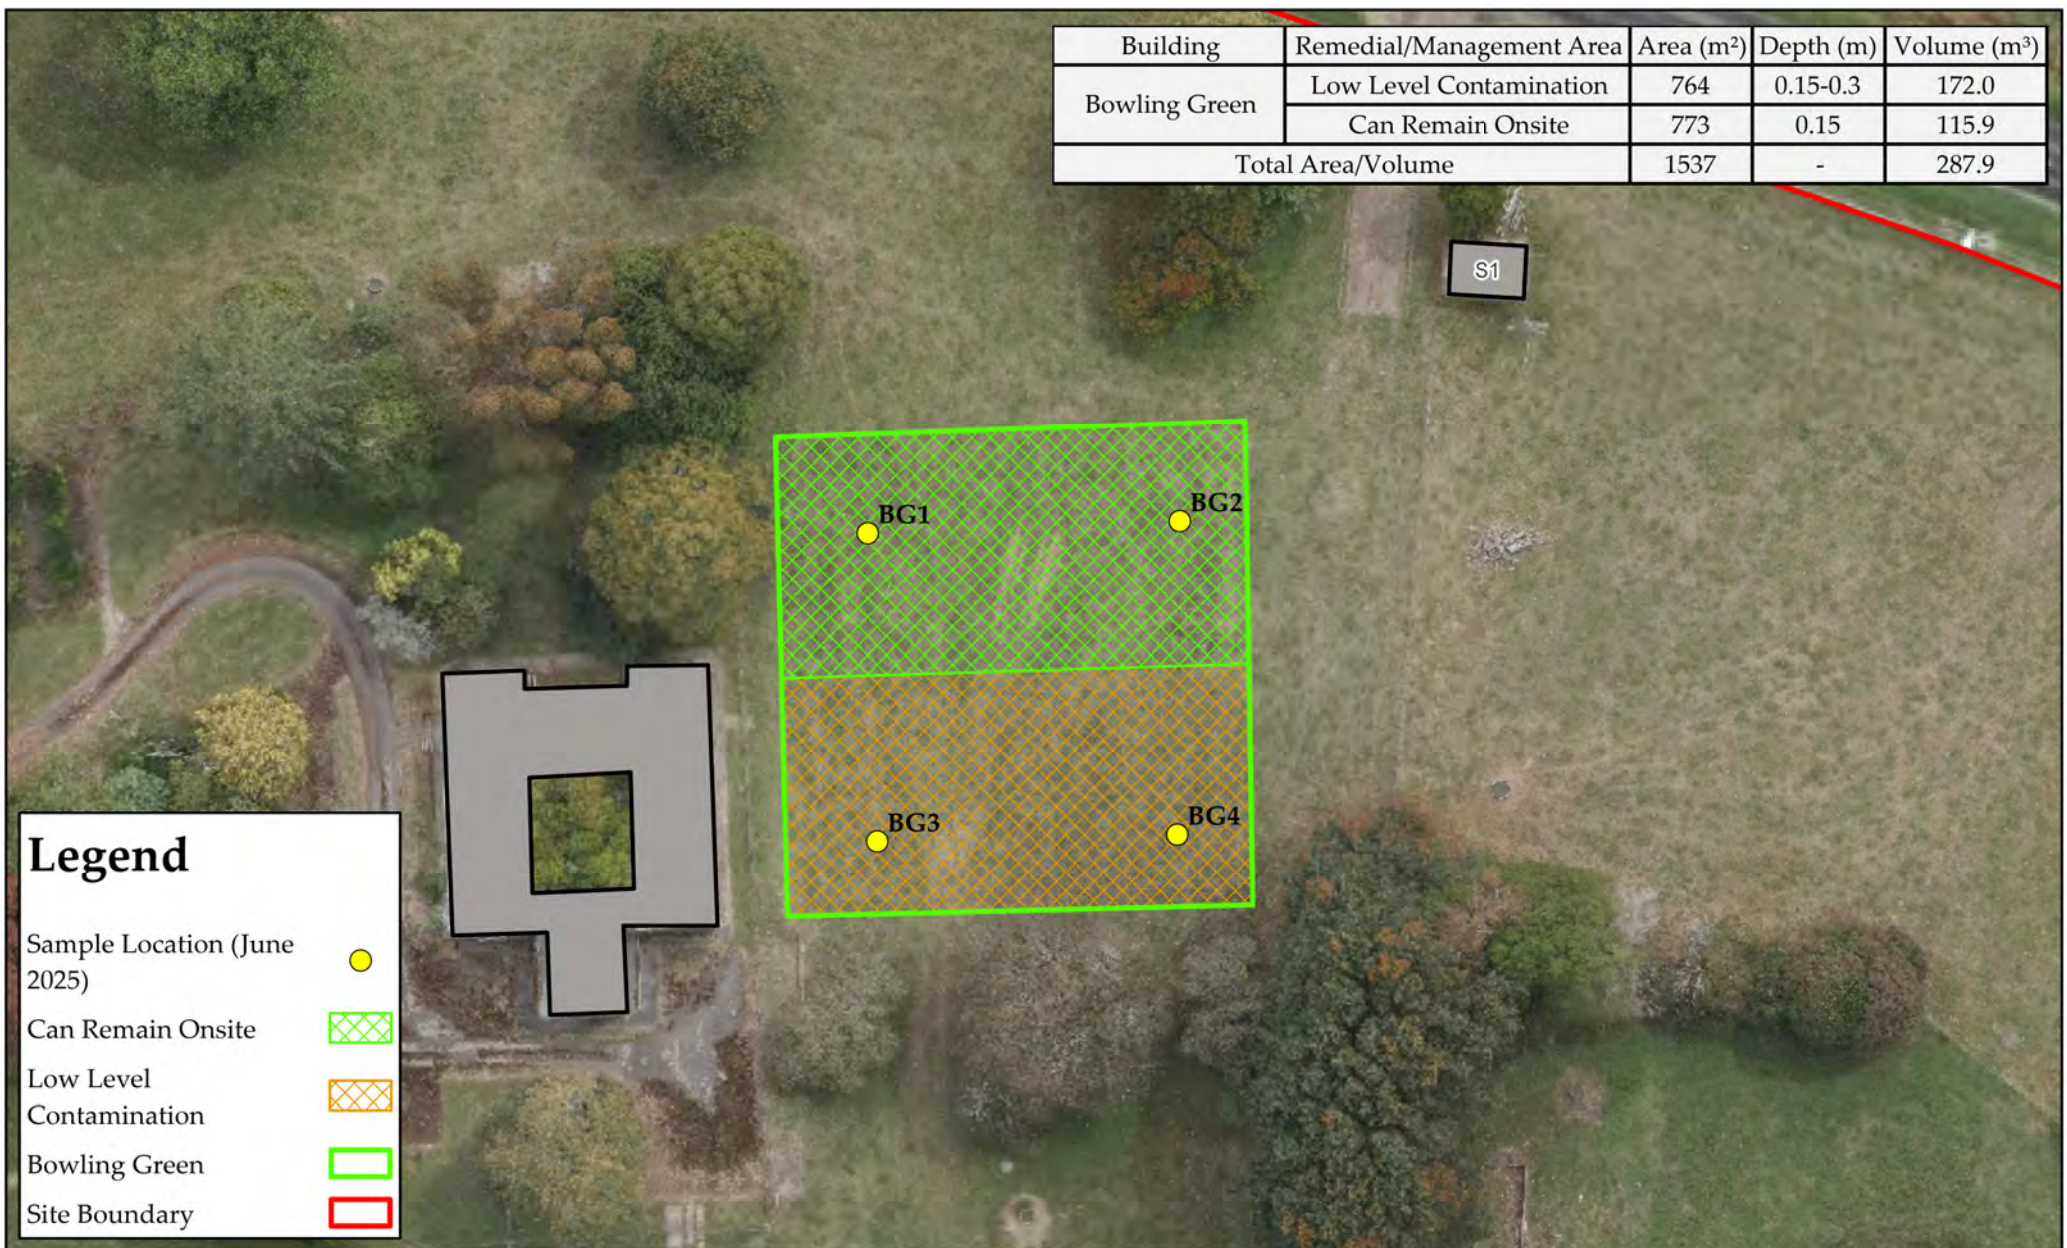
**Figure 2: Sample Location Plan - Bowling Green**

- On the 13<sup>th</sup> May 2025, 4 samples were collected from 4 locations at a single depth (0-0.15m) from soils within the historical bowling green footprint. Following this, on the 13<sup>th</sup> June 2025, 12 deeper samples were collected from the original 4 locations at 3 additional depths (0.15-0.3m, 0.3-0.5m & 0.5-0.7m). All 16 individual samples collected from the footprint of the bowling green were analysed for heavy metals, mercury, and OCPs, and a single sample (BG03 0.3-0.5m) was also analysed for PAHs, due to the identification of minor fill. Sample locations are shown in Figure 2.

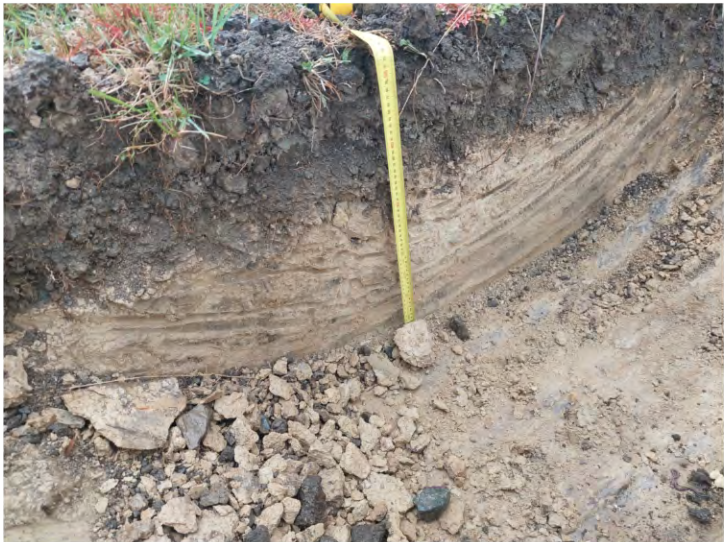
| <b>Profile:</b><br> | <b>Excavation Method:</b><br>5t Excavator |
| | <b>Remarks:</b><br>1. Groundwater not encountered on 19/03/25. |

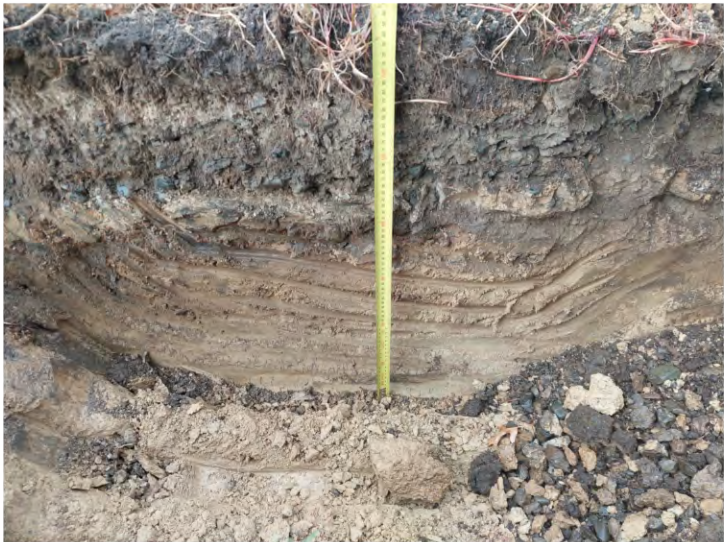
| Depth (m) | Description of Strata | Geological Unit | Graphic Log | Undrained Shear Strength (kPa) | | | | | Depth (m) | Dynamic Cone Penetrometer | | | | | | | | | | | Groundwater | |
|---|---|---|---|---|---|---|---|---|---|---|---|---|---|---|---|---|---|---|---|--|---|--|
| | EOTP: 0.65 m TARGET DEPTH | | | ○ | ● | | | | | 116<br>(32) | | | | | | | | | | | | |

| | <b>Remarks:</b><br>1. Groundwater not encountered on 19/03/25. |

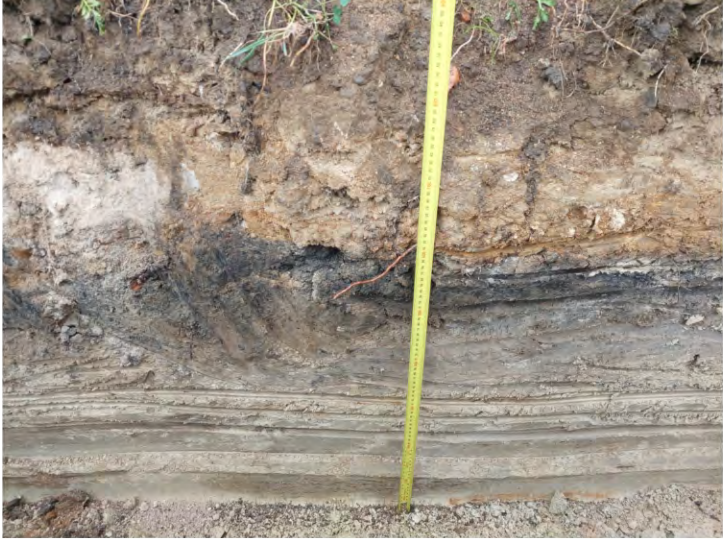
| | | Remarks:<br>1. Groundwater not encountered on 19/03/25. |

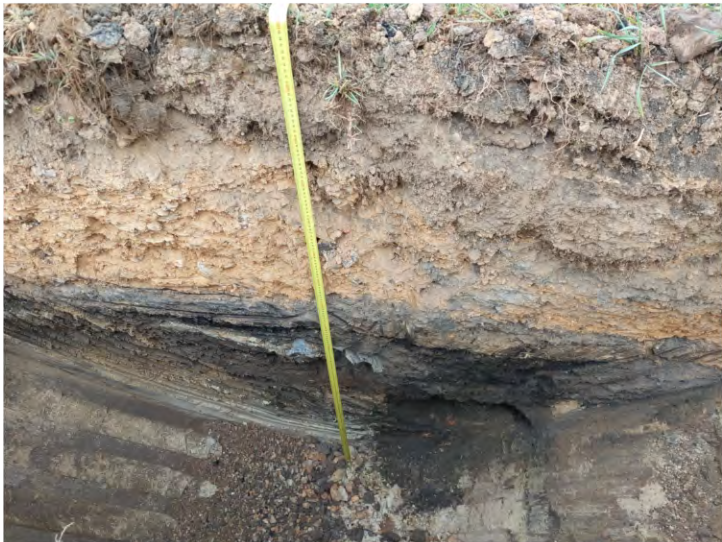
| | <b>Remarks:</b><br>1. Groundwater not encountered on 19/03/25. |

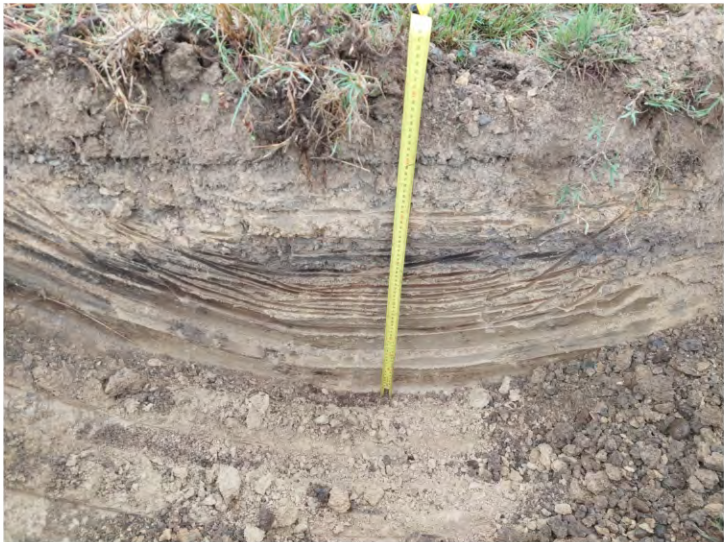
| Depth (m) | Description of Strata | Geological Unit | Graphic Log | Undrained Shear Strength (kPa) | Depth (m) | Dynamic Cone Penetrometer | Groundwater |
|---|---|---|---|---|---|---|---|
| 0.6 | | Kauroa-Hamilton Ash | | | 0.6 | | |
| 0.8 | EOTP: 0.70 m TARGET DEPTH | | | 177<br>(16) | 0.8 | | |

| <b>Profile:</b><br> | <b>Excavation Method:</b><br>5t Excavator<br><br><b>Remarks:</b><br>1. Groundwater not encountered on 19/03/25.<br><br><b>Datum:</b><br><br><b>Coordinates:</b> |
