# Appendix K Contaminated Land Reports

## Remediation of Former Tokanui Hospital Site

## Site-specific risk assessment

Former Tokanui Psychiatric Hospital

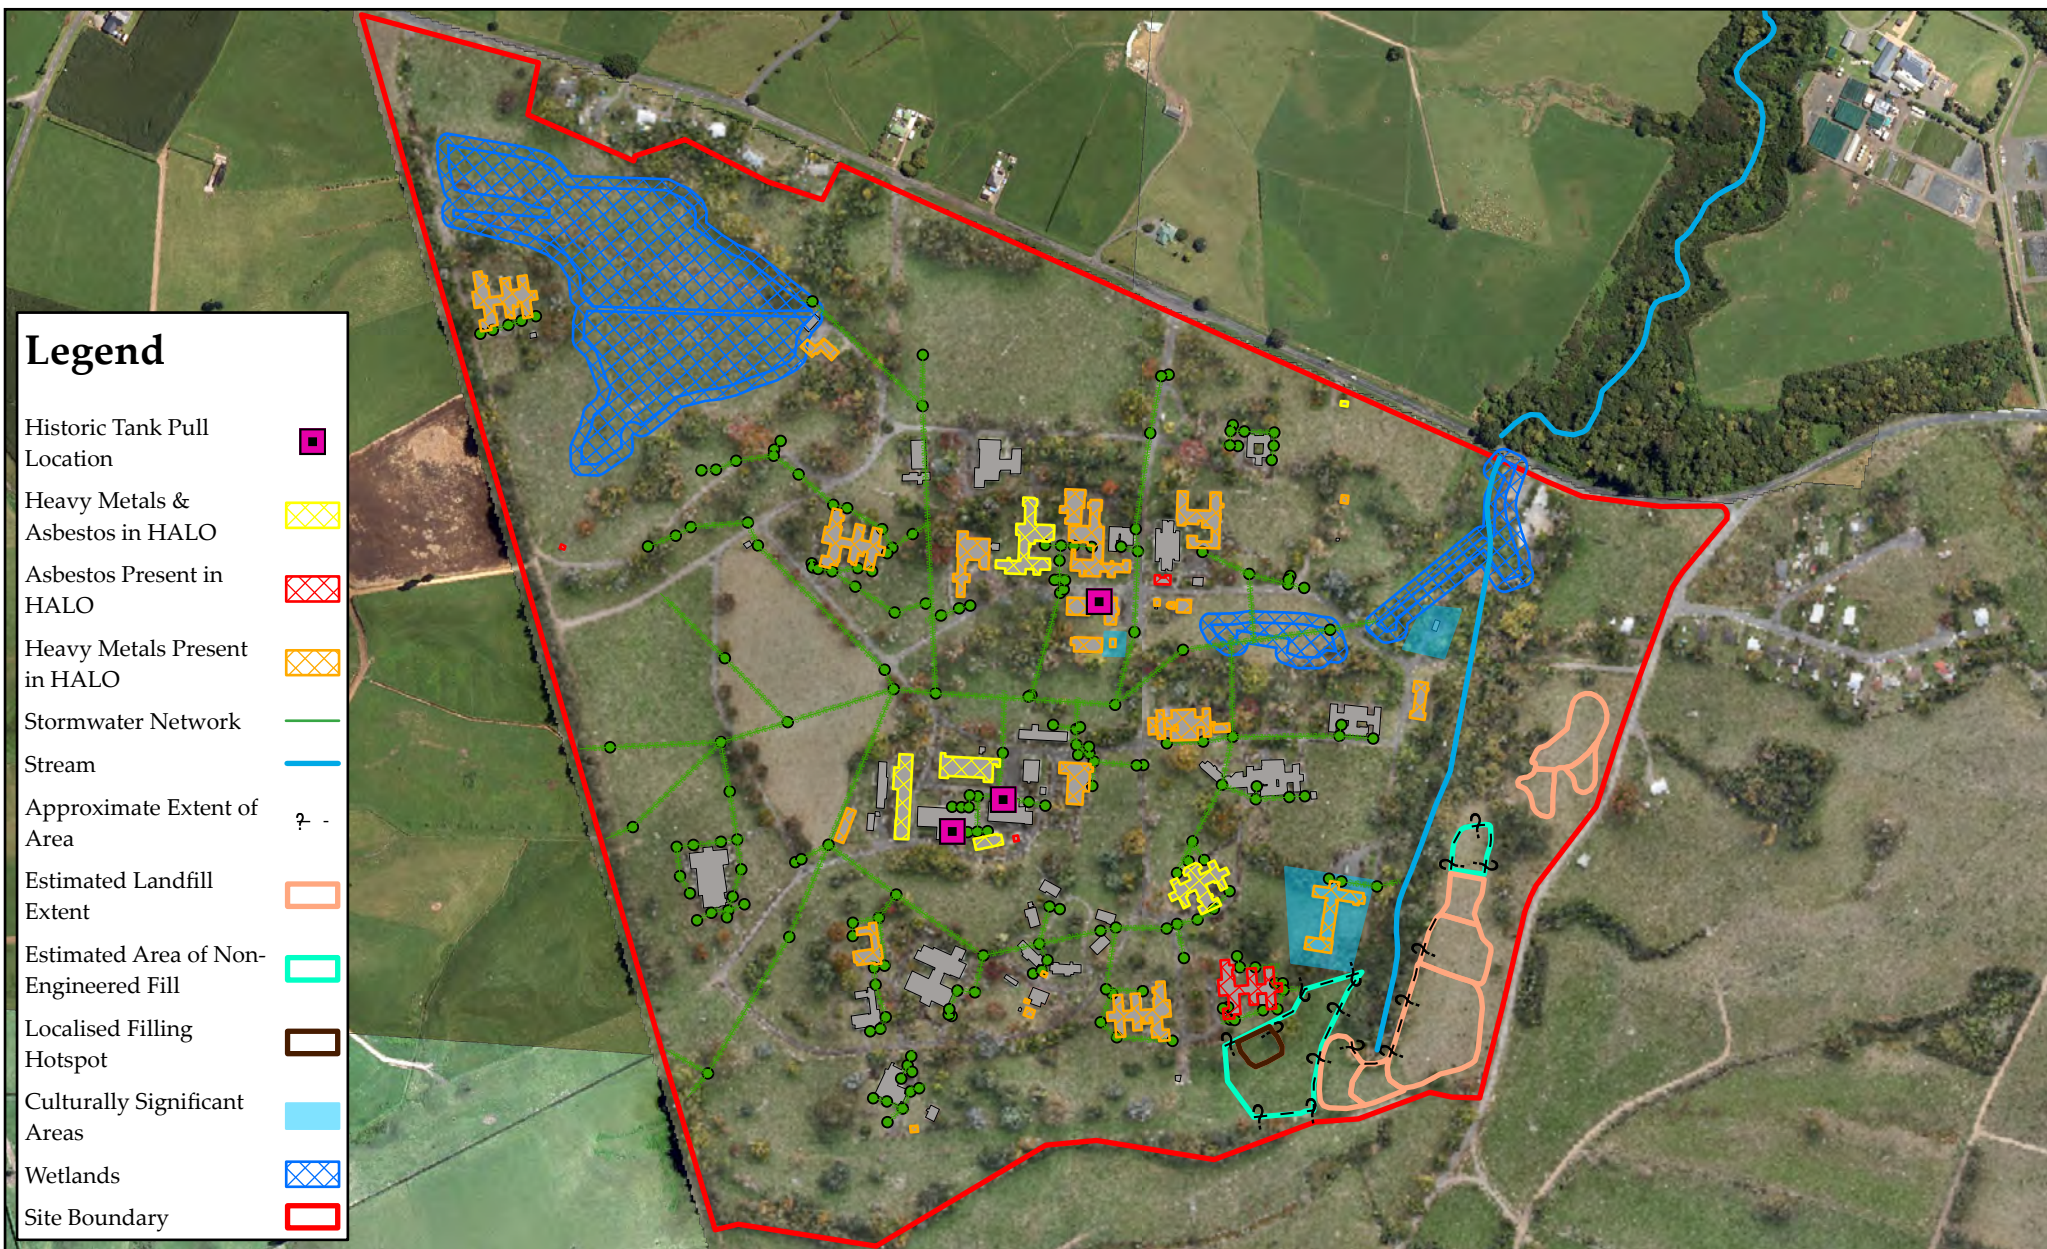
Data for each of these sources is assessed below. The locations of the sources are shown on Figure 4, together with key pathways and receptors:

- The stormwater network.
- The Wharekōrino Stream.
- The apparent historic wetland area.
- Areas requiring cultural oversight.
