FORMER TOKANUI HOSPITAL  
DEMOLITION AND REMEDIATION  
REMEDIAL ACTION PLAN – CONTAMINATED SOIL

FORMER TOKANUI HOSPITAL  
REMEDIAL ACTION PLAN – CONTAMINATED SOIL

**TOITŪ TE WHENUA – LAND INFORMATION NEW ZEALAND  
FORMER TOKANUI HOSPITAL DEMOLITION AND REMEDIATION  
149 TE MAWHAI ROAD, TOKANUI, TE AWAMUTU**

**REMEDIAL ACTION PLAN - CONTAMINATED SOIL**

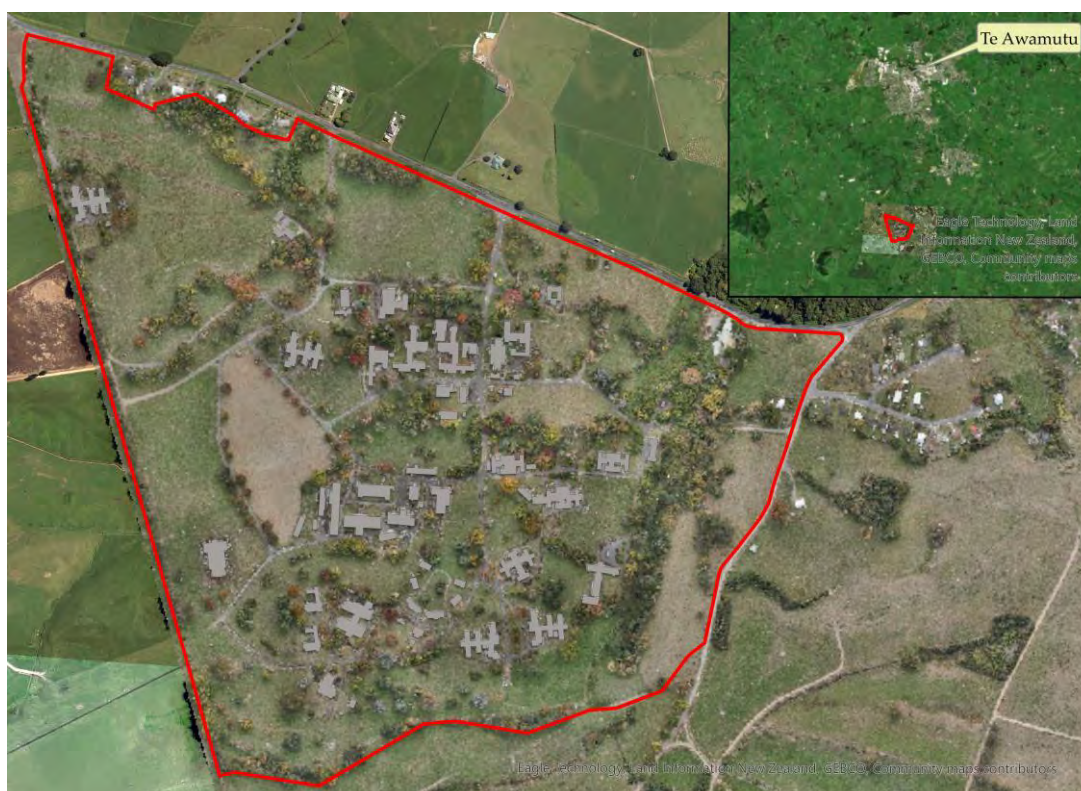
**Figure 1: Site location and extent**

The former Tokanui Psychiatric Hospital (the site) is approximately 80 hectares (ha) in area and is located roughly 14 km southeast of Te Awamutu, Waikato. The site was developed in 1912, and operated through to 1998. It contains 74 buildings, a decommissioned wastewater treatment plant (WWTP), swimming pool, eight substations, closed landfill (also referred to as the 'existing disposal site') and substantial roading and underground infrastructure and services. The site location and extent are shown in Figure 1 below.

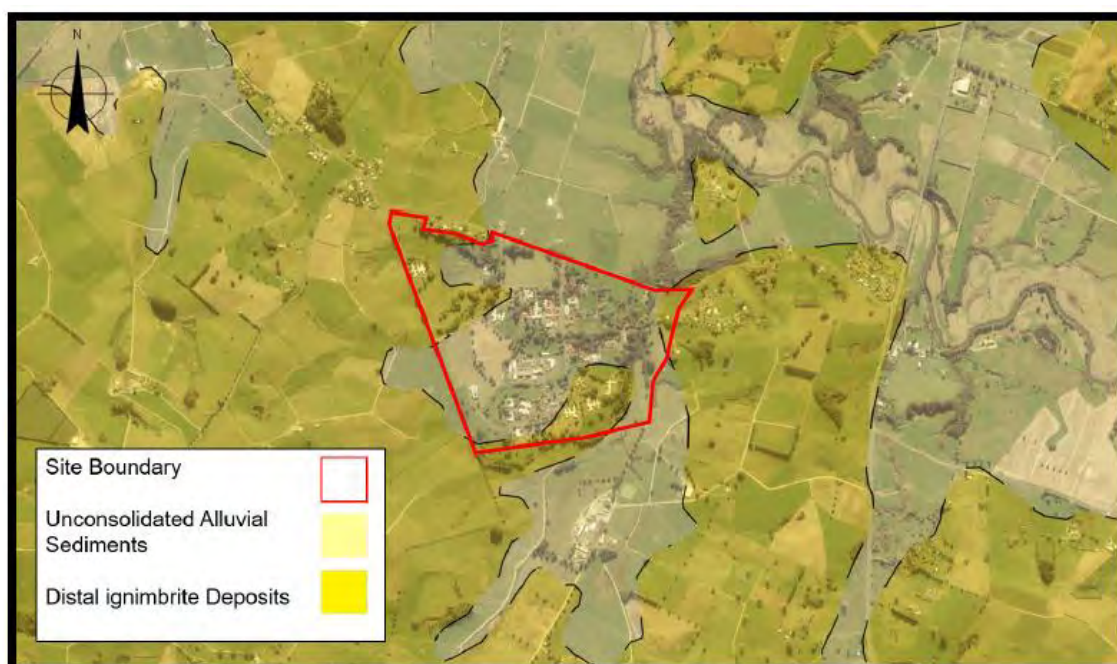
**Figure 4: Published Geology Map (source: GHD, PSI, May 2022)**

A small portion of the former Tokanui Hospital are underlain by early Pleistocene to middle Pleistocene River and igneous deposits consisting of alluvium dominated by primary and reworked, non-welded ignimbrite of the Walton Subgroup, which is part of the Tauranga Group.

Figure 4 below shows the underlying geology of the area.

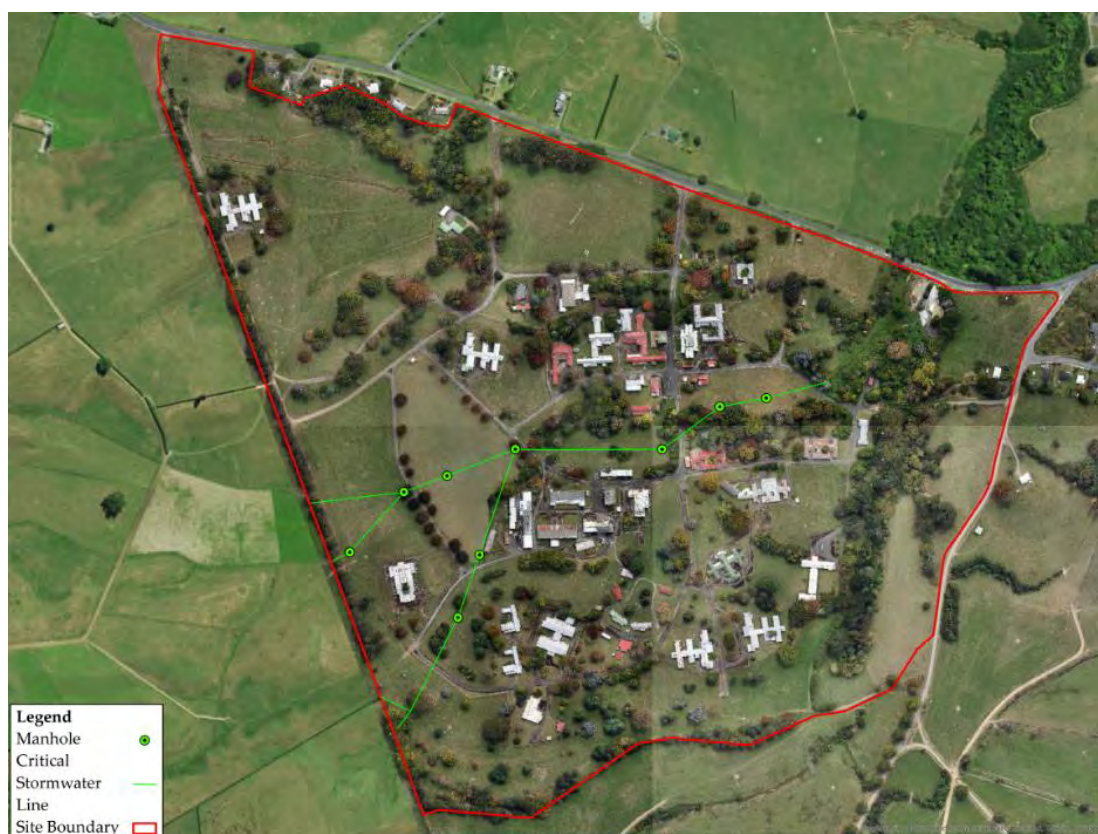
**Figure 7: Tokanui Hospital Site – Current Trunk Stormwater Reticulation conveying upgradient runoff through Site**

Investigation of the Site's stormwater system has found that runoff from upgradient farmland to the west of the site has been piped through the site as shown in Figure 7 below, meaning these historical watercourses have been infilled and also realigned as the stormwater pipe system alignment differs from the historical swamp/watercourse alignment.

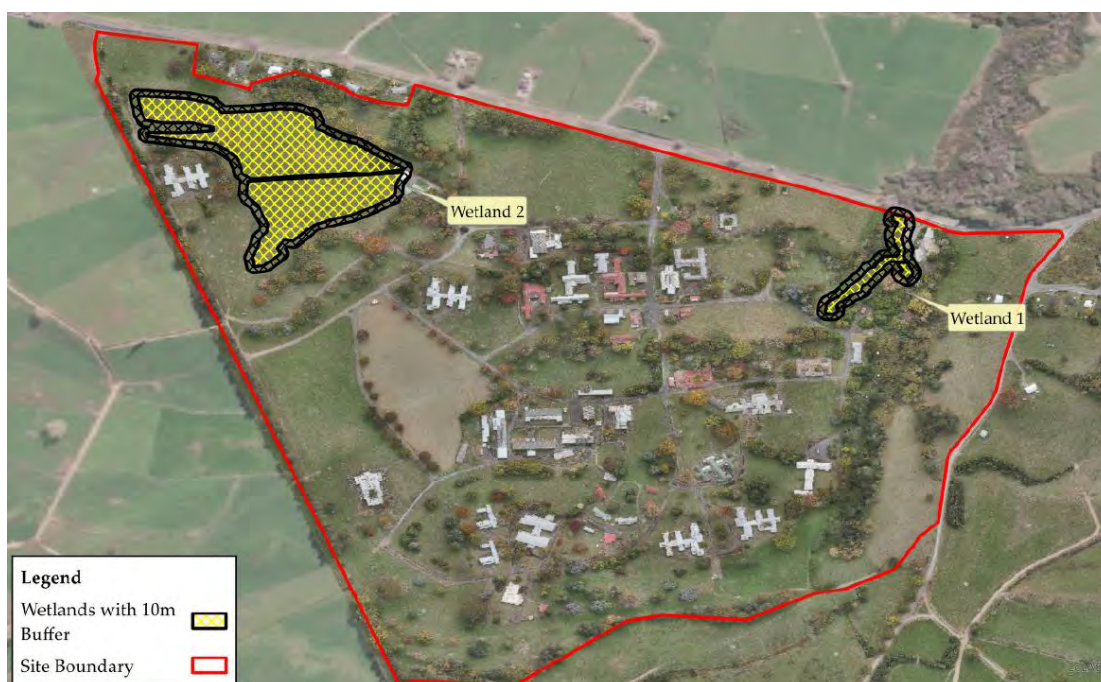
**Figure 8: Tokanui Hospital Site – Natural Wetland Extents from SLR Ecological Assessment**

Wetlands identified on the site from the ecological investigation (SLR, 2024), taking into account the latest definition of what is a natural inland wetland from the National Policy Statement - Freshwater Management (January 2024) are shown in Figure 8.

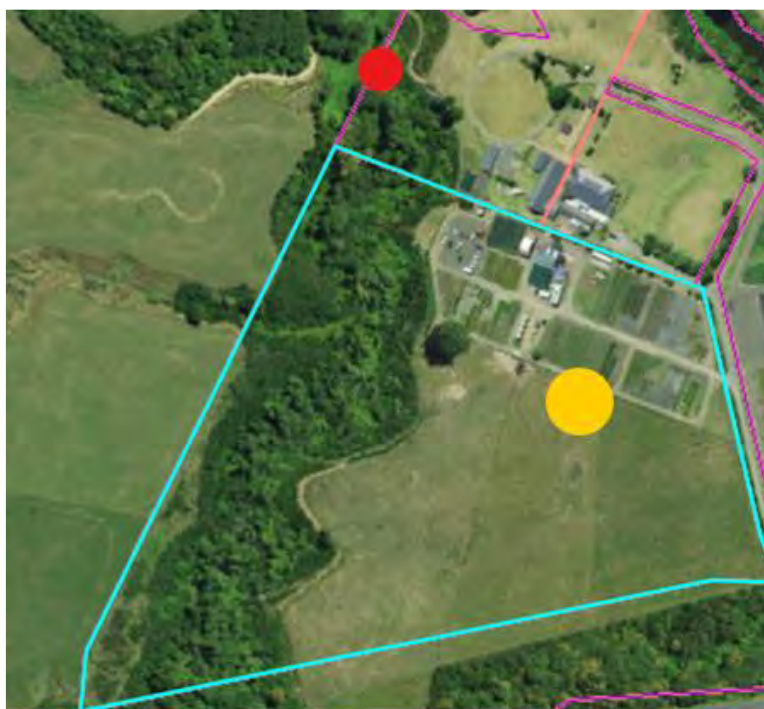
**Figure 9: Pūniu River Care Surface Water Take Inlet Location (red dot) on Wharekōrino Stream; yellow dot is location of their bore which is no longer used**

Pūniu River Care have a resource consent AUTH144702.01.01 valid till October 2037 to take water from the Wharekōrino Stream for irrigation of a 3-ha plant nursery during September-March inclusive, based on a daily maximum take of 100 m<sup>3</sup> and total annual take of not more than 10,000 m<sup>3</sup>. The inlet structure is located on the Wharekōrino Stream at the location of the red dot shown below in Figure 9, with Bore 72, Station 10906, indicated by a yellow dot.
