# Appendix L    Ecological Impact Assessment

## **Remediation of Former Tokanui Hospital Site**

### **Assessment of Environmental Effects**

# Ecological Impact Assessment

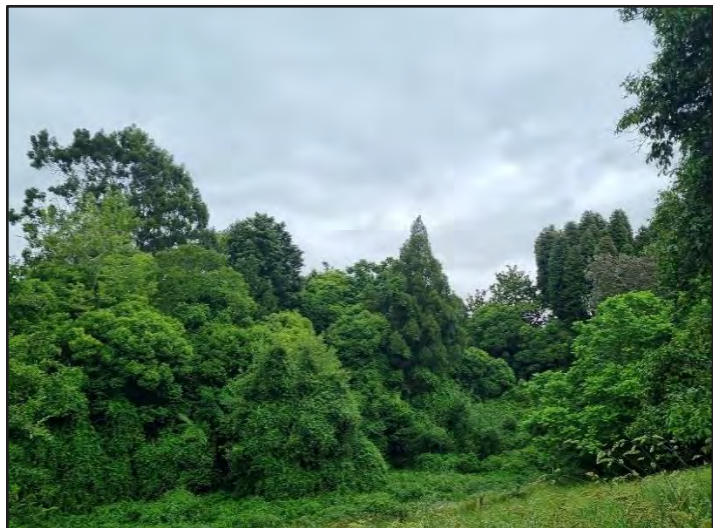
**Photo 4: Large exotic trees adjacent to the stream bordering the site.**

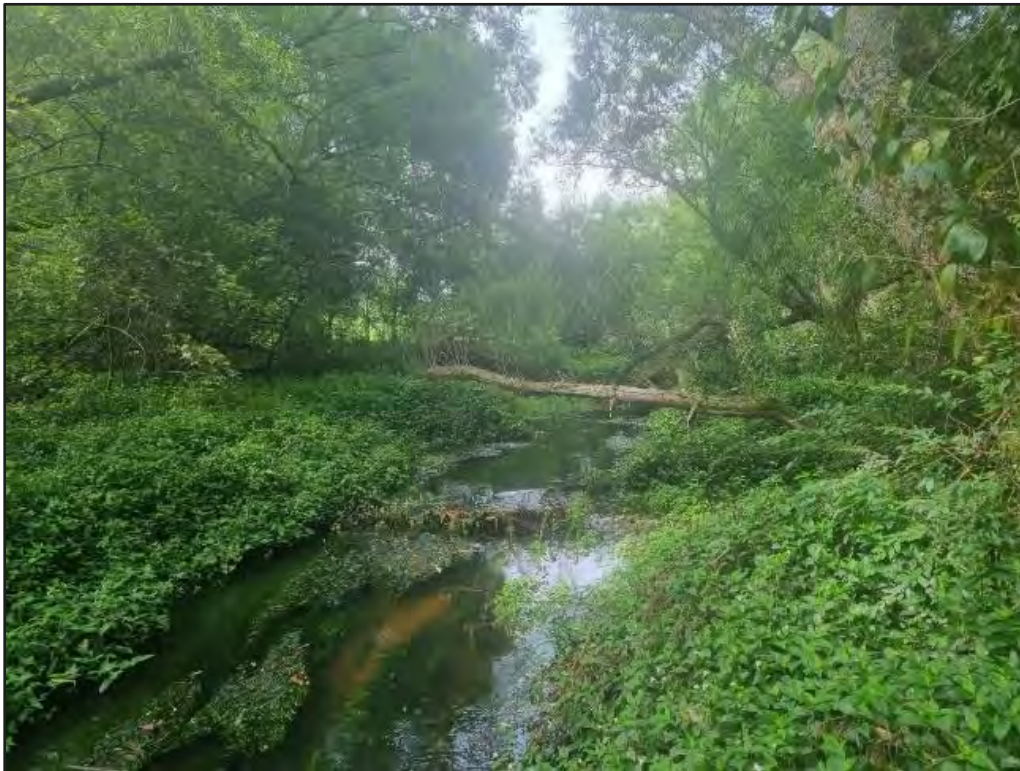
**Figure 5: Representative reach of the Wharekōrino Stream dominated by exotic vegetation.**

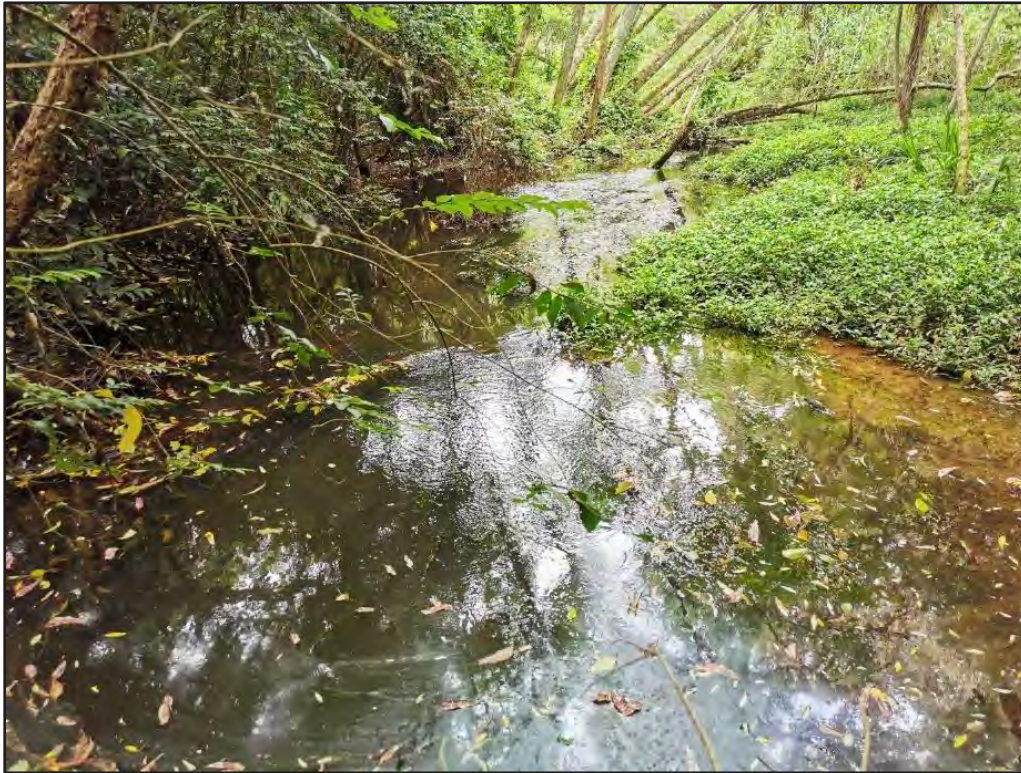
**Figure 6: Exotic vegetation within the Culvert 2 works area.**

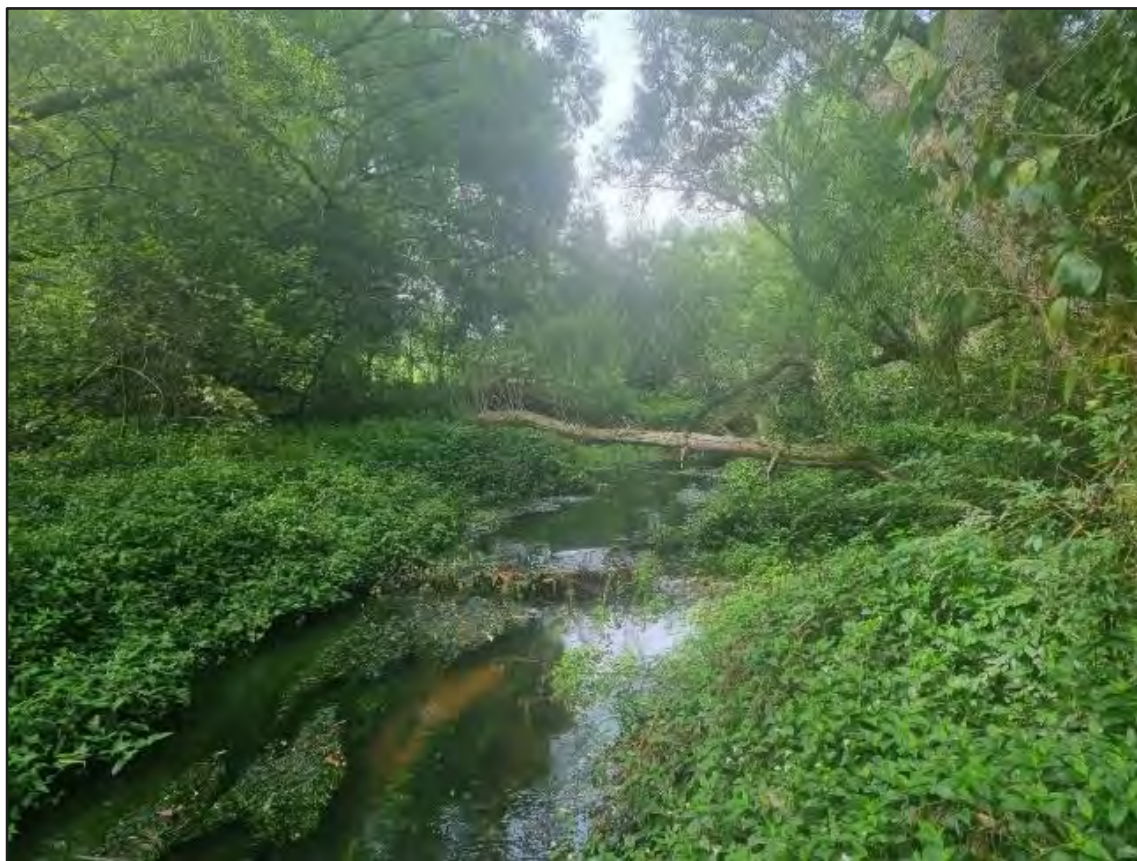
**Figure 4: Stream habitat upstream of Culvert 2.**

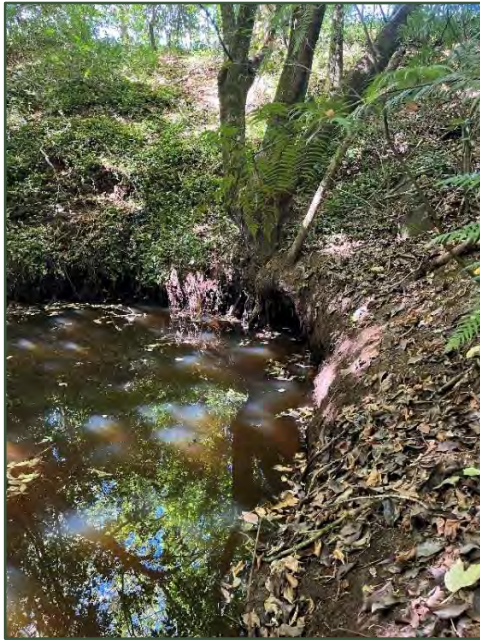
**Figure 7: Culvert 3 outlet**

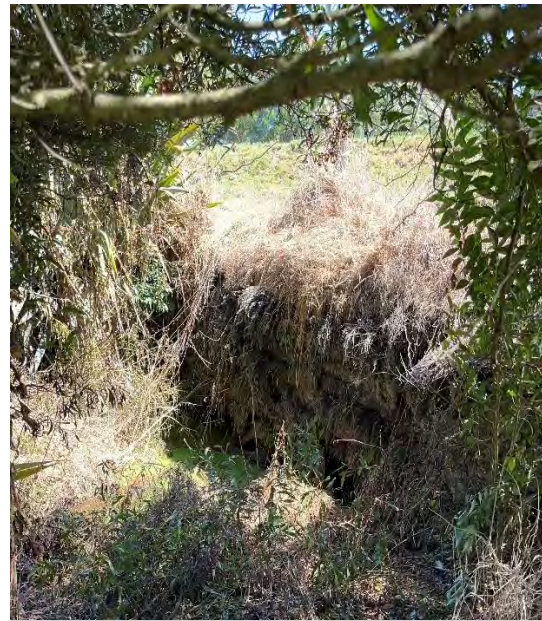
**Figure 8: Culvert 3 inlet.**
