# **Appendix M    Flood Risk & Mitigation Assessment**

## **Remediation of Former Tokanui Hospital Site**

SLR Project No.: 880.V11547.00001

FORMER TOKANUI HOSPITAL  
EXISTING DISPOSAL SITE – FLOOD RISK & MITIGATION  
ASSESSMENT REPORT

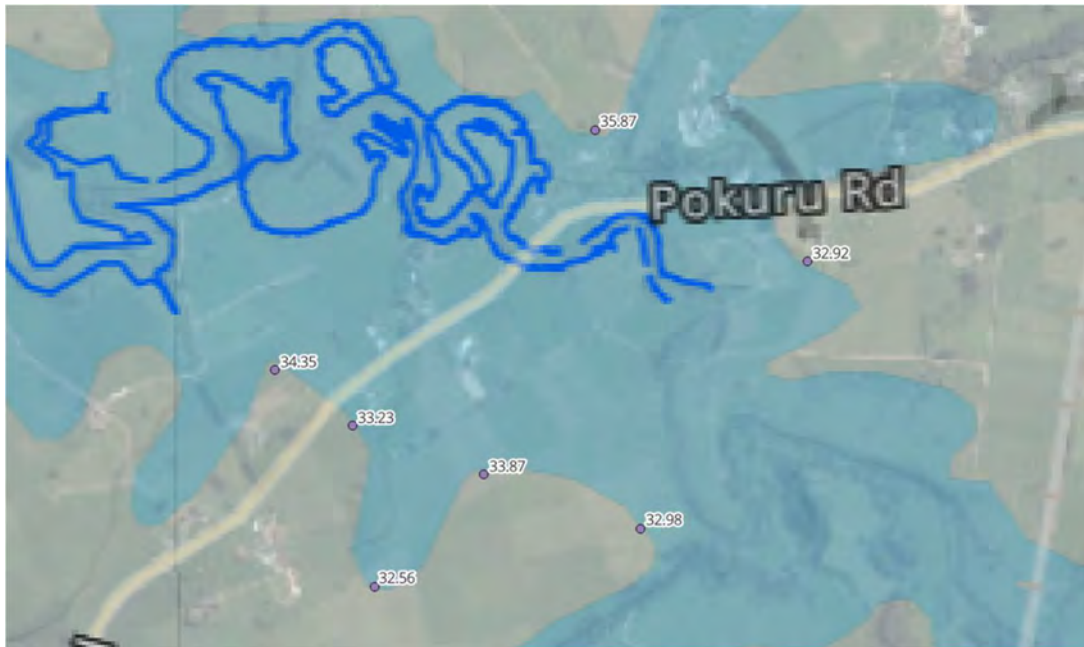
**Figure 14: Flood levels at Pokuru Rd bridge based on WRC Flood Hazard Extent.**

Checking contour data against the WRC flood extent gives higher flood levels of 32.2mRL to 36mRL in this area, as shown in Figure 14, again noting that these levels are not consistent (i.e. flood levels upstream are lower than downstream and flood levels vary on opposite sides).

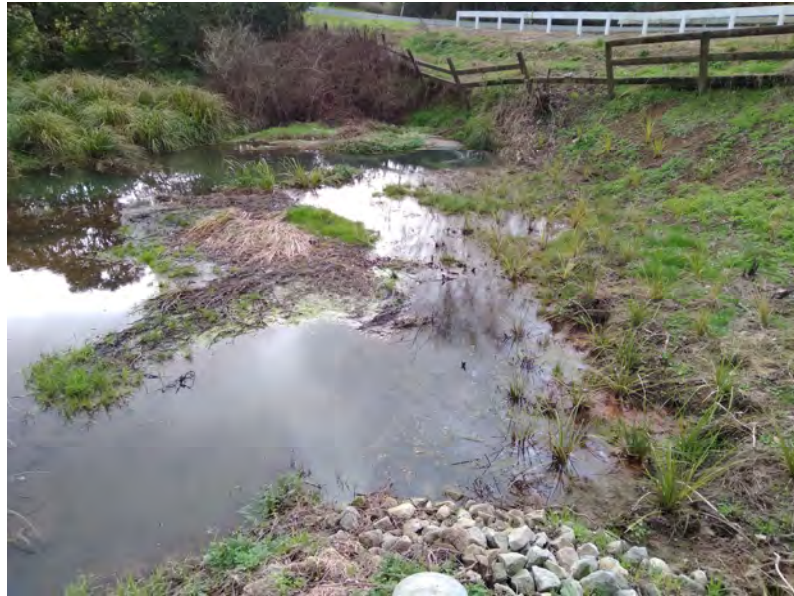
Culvert 1 Inlet – showing signs of bank slumping/  
subsidence

- (b) It was explained that several attempts had already been made to locate Culvert 1 but without success, due to it being submerged. Photos were shared showing some signs of subsidence in the road embankment on the inlet side of this culvert. Mr Hudson also advised that fallen trees and willows is relatively common in the district on small streams similar to this one and these can cause culverts upgradient of them to be submerged. He advised that if the culvert was found to be blocked or collapsed, or downstream trees need removing, then their road maintenance crew can assist with this.

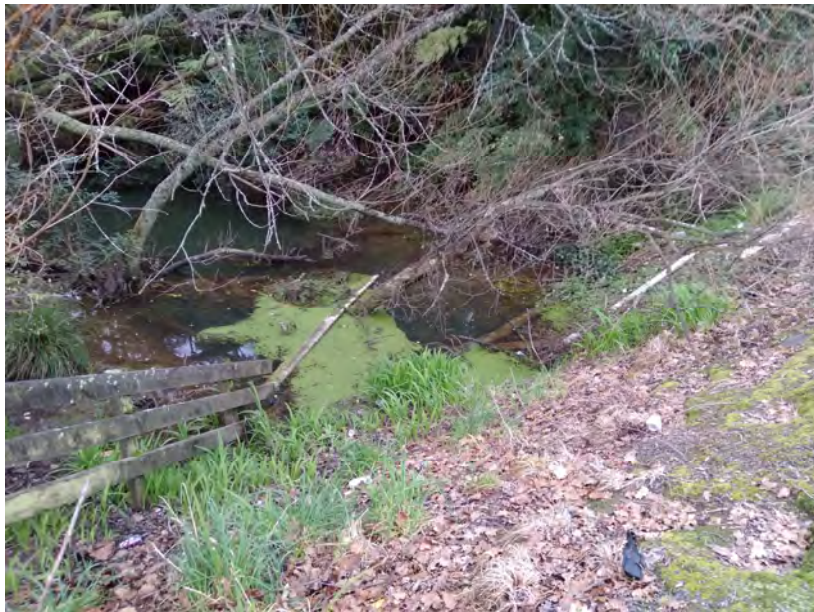
Culvert 1 Outlet – note extensive debris/windfall

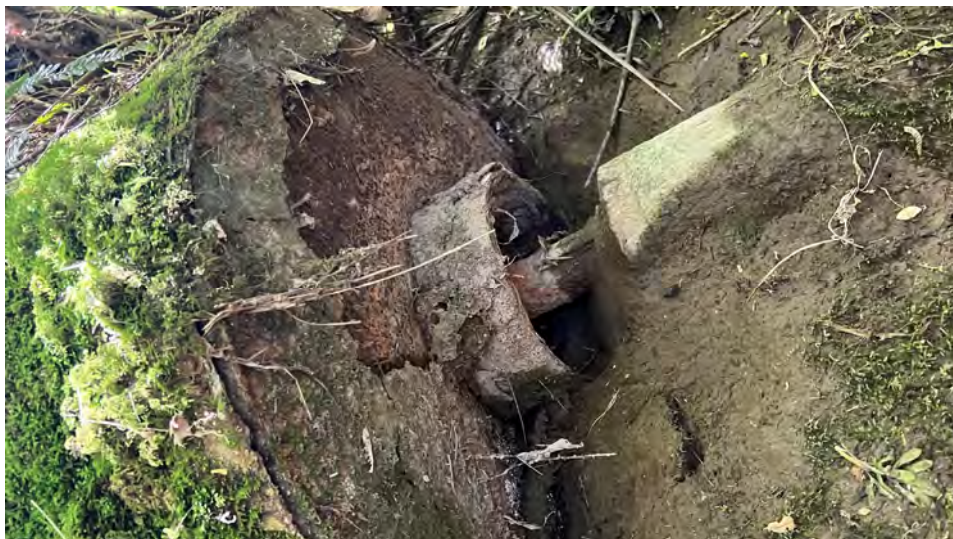
Unidentified feature at western bank - Culvert 3 Outlet
