# Appendix G: Ecological Impact Assessment

**Tokanui Landfill Upgrades**

# Ecological Impact Assessment

## Tokanui Hospital Remediation

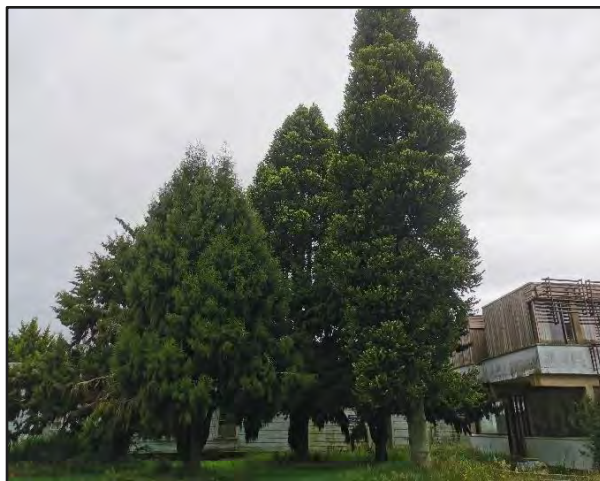
**Photo 1:** Large kauri and rimu trees next to a building on site, with grass understorey.

Large planted native trees (>4 m height) were sporadically located across the site and present in low numbers. These species included tōtara (*Podocarpus totara* var. *totara*), rimu, miro (*Pectinopitys ferruginea*), one kahikatea (*Dacrycarpus dacrydioides*) and five kauri (*Agathis australis*); the only Threatened – Nationally Vulnerable species (de Lange et al., 2018) (Photo 1). Large native trees were often in a stand amongst other native or exotic trees with grassed or no understorey. The largest stand of native trees was located in the northeastern part of the site and included tōtara with occasional rimu and miro (Photo 2). Native tree locations are shown on Figure 4.

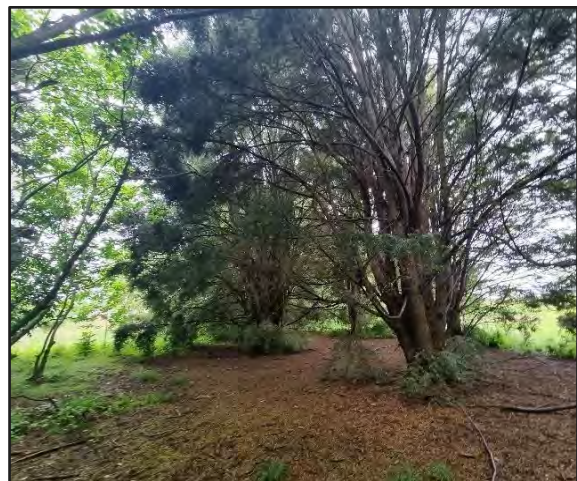
**Photo 2:** Native tree stand with no understorey.

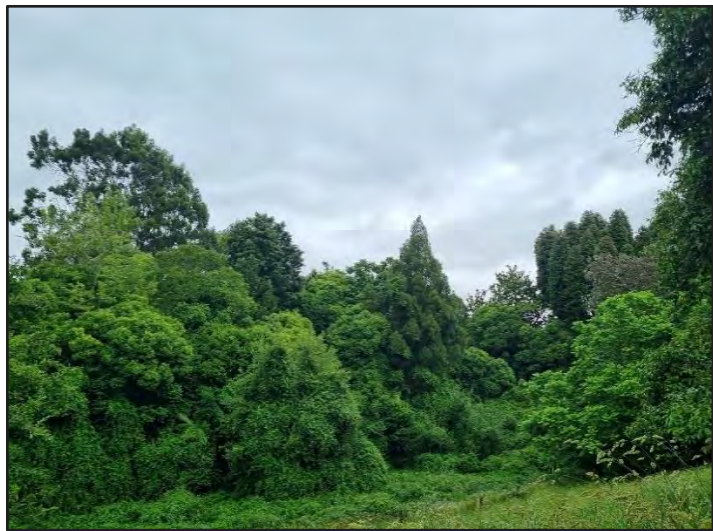
**Photo 4: Large exotic trees adjacent to the stream bordering the site.**

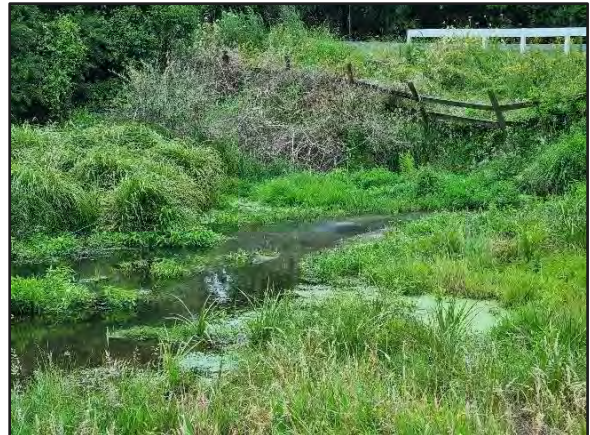
**Photo 6: Pooling above Culvert 1.**

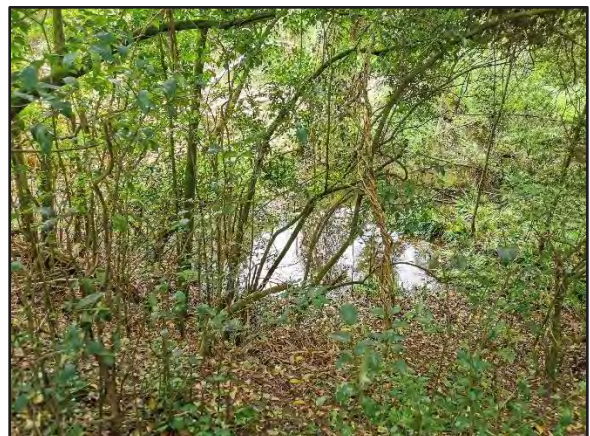
**Photo 8: Upstream of Culvert 2, no flow evident.**

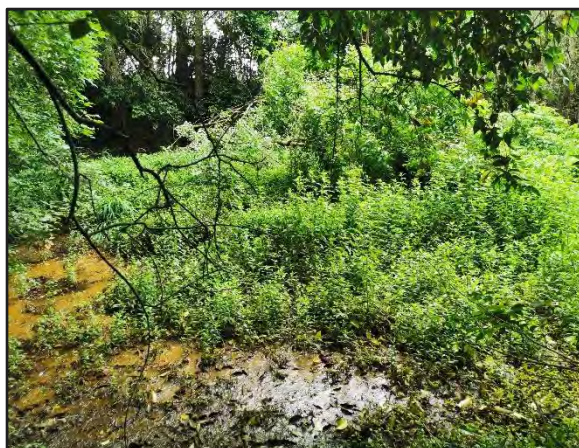
**Photo 9: Downstream of Culvert 3.**

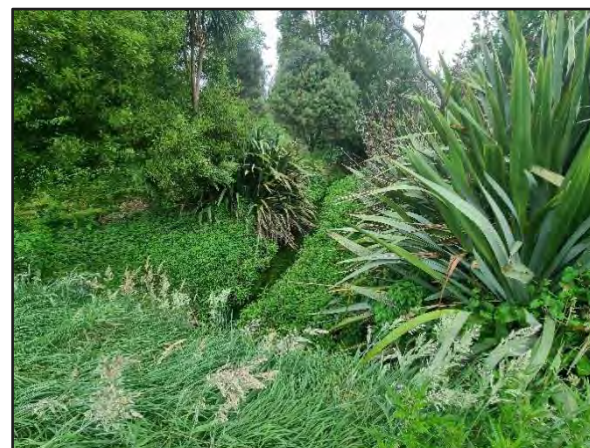
**Photo 10: Upstream of Culvert 3.**

Culvert 3 has been observed with high flow, preventing inspection of its condition (Fraser Thomas, 2024). Fast, uniform flows through a culvert can also likely act as a barrier to fish passage for some native fish species.

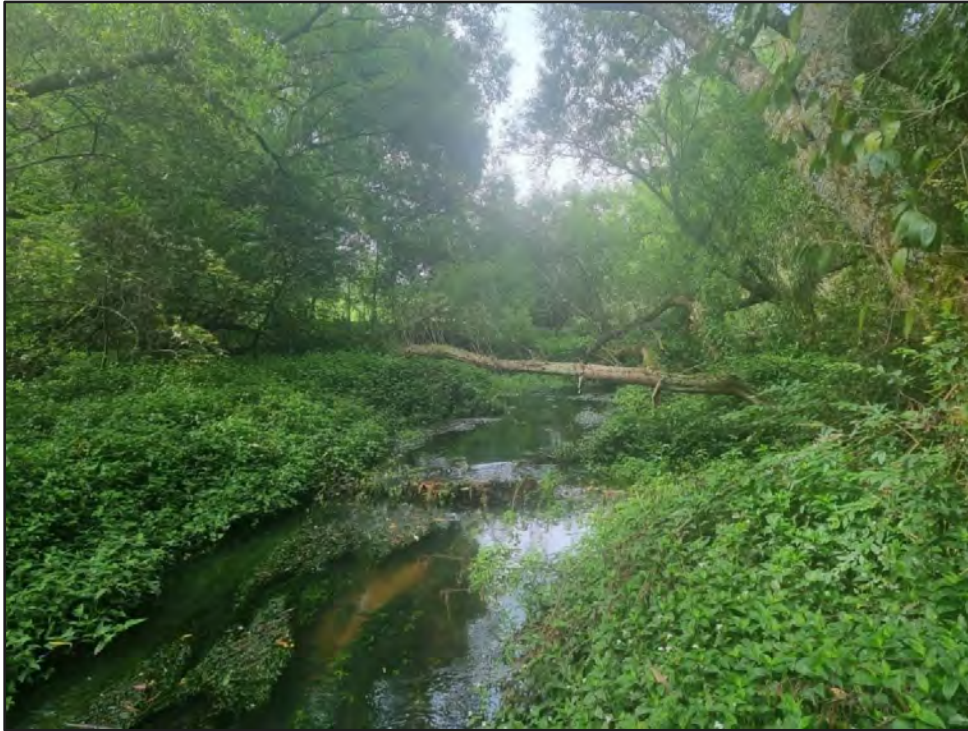
**Photo 11: Looking upstream of the assessment reach.**

The assessed reach of the Wharekōrino Stream is located upstream of the old hospital access road. Vegetation was predominantly exotic in composition, with gum trees, Japanese honeysuckle, crack willow, and Tradescantia dominating the riparian zone on both banks (Photo 11). Both banks had little evidence of active erosion and were fenced off from stock access. The soft bottomed watercourse meandered along a natural flow path with a gently sloping gradient and wide, deep channel. The stream substrate was primarily made up of sand and fine sediments which were loosely packed, resulting in bars and many large, deep pools. Water was clear, cold, and fast flowing, however, due to the naturally low gradient, velocity slows with distance downstream. Submerged macrophytes were prolific with native blunt pondweed (*Potamogeton ochreatus*) being the most abundant. Exotic macrophytes, including water purslane (*Ludwigia palustris*), Primrose willow (*Ludwigia peploides sub. monteridensis*) and water pepper (*Persicaria hydropiper*) were also present, and no periphyton was observed. The abundance of macrophytes, deep pools, and overhanging Tradescantia provides a large amount of habitat for freshwater fish. In addition, some woody debris and root mats provide habitat diversity for macroinvertebrates.

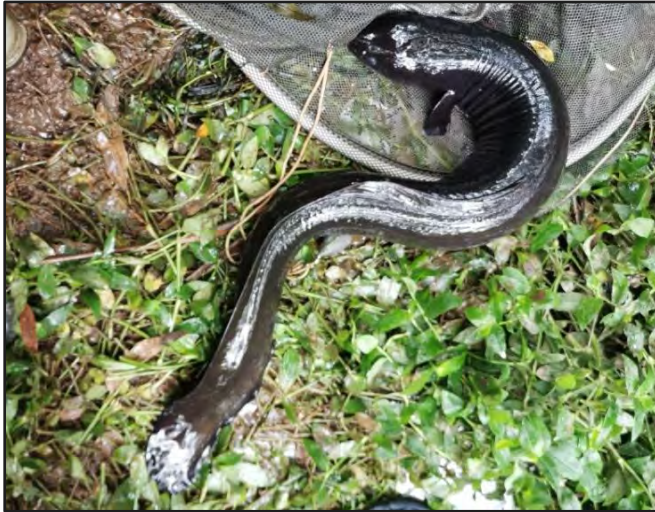
**Photo 12: Longfin eel captured within the survey reach.**

Two native fish species were captured during the fish survey, including shortfin eels (Not Threatened, Dunn et al., 2017) at various life cycle stages, and a longfin eel, an At-Risk species (Table 7). These species have also been recorded in the NZFFD at locations upstream and downstream of the survey site. *Gambusia* (*Gambusia affinis*), a pest fish common throughout the region, were observed downstream of the blocked Culvert 2 during the site visit. *Gambusia* were not observed upstream of the culvert, suggesting it is acting as a fish passage barrier to this species.

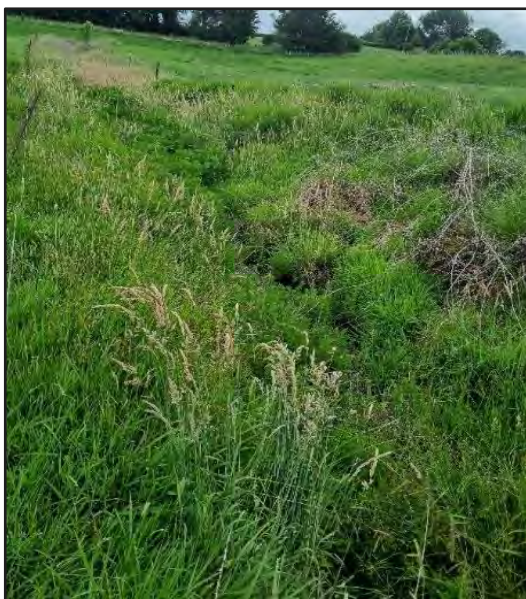
**Photo 13: Artificial watercourse dominated by creeping bent.**

Approximately 721 m of artificial watercourse is present within pasture in the northwest portion of the site. All watercourses supported an exotic macrophyte community dominated by creeping bent (*Agrostis stolonifera*) and Yorkshire fog (*Holcus lanatus*) (Photo 13 and Photo 14). The watercourses were shallow and had wetted substrate with very shallow pools observed in some areas. Riparian vegetation was predominantly exotic grass, as the watercourses are within grazed pasture, do not connect to any natural aquatic habitat, and were likely created to drain the wetland areas for grazing purposes. It is unlikely native fish species reside within these watercourses due to an absence of a connection to other aquatic habitat and the lack of suitable instream habitat.

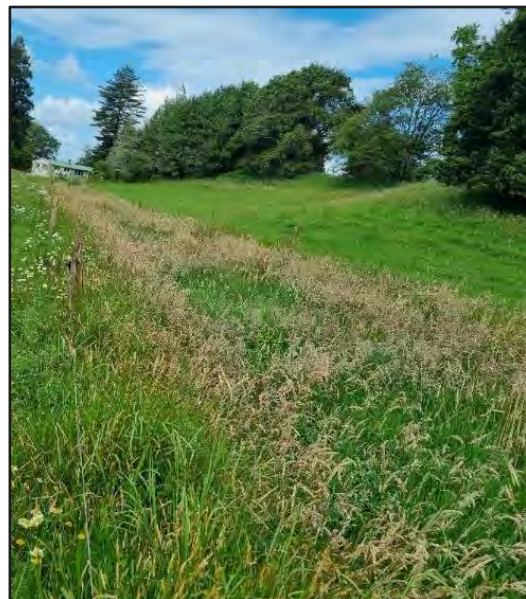
**Photo 14: Artificial watercourse dominated by Yorkshire fog.**

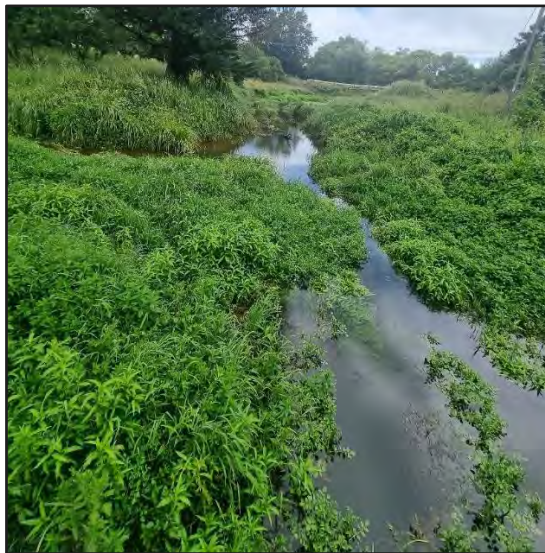
**Photo 15: Wetland 1, facing downstream.**

Two natural inland wetlands were identified on site (Figure 4). Wetland 1 is a riverine wetland encompassing the northern extent of the Wharekōrino Stream within the site bounds and its adjacent floodplains (Photo 15 and Photo 16). It is a small swamp wetland that is likely to have been induced by stormwater inputs and the downstream culvert, which is undersized, impeding flows. The main channel is also modified, being incised and dominated by exotic macrophytes. Vegetation was predominantly gypsywort (*Lycopus europaeus*), with buttercup (*Ranunculus repens*), Yorkshire fog, water pepper, rautahi (*Carex geminata*), watercress (*Nasturtium officinale*), and creeping bent also present. The only native species observed was rautahi, present along a portion of the true left bank. The wetland passed the Rapid Habitat Assessment. Native freshwater fish, including At-Risk species, likely reside within the wetland (Section 4.8). The wetland provides important habitat in an ED where wetlands are sparse and provides a connection to habitat upstream and downstream.

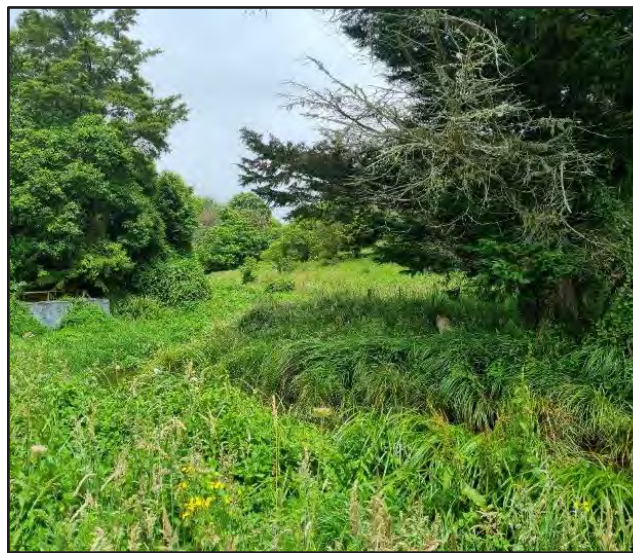
**Photo 16: Wetland 1, from the true left bank, looking upstream.**

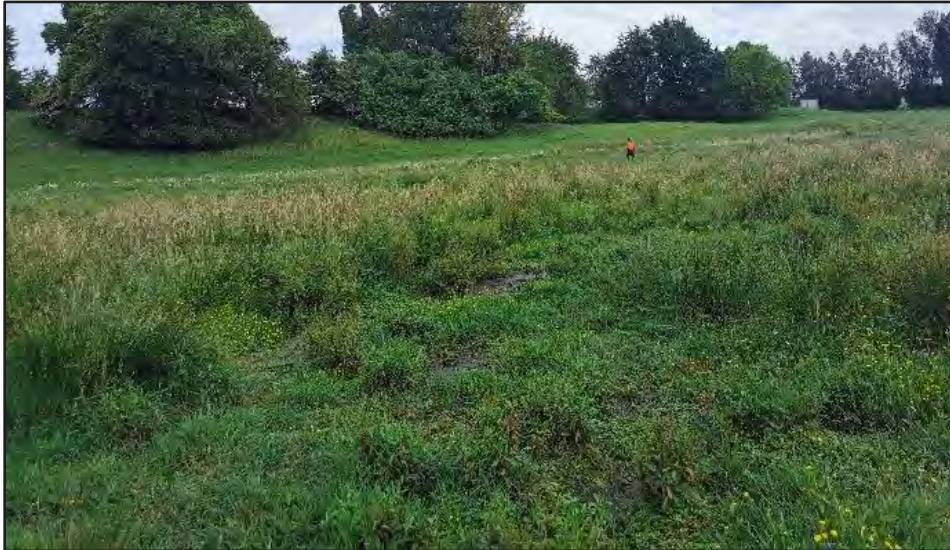
Photo 17: Looking across Wetland 2.

Wetland 2 is a modified natural wetland with drainage channels constructed to allow for grazing of the area. At the time of the site visit, the area was wet underfoot and dominated by creeping bent, with the occasional buttercup and soft rush (*Juncus effusus*) (Photo 17). Although pasture species were present in patches (mainly sweet vernal, *Anthoxanthum odoratum*), the area passed the Prevalence and Dominance tests. The drainage channels intersecting Wetland 2 meet the updated NPS FM exclusion criteria as they are artificial constructed water bodies and are therefore excluded from the identified wetland area (Appendix B).

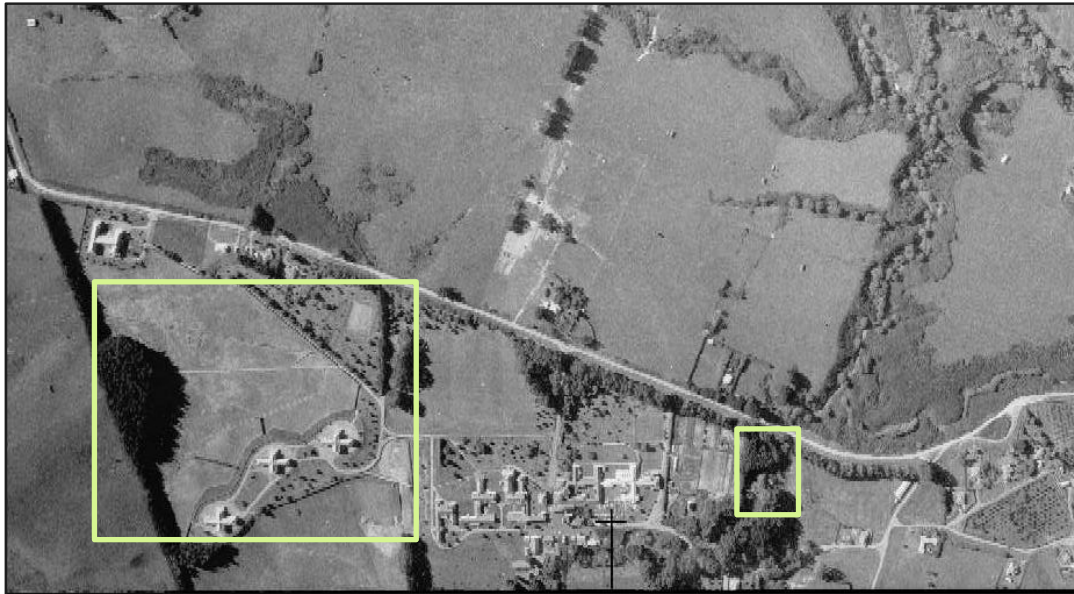
**Photo 18: Wetland 1 (right box) and wetland 2 (left box) in 1944.**

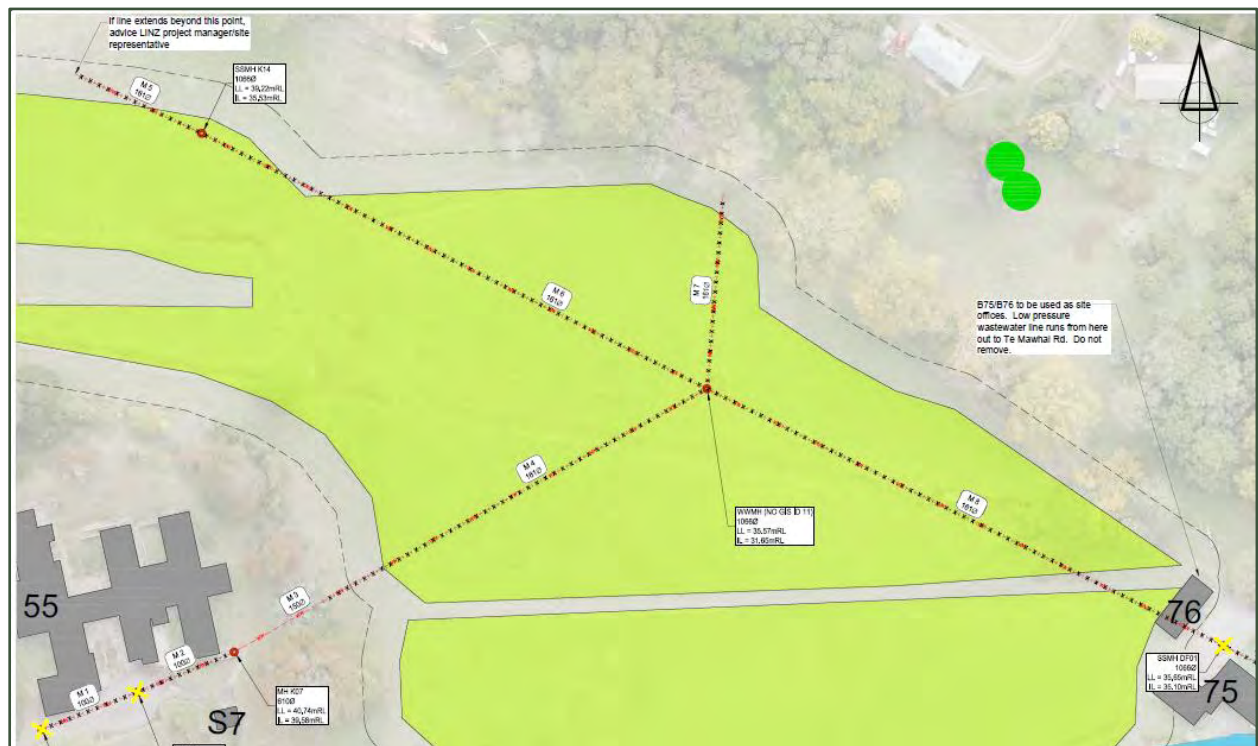
Figure 7: Wastewater lines to be removed within wetland 2 (green area).

Within wetland 2 above ground wastewater lines and supports, below ground electricity cables, and a building and waterpipe adjacent to the wetland are all being removed (Figure 7 and Figure 8). All works will be conducted during an extended dry period with a small excavator travelling along swamp mats with works being done in sections. Backfilled trenches and damaged vegetation will be reseeded/replanted with appropriate vegetation.

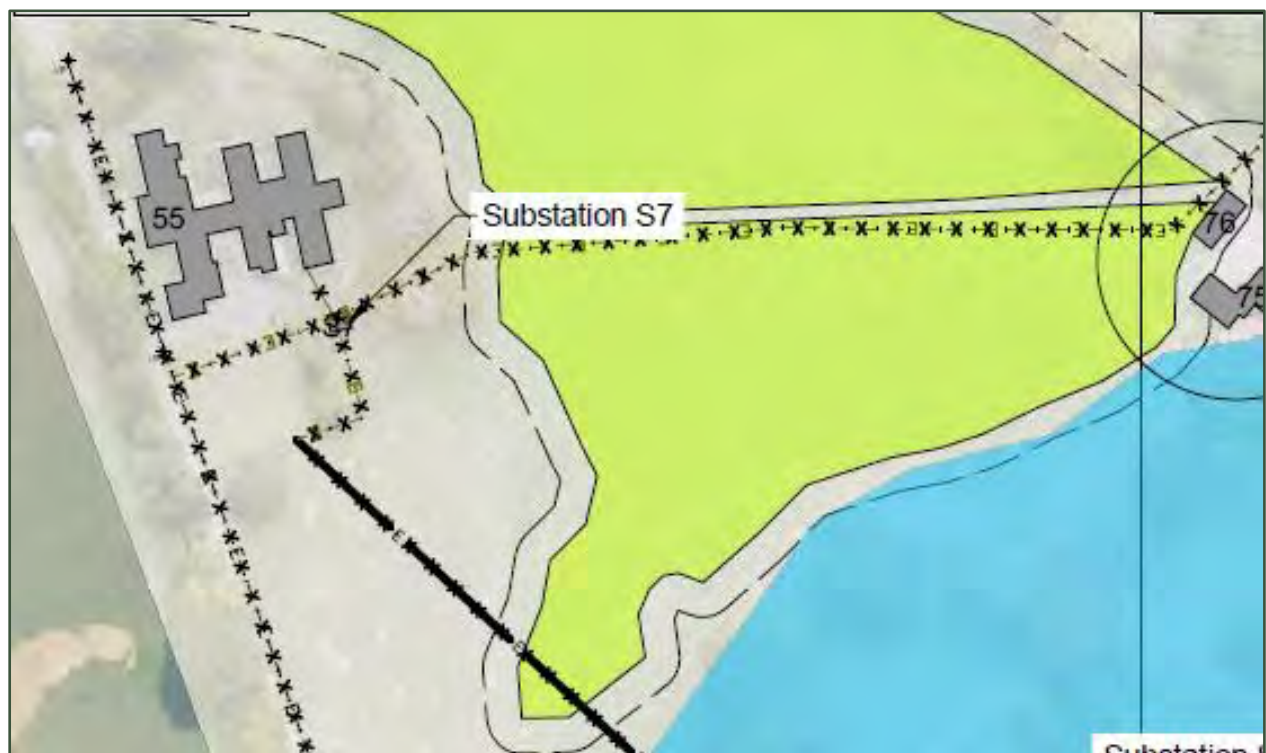
Figure 8: Power line to be removed across wetland 2 (green area).

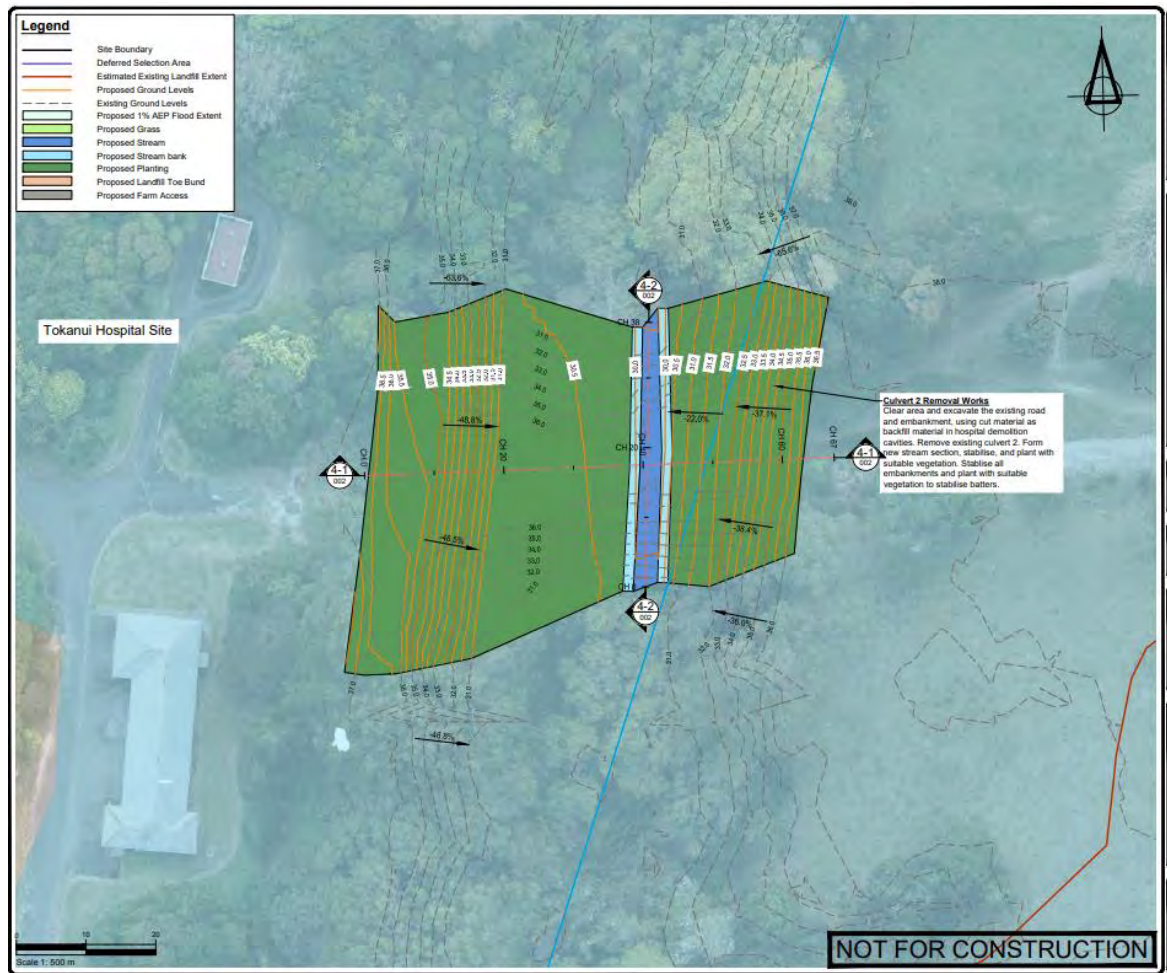
**Figure 12: Proposed removal of road embankment and Culvert 2 intersecting the Wharekōrino Stream.**

- Establishment of erosion and sediment controls; including temporary damming of the stream and a diversion of stream by pumping of water.
- Undertake fish relocation as per the Fish Management Plan (FMP; Appendix F).
- Removal of vegetation, infrastructure and soil. This is to be disposed of or reused where appropriate.
- Trim stream banks to tie in with existing stream profile.
- Place clean topsoil along stream batters (100 – 150 mm thick) and cover with biodegradable matting.
- Undertake planting as per the Planting and Management Plan (PMP, Appendix E).
- Remove temporary dams and erosion/sediment controls.

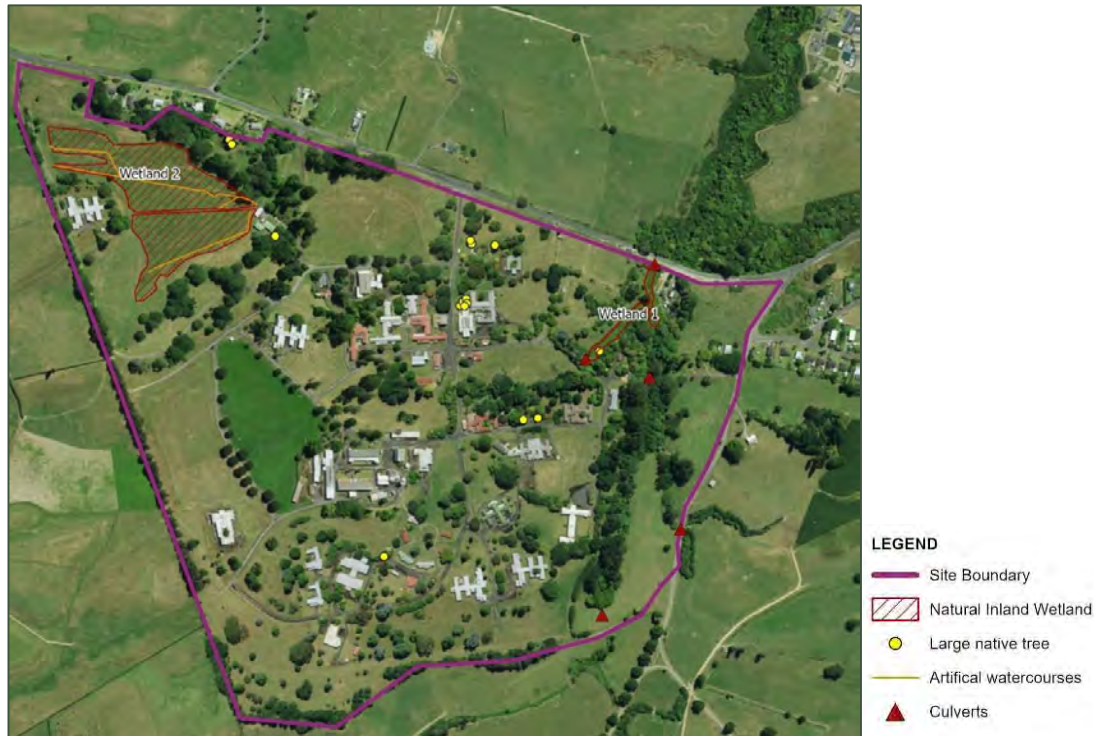
**Figure 1** Location of wetlands

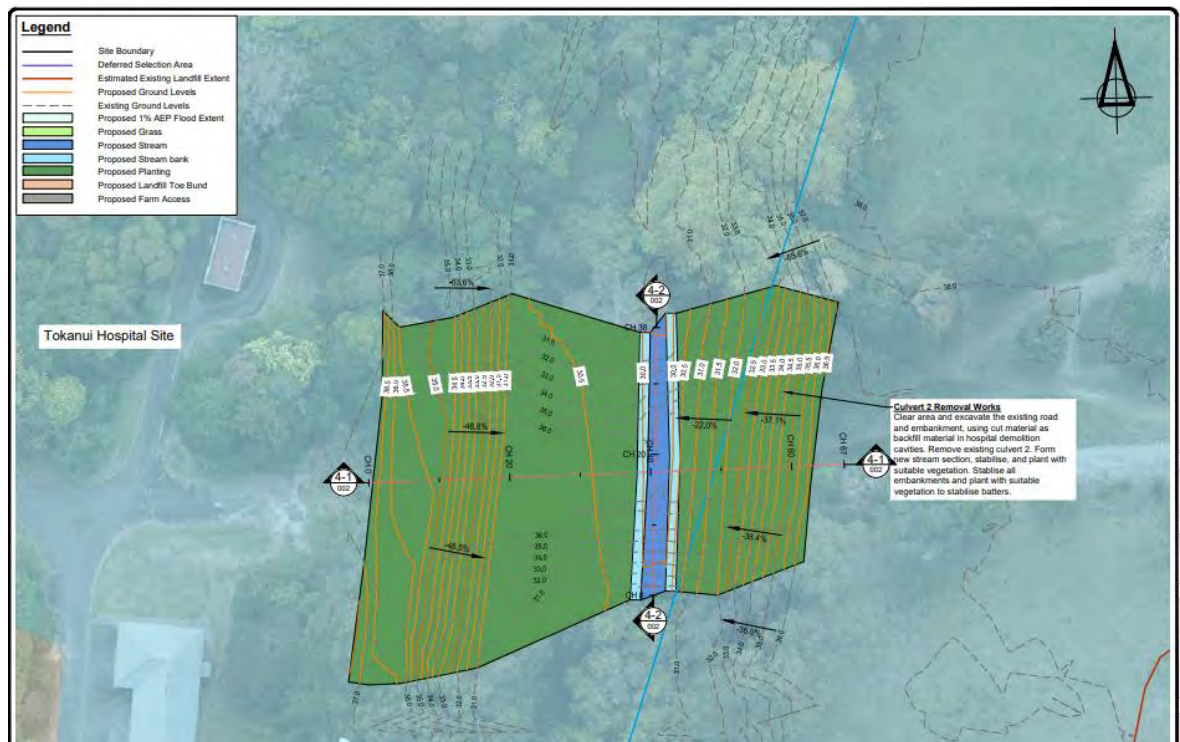
Figure 1: Culvert 2 works area.

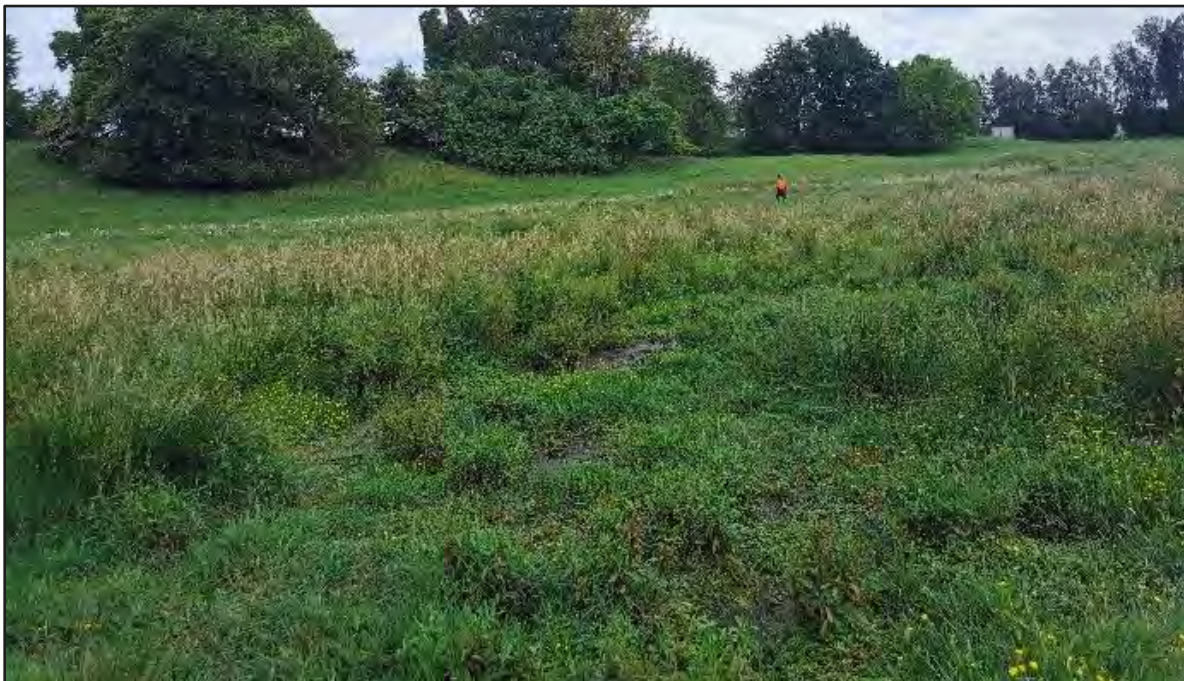
**Figure 7: Pastural wetland.**

The pastoral wetland, Wetland 2, is a modified natural wetland with drainage channels created to allow for grazing of the area. The area was dominated by creeping bent (*Agrostis stolonifera*), with occasional buttercup (*Ranunculus repens*) and soft rush (*Juncus effusus*) and was wet underfoot during the site visit (Figure 7).

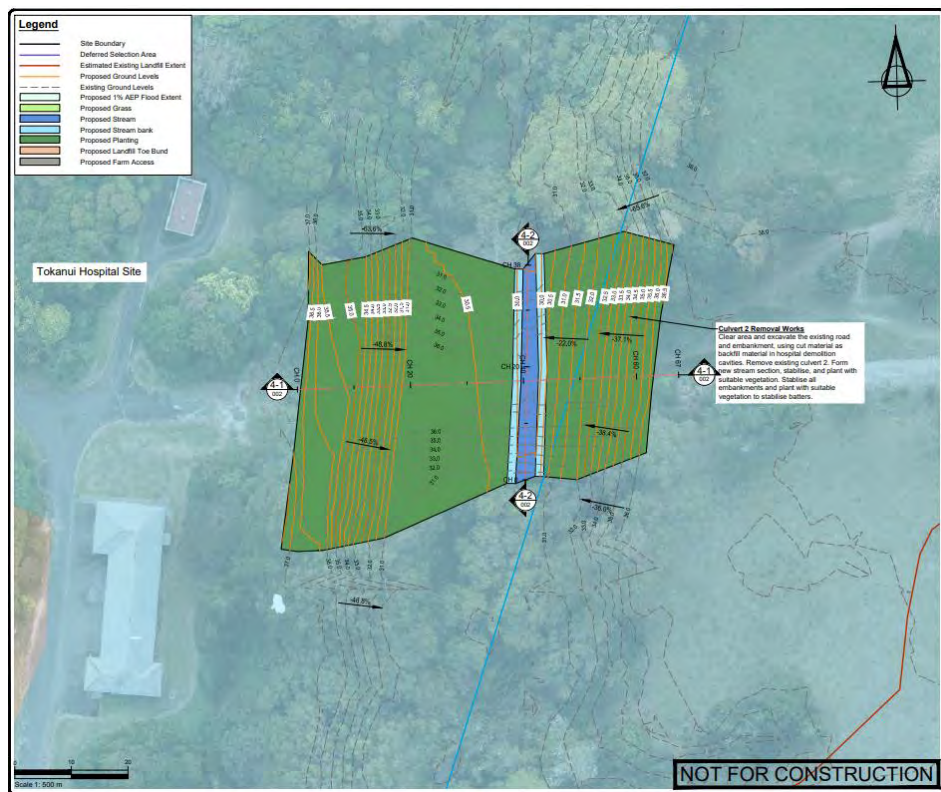
**Figure 2: Proposed removal of road embankment and Culvert 2 intersecting the Wharekōrino Stream.**

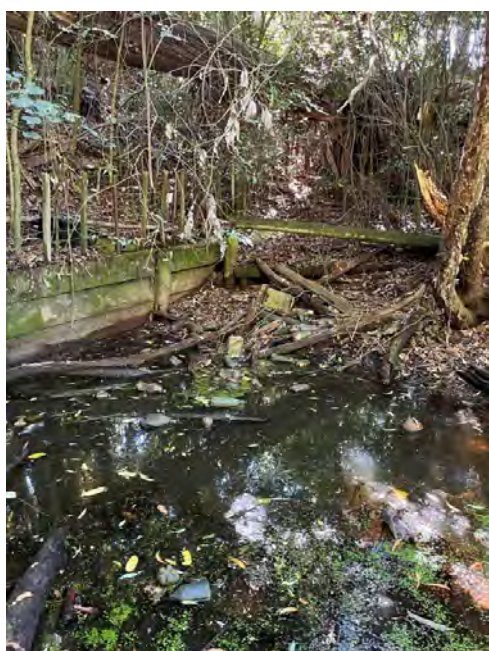
**Figure 5: Inlet of Culvert 2 with Pooled water and debris directly upstream.**

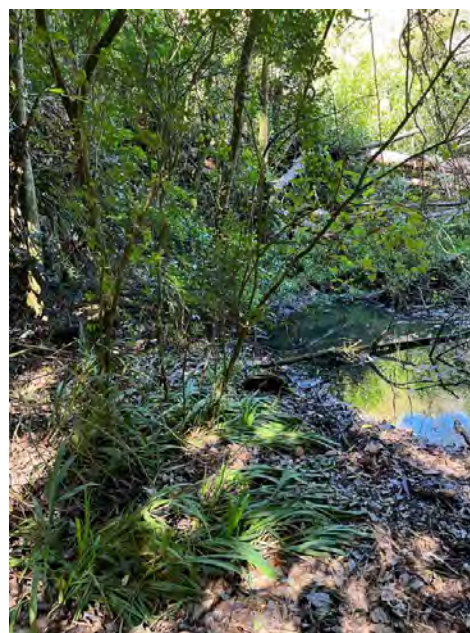
**Figure 6: Culvert 2 outlet.**

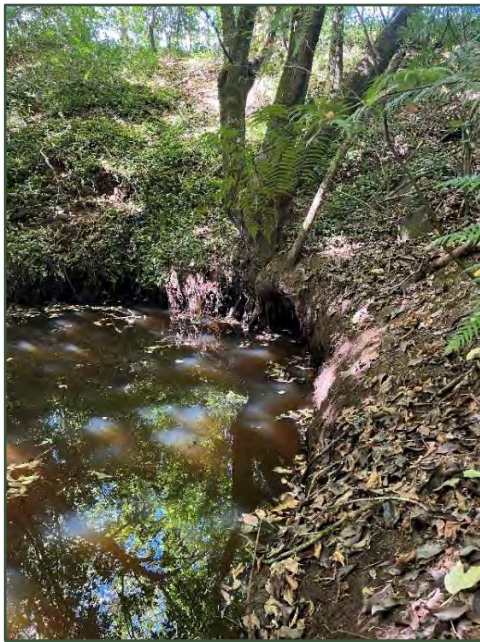
**Figure 7: Culvert 3 outlet**

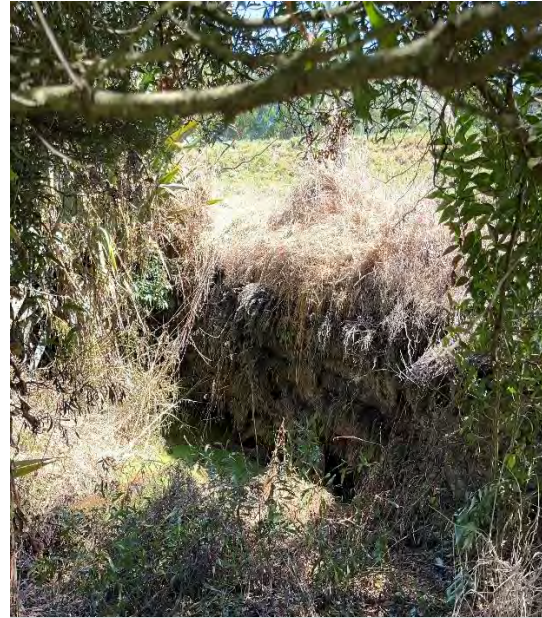
**Figure 8: Culvert 3 inlet.**
