From: "Kathryn Drew" <kdrew@bbo.co.nz>
Sent: Thu, 6 Oct 2022 15:03:37 +1300
To: "Tim Wilson" <tim@kineticenvironmental.co.nz>
Cc: "Ciaran Murphy" <ciaran@kotareconsultants.nz>; "Kevin Hill" <kevin.kph@xtra.co.nz>; "Emma Ruttley" <Emma.Ruttley@waipadc.govt.nz>
Subject: External Sender: RE: Te Awa Rise Ltd - Waipa DC further information request
Attachments: Response to s92 Request - District Council.PDF

On behalf of Te Awa Rise Ltd please find attached a response to points 1-16 of the Waipa District Council s92 request for SP/0107/22 & LU/0161/22.

TE AWA RISE

Attachment 3 – Draft Operations and Maintenance Plan

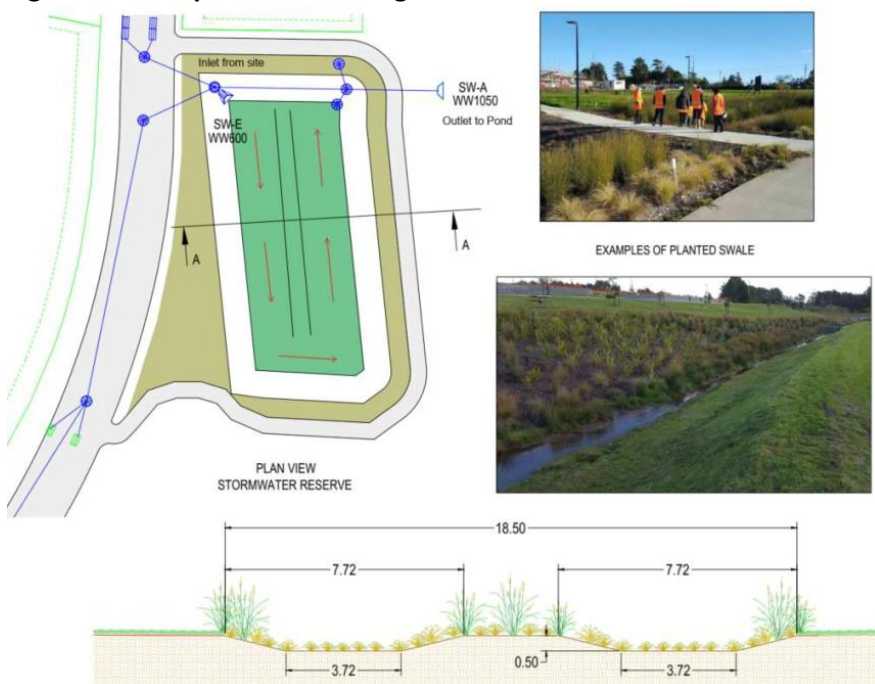
Figure 1: Conceptual Swale Design

The majority of Lot 400 is not proposed to be mown, instead will be planted as per the details in the Te Miro Stormwater Report (Appendix M of the AEE) and the concept plan below. Future detailed design/planting plan will be provided to Council as part of engineering design approval and conditions of consent to this effect are expected. The only portion of Lot 400 that may require mowing is the edges of the walkway. Anything over 1:3 will be planted.

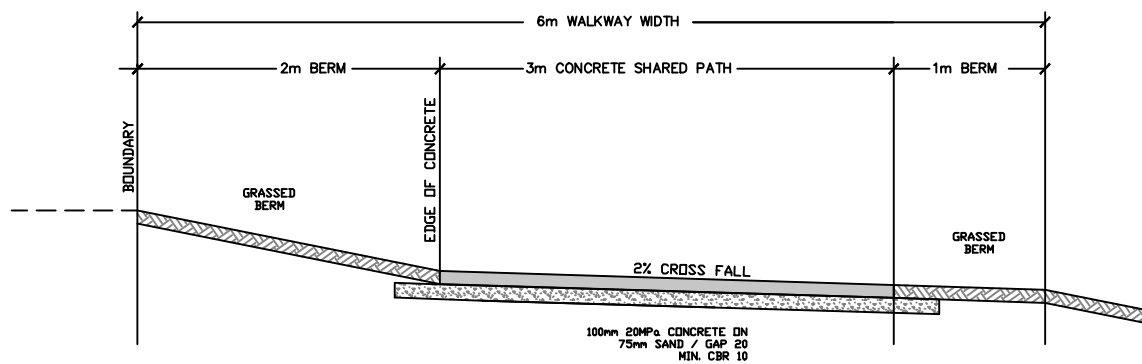
TYPICAL CROSS-SECTION 3m WIDE SHARED PATH WITHIN 6m CORRIDOR – GULLY LOT 501

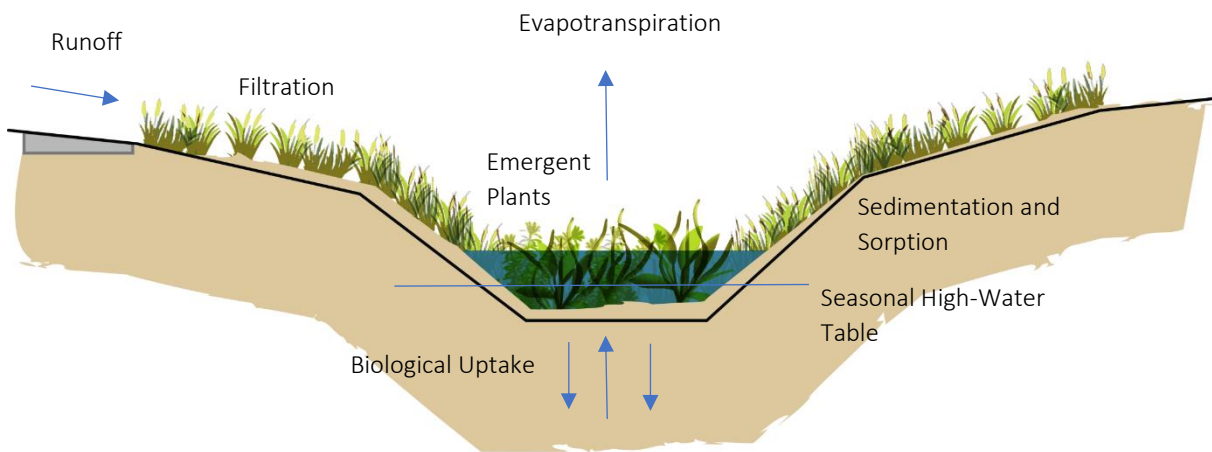
Swale Type	Distinguishing Features	Pollutant Removal Mechanisms
Wet Swale	<ul style="list-style-type: none"> Emergent wetland vegetation Microtopographic pools and shallow areas Seasonal high-water table Wetland soils Will appear soggy and wet 	<ul style="list-style-type: none"> Enhanced gross filtration, sedimentation, and chemical/biological transformations Evapotranspiration and volatilization
Grass or Vegetated Swale	<ul style="list-style-type: none"> Established, dense turf with maintained low grass height OR densely planted with vegetation. Dry when not raining 	<ul style="list-style-type: none"> Filtration, sedimentation (modest) Infiltration, chemical precipitation, microbial degradation, and vegetation uptake

Figure 3 Wet swale

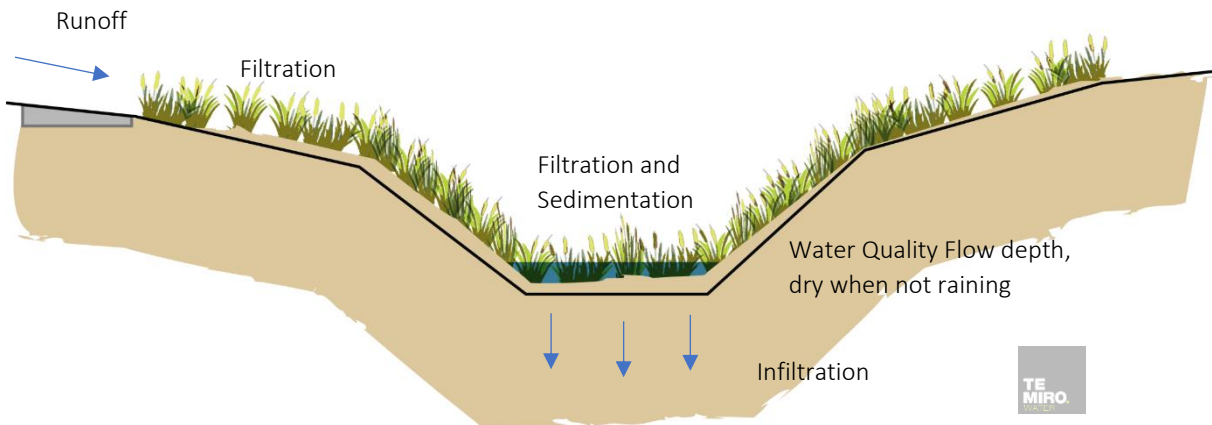
A vegetated swale will treat stormwater runoff and provide stormwater treatment through physical filtration and infiltration. High flows will bypass the swale and discharge direct to the pond. Conventional swale examples are provided to the right and a wet (or wetland) swale is shown above.

Figure 4 Conventional swale used at Te Awa Rise

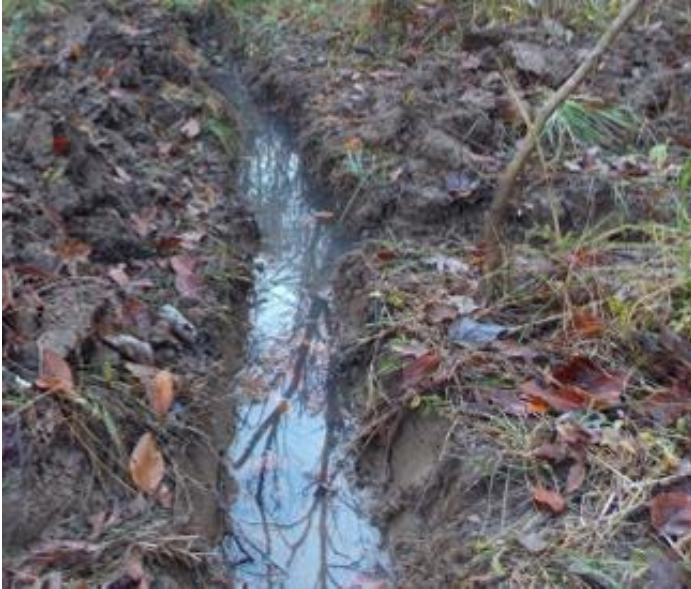
Ponded water or boggy conditions

Problem	Possible Causes	Investigations	Options
Ponded water or boggy conditions	The under-drain is blocked.	Check that the under-drain is free draining.	- Use high-pressure water to flush the under-drain via inspection or access pits and pipes.
	There is no under-drain.	Partially excavate the swale invert to inspect if there is an under-drain.	- Install an under-drain and sand trench.
	Fine sediment is clogging the filter sock over the under-drain.	Check whether the filter cloth around the under-drain is free draining and undertake the following simple dispersibility test to assess whether the soil contains fine clays, which are likely to be clogging the filter cloth. This can be done by: 1. Place soil in a jar of water, shake. 2. If it takes more than about two hours to clear, then the soils consist of fine clays that will block filter cloths.	- Remove the filter cloth from around the under-drain. This will generally require exposure of the pipe. - If there is excessive clay or fine sediments, replace the soil media in the invert. - If clay soils cannot be avoided: o use a layer of gravel or sand to separate the under-drainage and soils, o remove filter fabrics, o ensure good vegetation cover.

The soil is poorly drained.	Investigate soil quality.	- If the upper soil layer is impermeable, replace the soil media. - Retrofit the swale with under-drainage and sand trench.
	The swale is uneven from sag points caused by poor construction, local erosion, or patches of accumulated sediment	Check for local sag points after rain.	- Fill localised sag points with topsoil or remove excess sediment. Re-grade the swale batters and invert. Re-establish vegetation if required. - If the sag points are caused by erosion, refer to 'Scour of the base or erosion' in this table. - If the sag points are caused by excess sediment, refer to 'Excess sediment' in this table.
	Groundwater is intruding via a raised groundwater level.	Check invert and batters for signs of groundwater intrusion, e.g. diffuse discharge (seeps) or precipitation of minerals (typically iron oxides) at the groundwater-soil surface interface. The investigation may require shallow monitoring wells to be installed adjacent to the swale to understand groundwater.	- Install a sand trench and under-drain within the invert of the swale to drain ponding water. - Install under-drainage sand trenches either side of the vegetation within the swale and under-drain. - Rebuild the swale with an impervious liner in the base, considering where groundwater will discharge.

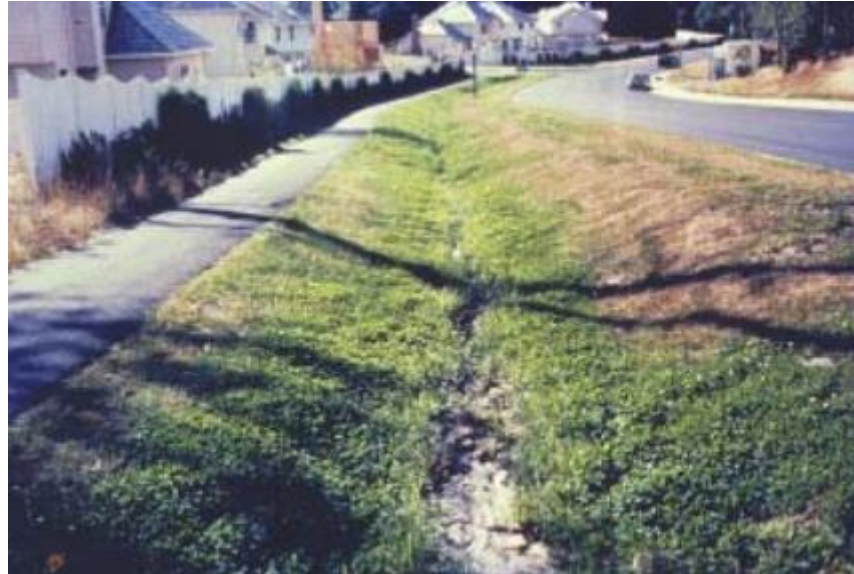
Excess Sediment (Auckland Council TP10).

Vegetation that is too dense or high has reduced the flow area.	Identify if the vegetation in the swale matches the design channel roughness coefficient (- Remove the vegetation and replace with species that provide the design channel roughness coefficient
	Excess sediment has reduced the flow area.	Refer to 'Excess sediment accumulated in the invert of the swale'.	
	Culverts at driveway cross overs are undersized.	Assess if the culverts are sized correctly by confirming the design flow and verifying the pipe and culvert sizes required to convey the design flow.	- Install a correctly sized culvert
	Coarse debris and litter is blocking culverts at driveway crossovers.	Investigate the source(s) of the debris and litter.	- Retrofit the catchment with litter control mechanisms. - Educate the public to help reduce the volume of litter entering the drainage system.
Excess sediment	Increased or unexpectedly large sediment loads are coming from the catchment due to unforeseen activities or because of poor erosion and sediment control	Investigate upstream catchment activities to identify the sediment source.	- Enforce erosion and sediment control on construction sites within the catchment. - Install additional sediment capture upstream of the asset (e.g. sediment forebays).
