# Engineering and Environmental Assessment

Interpretation and Recommendations

Client: Waipa District Council

**AECOM New Zealand Limited**

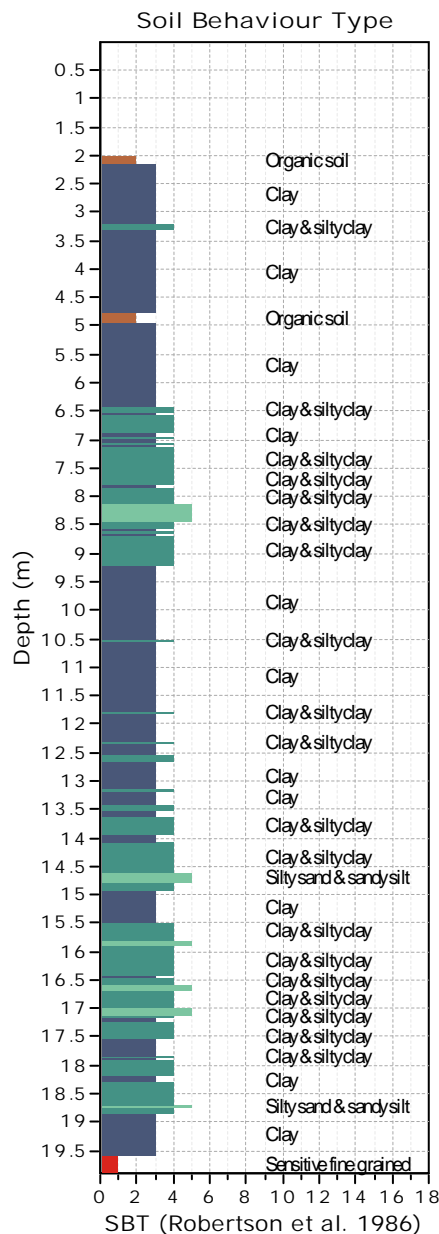
Shaft diameter: 0.07 m  
Tip diameter: 0.07 m  
Unit friction area: 0.220 m<sup>2</sup>  
Tip area: 0.004 m<sup>2</sup>

Pile shaft Group: Group IA  
Pile tip Group: Group I  
Pile shaft FOS: 2.00  
Pile tip FOS: 2.00

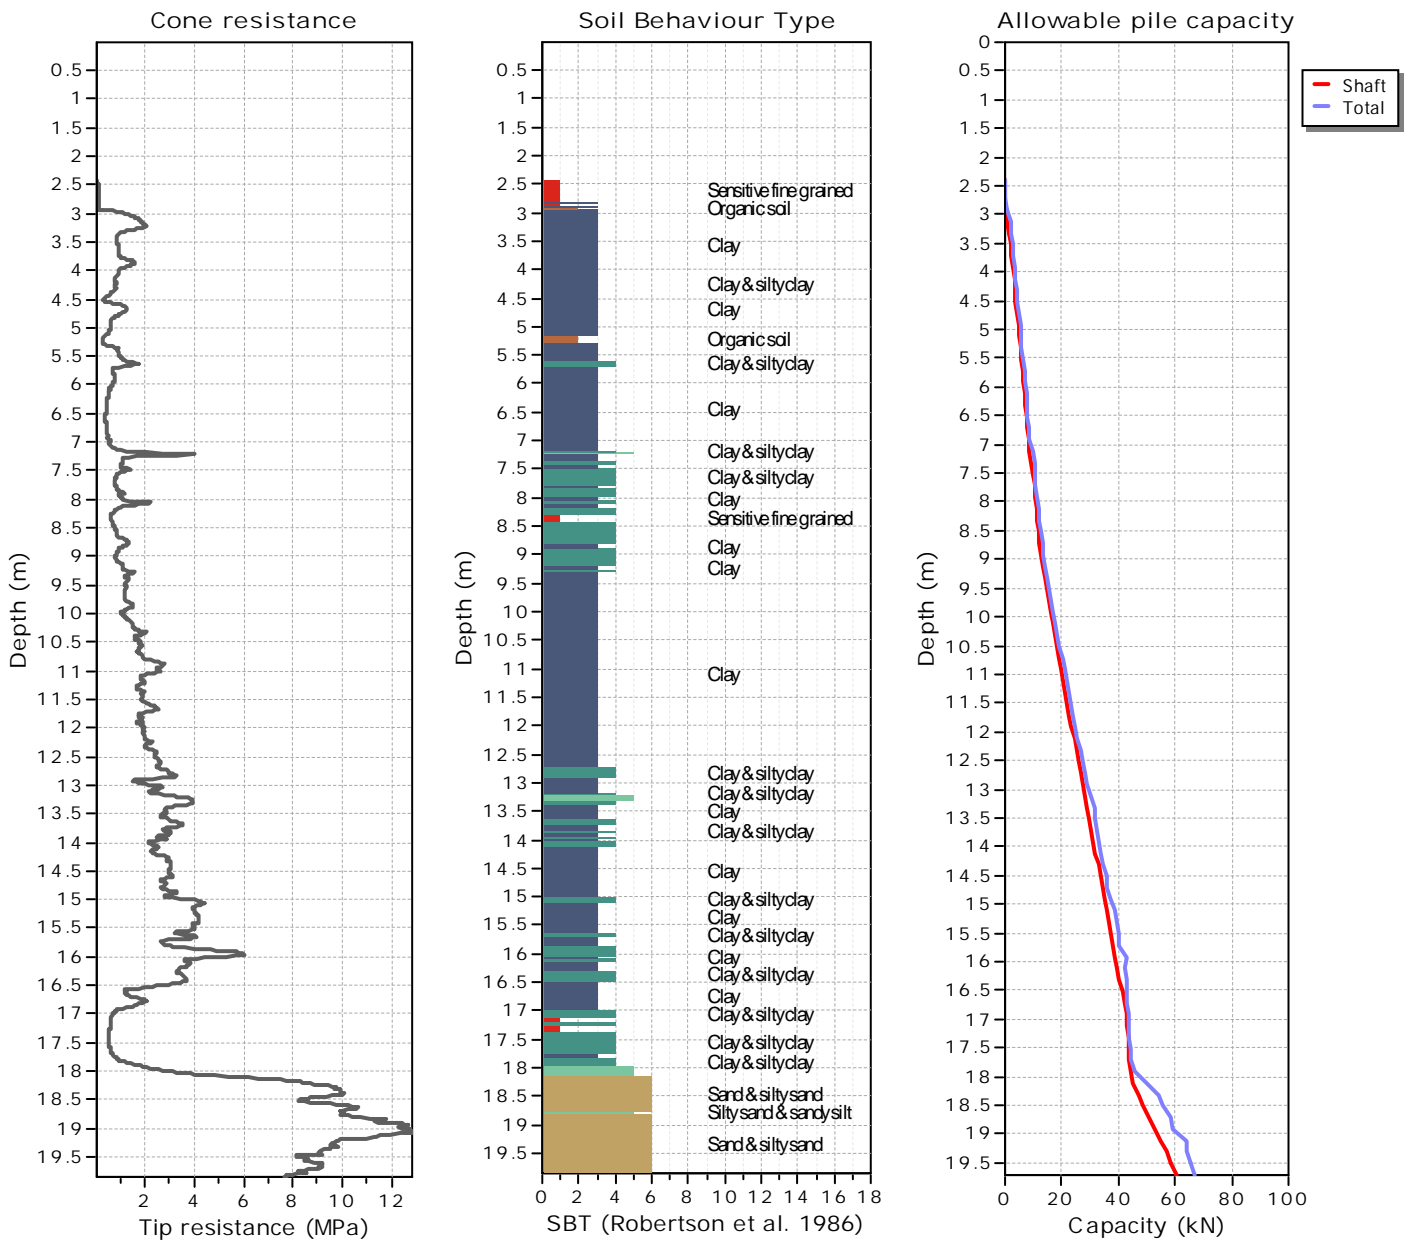
Shaft diameter: 0.07 m	Pile shaft Group: Group IA
Tip diameter: 0.07 m	Pile tip Group: Group I
Unit friction area: 0.220 m <sup>2</sup>	Pile shaft FOS: 2.00
Tip area: 0.004 m <sup>2</sup>	Pile tip FOS: 2.00

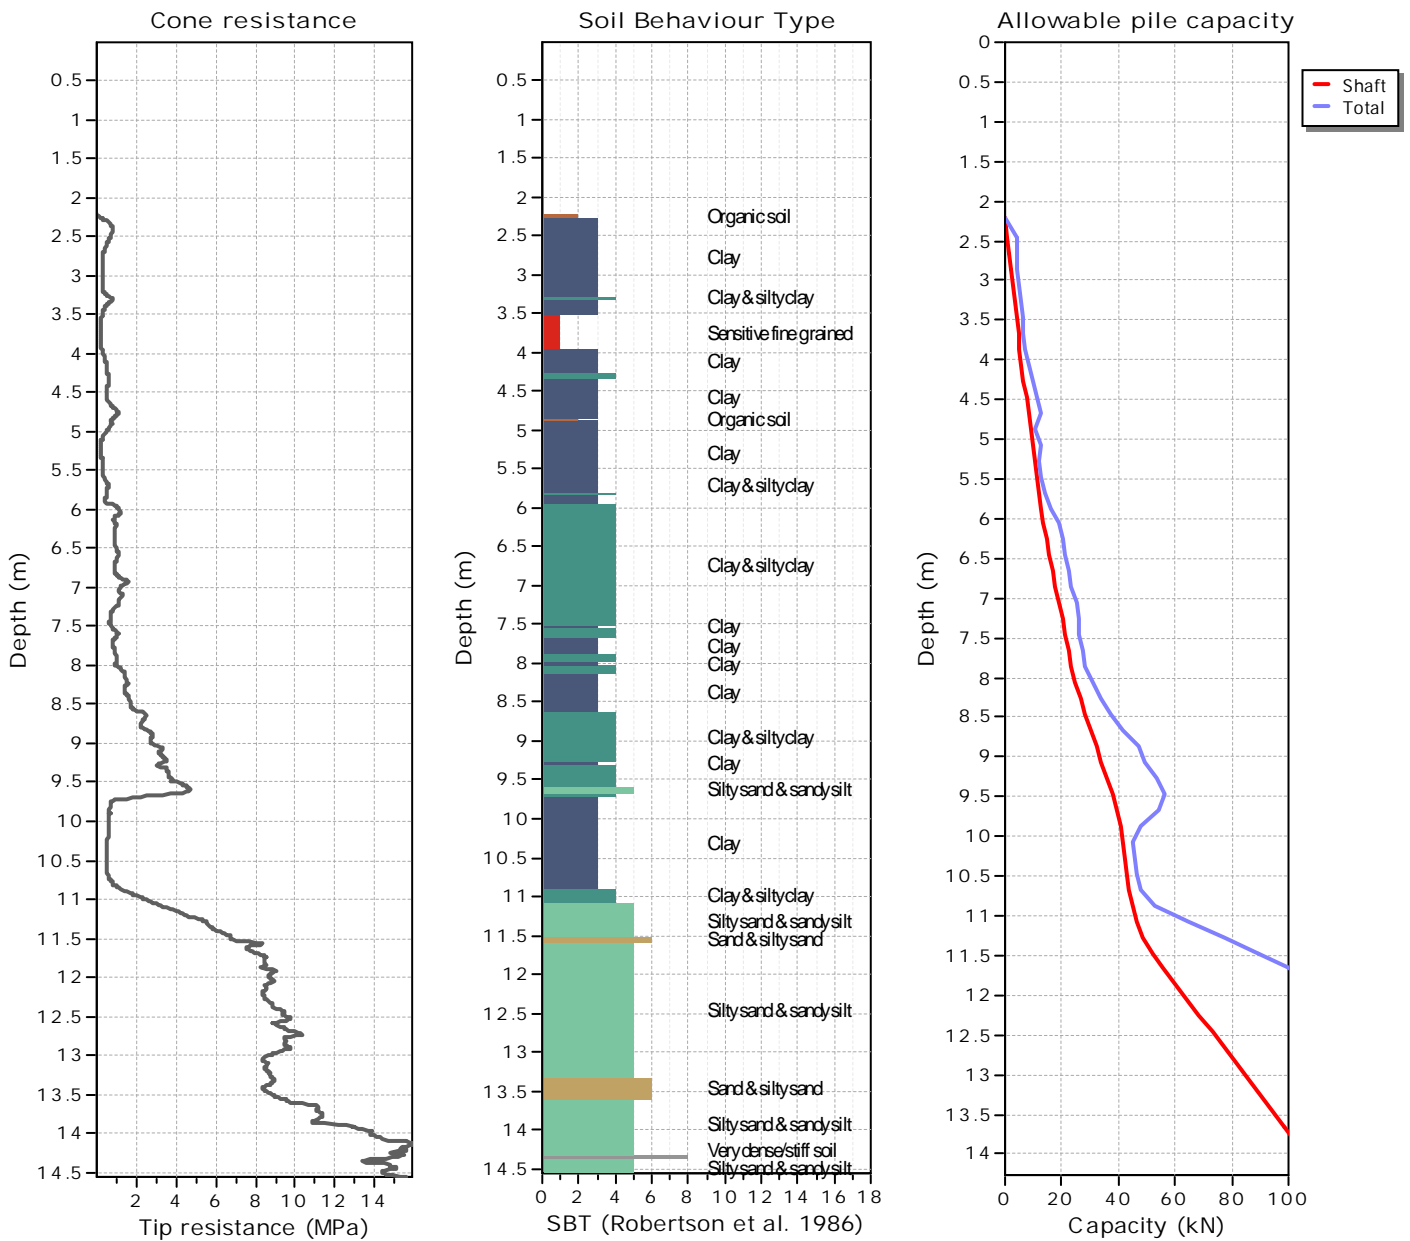
Shaft diameter:	0.17 m	Pile shaft Group:	Group IIA
Tip diameter:	0.17 m	Pile tip Group:	Group II
Unit friction area:	0.534 m <sup>2</sup>	Pile shaft FOS:	2.00
Tip area:	0.023 m <sup>2</sup>	Pile tip FOS:	2.00

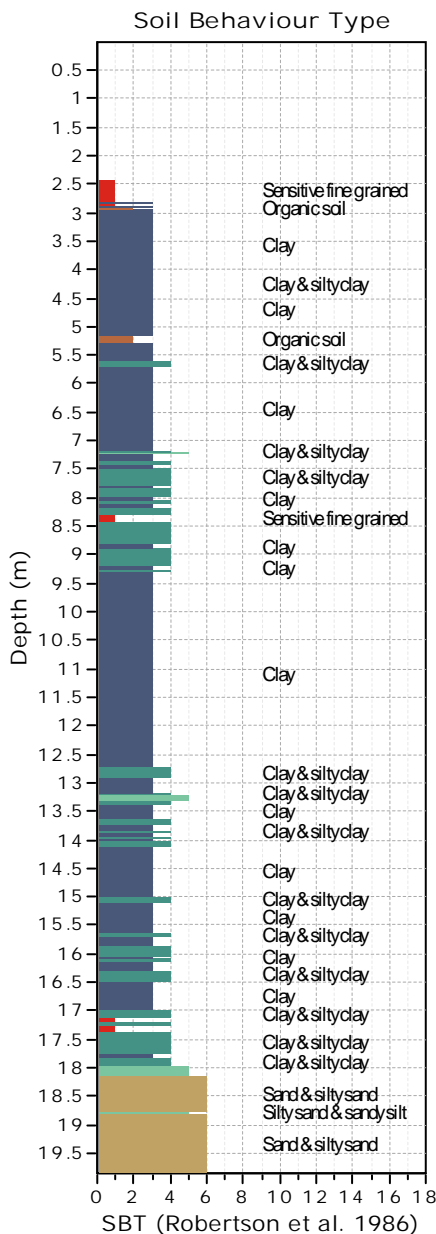
Pile shaft Group: Group IA  
Pile tip Group: Group I  
Pile shaft FOS: 2.00  
Pile tip FOS: 2.00

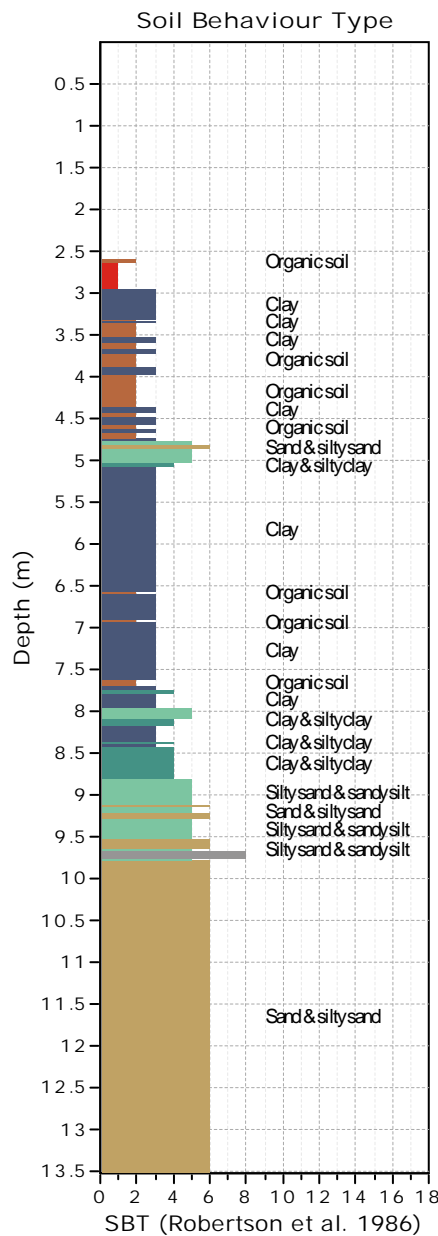
Pile shaft Group: Group IA  
Pile tip Group: Group II  
Pile shaft FOS: 2.00  
Pile tip FOS: 2.00
