Liquefaction Desktop Study

Ngahinapouri Village Concept Plan

Tonkin & Taylor Ltd

1008305.1000.v2

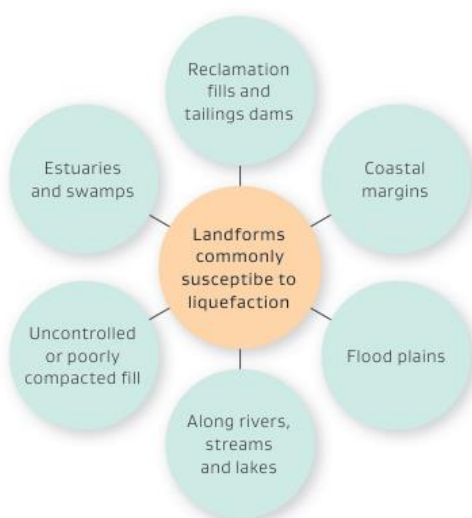
Figure 2.2: Some landforms commonly susceptible to liquefaction, (MBIE/MfE/EQC, 2017).

The conditions often susceptible to liquefaction occur in geologically young sedimentary deposits such as those shown in Figure 2.2. In general terms, loose sands, some silts and in some cases gravels are most susceptible. While clays generally do not liquefy, they may still soften during an earthquake. Soil types which are susceptible to liquefaction include:
