# **Appendix P     Draft Demolition, Deconstruction and Remediation Management Plan**

## **Remediation of Former Tokanui Hospital Site**

### **Assessment of Environmental Effects**

FORMER TOKANUI HOSPITAL  
DEMOLITION AND REMEDIATION  
DEMOLITION, DECONSTRUCTION & REMEDIATION  
MANAGEMENT PLAN - DRAFT

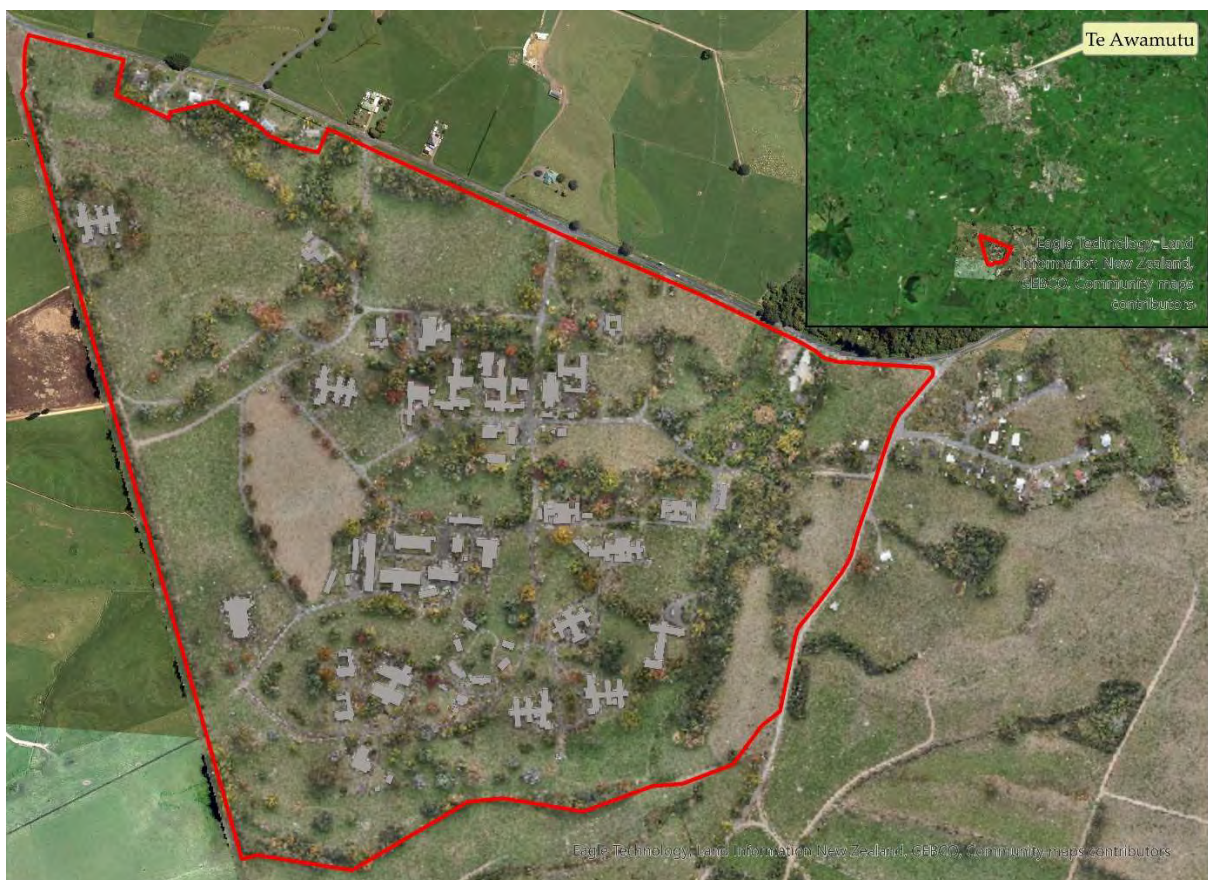
**Figure 1: Site location and extent**

The former Tokanui Hospital (the Site) was a psychiatric hospital approximately 80 hectares (ha) in area, with 76 buildings, a wastewater pump station, swimming pool, eight substations, a closed landfill (also referred to as the 'existing disposal site') and substantial roading and underground infrastructure and services. The site location and extent is shown in Figure 1

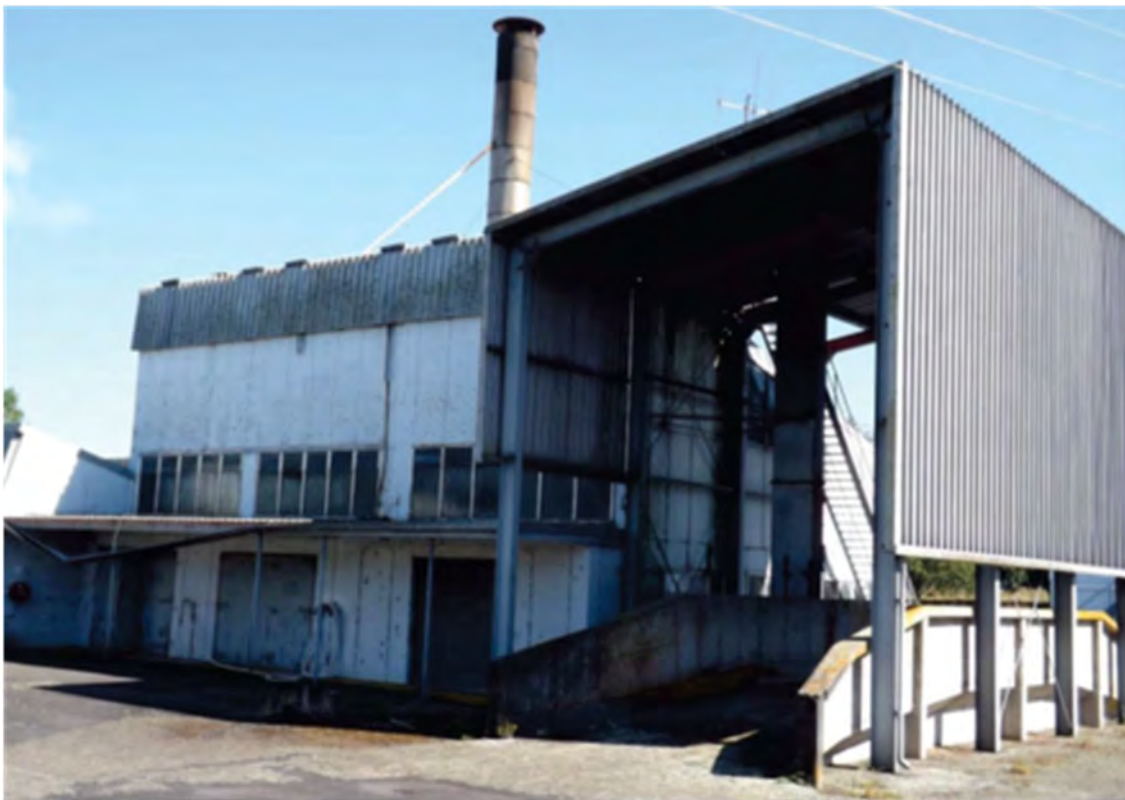
**Figure 3: Boiler House**

The boiler house (B68) is shown in Figure 3.

- Large steel frame lean-to addition to the north of the main boiler room and bolted back to the reinforced concrete hopper framing.
- Steel frame portal legs cased in concrete to approximately 3m above ground level. Reinforced concrete perimeter walls to same height with timber framing above.

- Three large diameter metal chimneys to 15-20m above ground level stabilised with tie wires attached to main building.
- Slab-on-grade ground floor. Assumed pad bases to columns and strip footings to masonry walls.

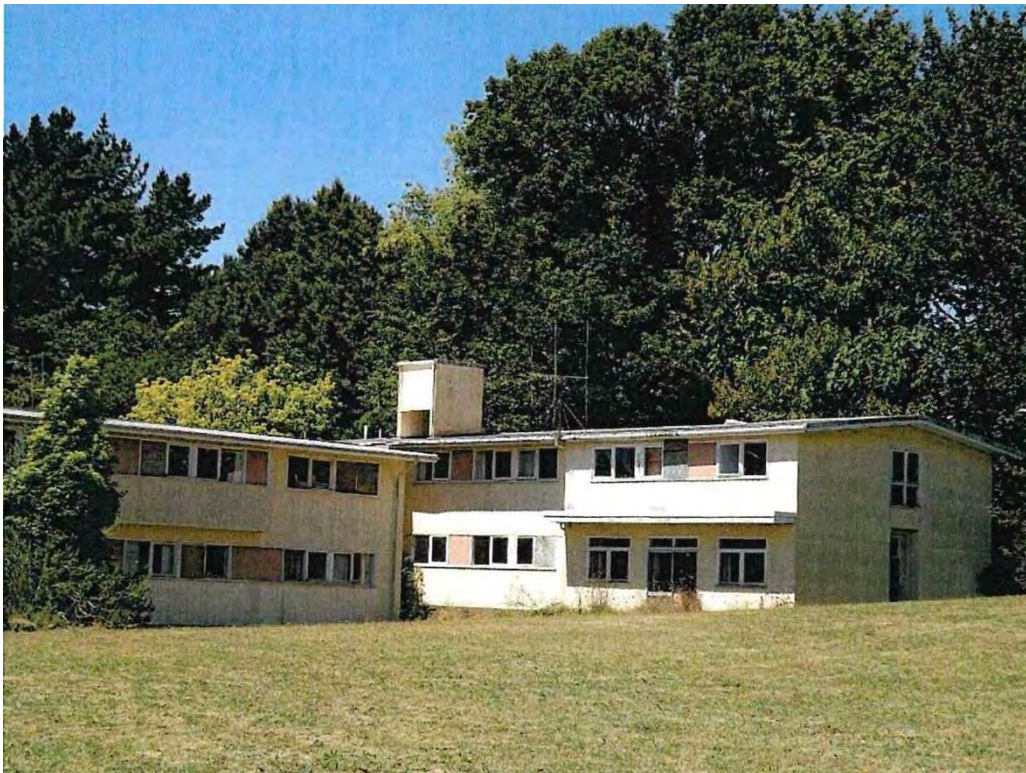
**Figure 4: Ward 21 (B26)**

Ward 21 (B61) is shown in Figure 4.

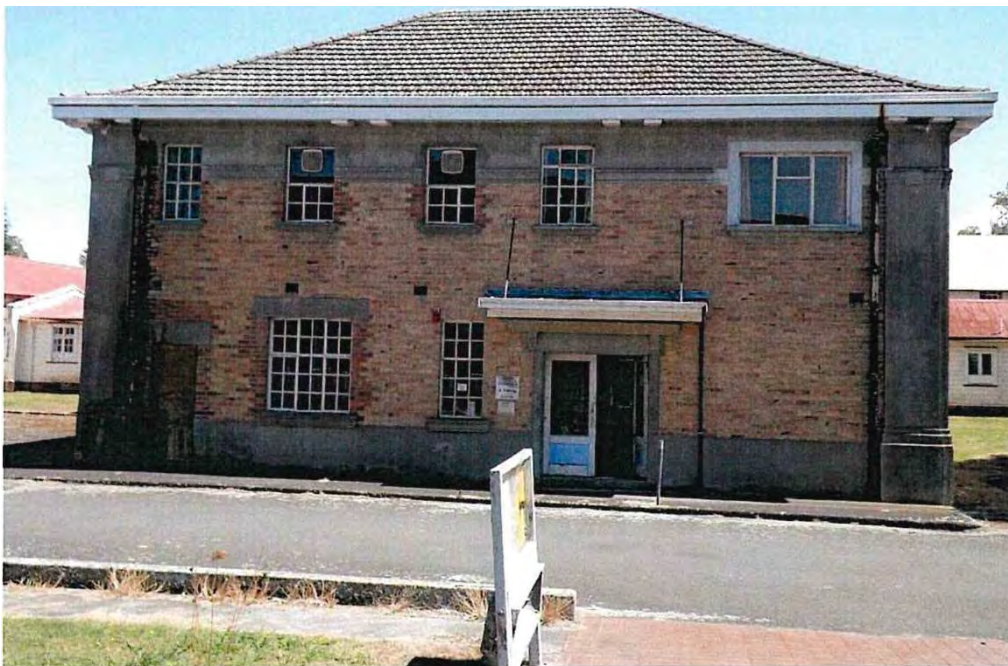
**Figure 5: Waipā Community and Training Centre (B10)**

The Waipā Community and Training Centre (B10) is shown in Figure 5.

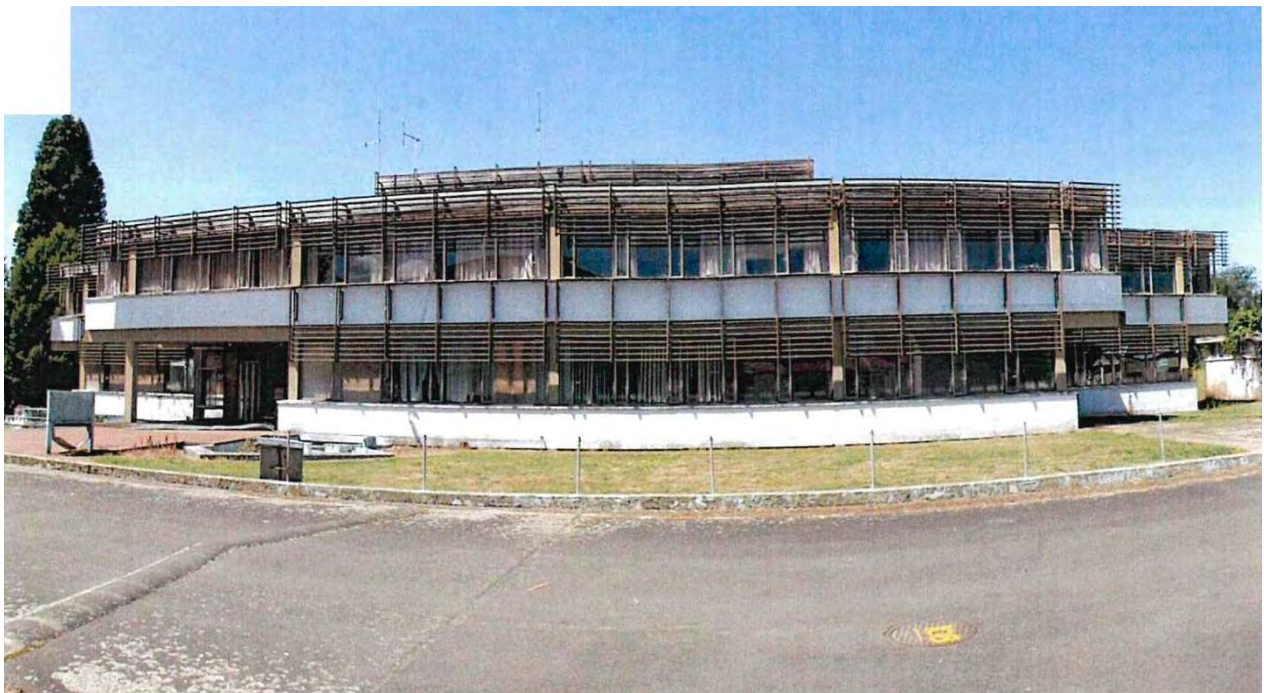
**Figure 7: Main Administration Building (B1)**

The main administration building (B1) is shown in Figure 7.

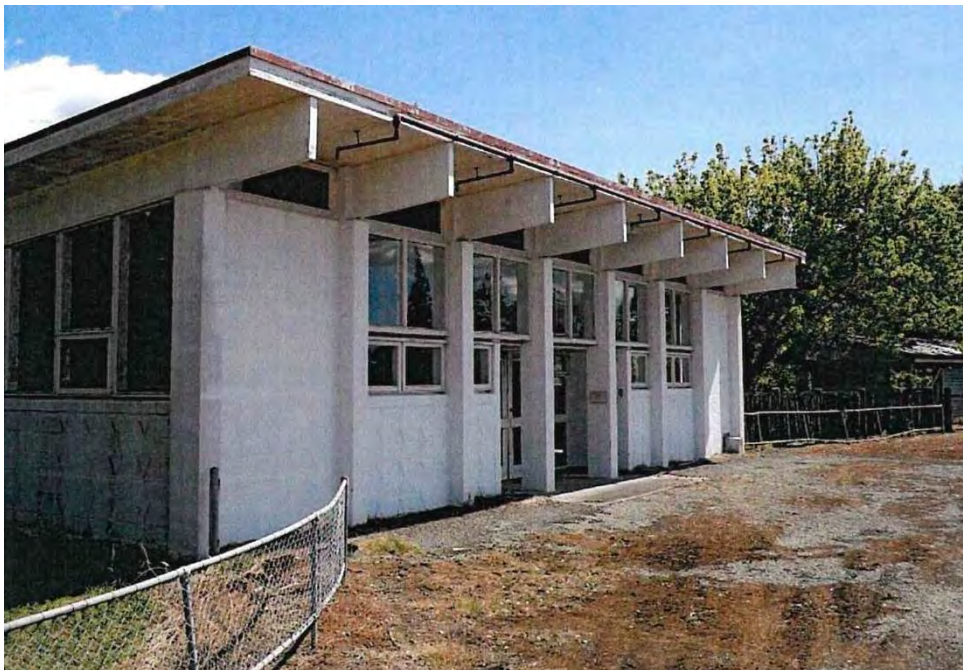
**Figure 8: Village Hall (B36)**

The Village Hall is shown in Figure 8.

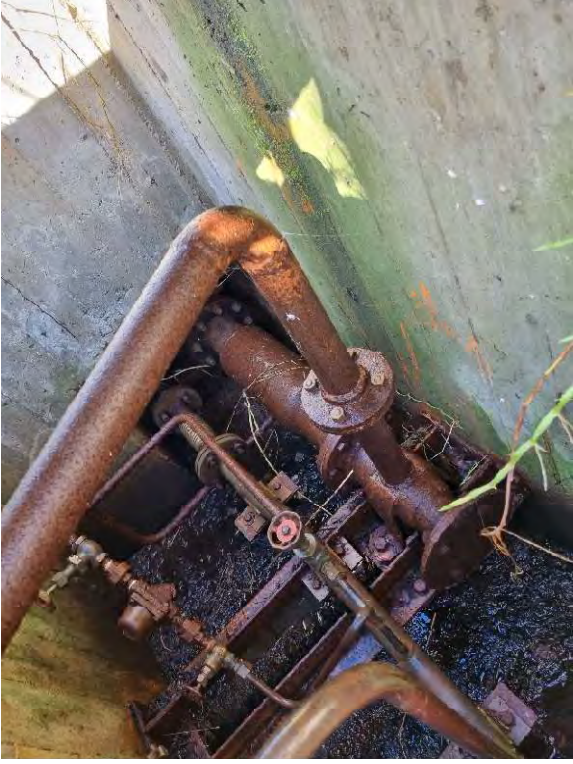
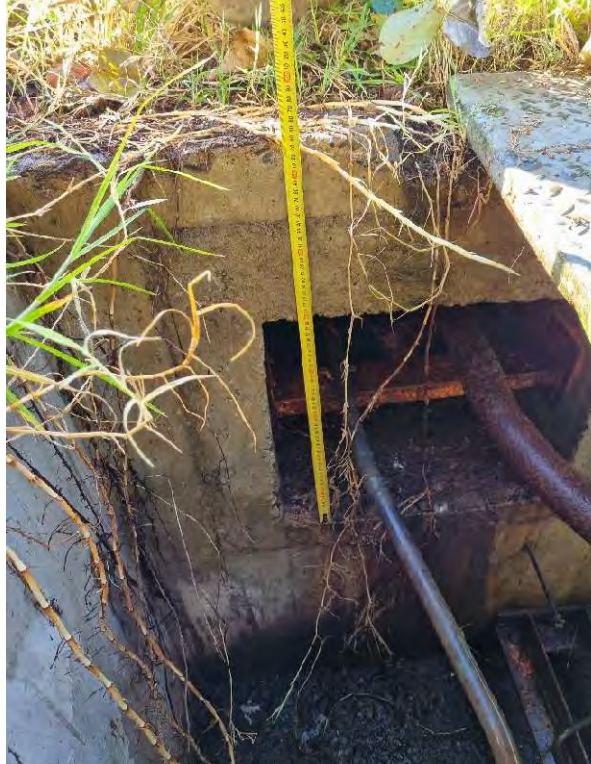
| Chamber – LID K01 located at B55 Ward K | Chamber – LID K01 located at B55 Ward K showing the internal duct height as 500mm |

**Figure 13: Representative Photos of the Concrete Ducting System**

Based on historical plans, composition of the steam lines was generally ungalvanized mild steel of either medium or heavy grade. The return condensate lines were copper. In some areas there was a third pipe, conveying hot water pipes, but some drawings refer to this as “to be removed”. Bronze anchors and guides for the condensate pipes are referred to on some drawings. Pipe sizes are shown as varying from 1.5” to 2.5” (38-63mm for condensate) and 2”-6” (50-150mm) for steam. The pipe system includes significant numbers of valves, anchors, brackets and guides. Cover over the concrete ducting varies but is around 400mm on the drawings reviewed, which only cover a small part of the overall system.

Some photos of the ducting are included below for information. More details and photos are included in the Horizontal Infrastructure Report.

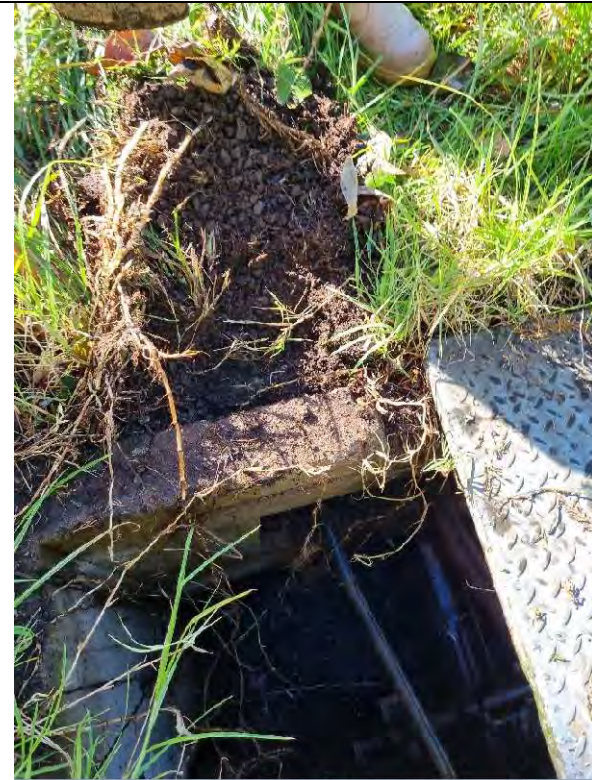
Chamber – LID K01 showing 50mm cover where the duct connects to the building

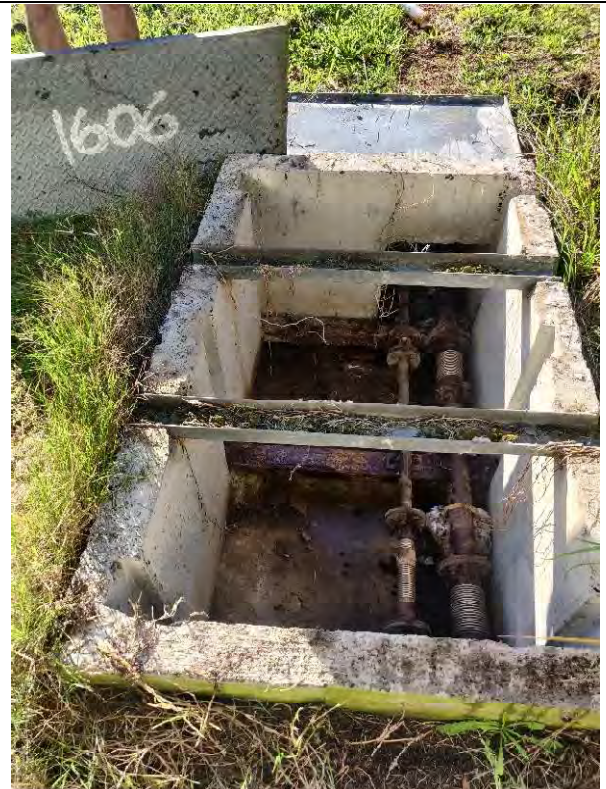
Chamber 1606 at B48 Ward 16

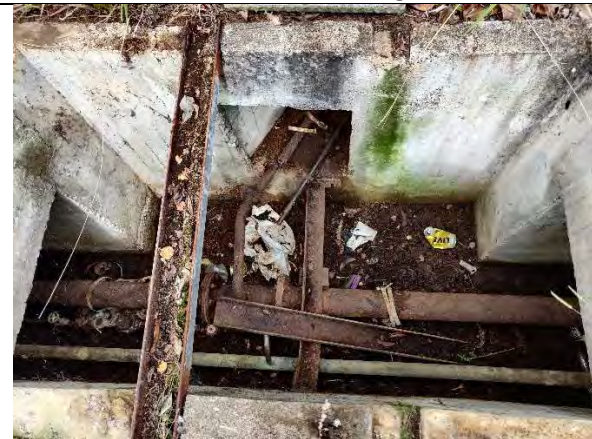
Chamber EDU04 at B51 EDU

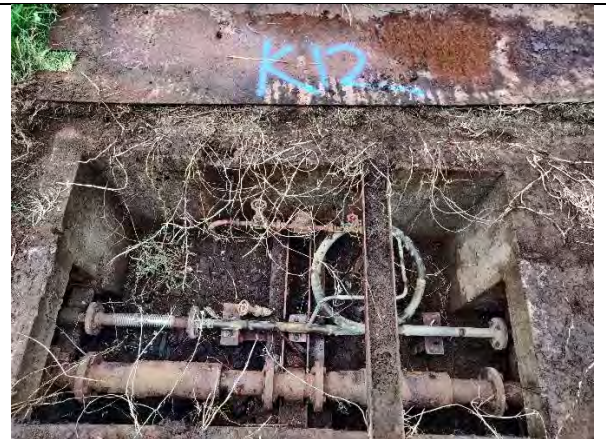
Chamber K12 Located NW of the site

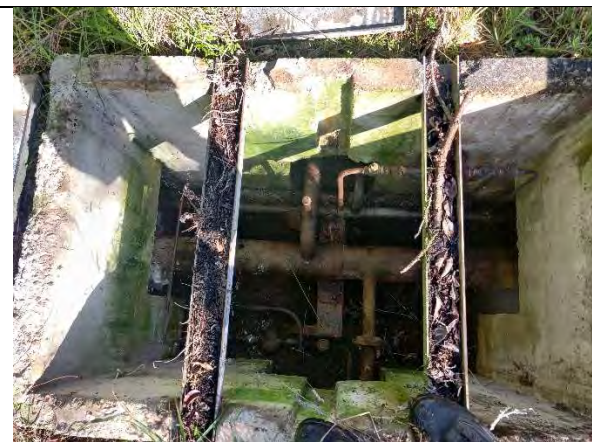
Chamber H08 located at B48 Ward 16

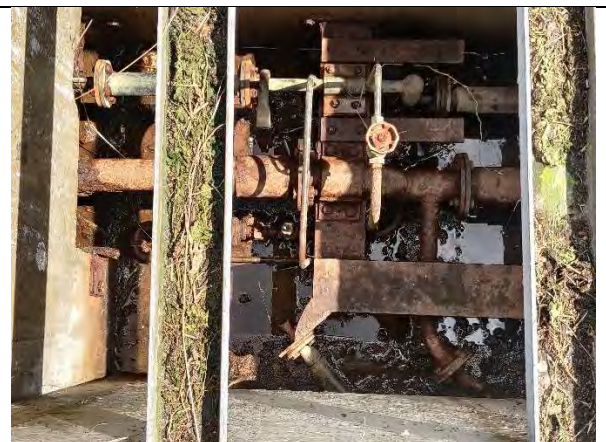
Chamber 925 located at B29 Ward 7

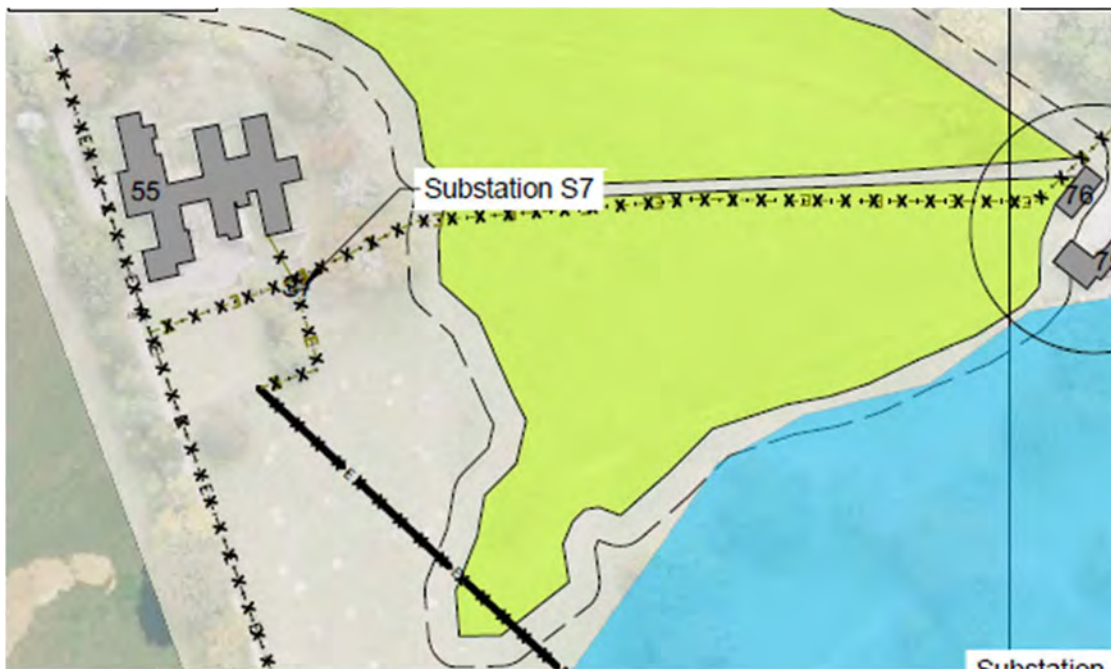
Figure 16: Extent of below ground power cable and above ground power cable in wetland area.

The length of power cabling through the wetland area is approximately 210m long, as shown in Figure 16 below. There is also a small section of overhead power cabling that passes through the southern tip of the wetland.

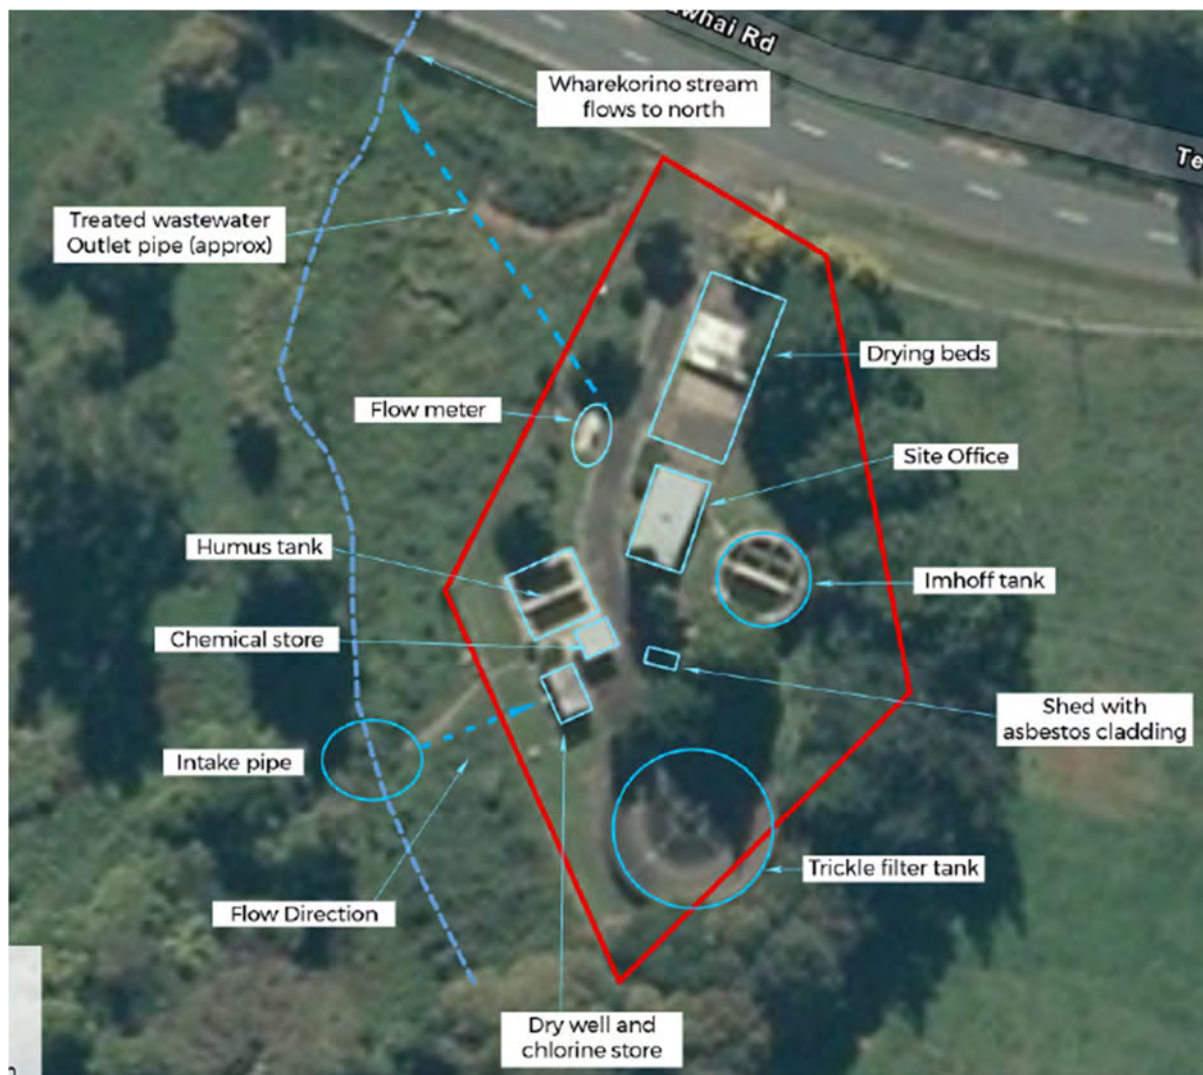
**Figure 17: Former WWTP Pre-decommissioning**

The WWTP, pre-demolition, is shown below in Figure 17.

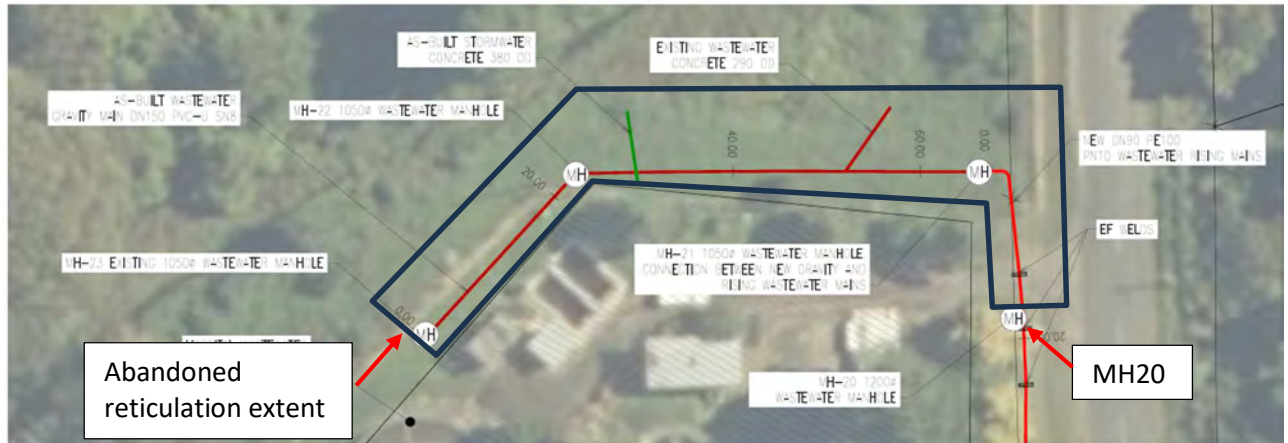
**Figure 20: Abandoned wastewater line and MHs (item 13)**

When the WWPS became operational, an existing section of wastewater rising and gravity mains from MH20 to the end of the wastewater line (MH23) was abandoned, as shown in Figure 20. This work comprises three DN150 PVC gravity pipes of total length around 67m, with three associated wastewater manholes, and a short section of 380OD stormwater pipe as shown in Figure 20. All of this pipework is less than 800mm deep, except the first 18m of wastewater pipe from MH23 towards MH22.

- Item 12: Relocate fence to reduce compound size. LINZ to confirm extent.
- Item 13: Remove wastewater pipes down to 800mm depth out to the boundary with the road reserve and remove the stormwater pipe and associated three WWMHs shown in Figure 20. Cap the line at the road reserve boundary and at each end of the wastewater pipe greater than 800mm depth from MH23 to MH22.

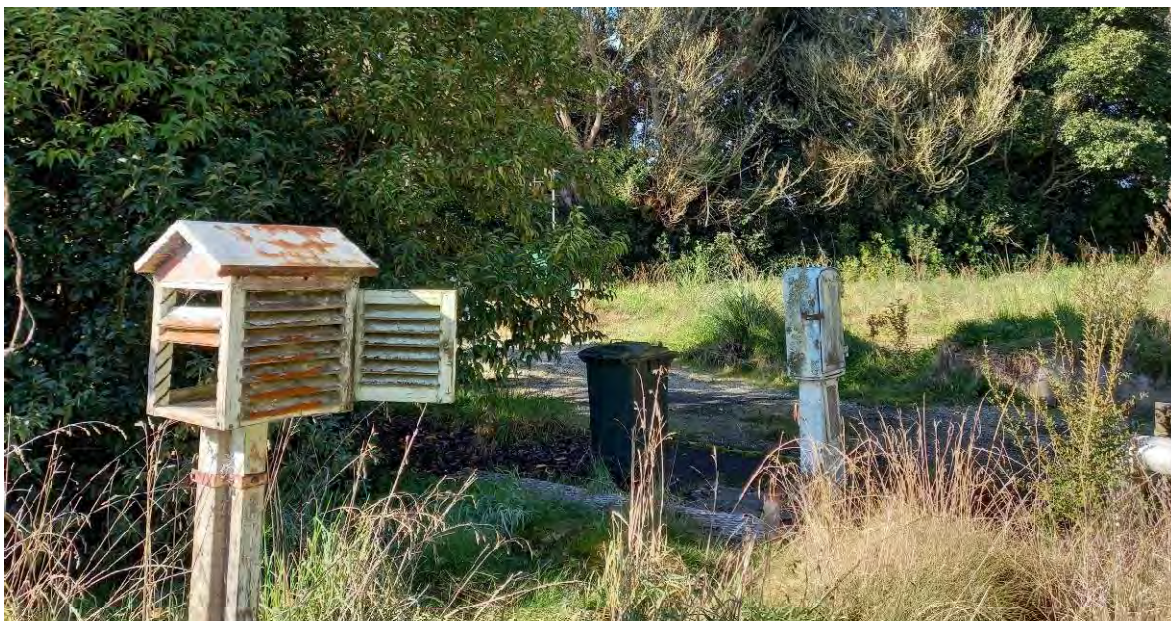
**Figure 21: Former flow meter area**

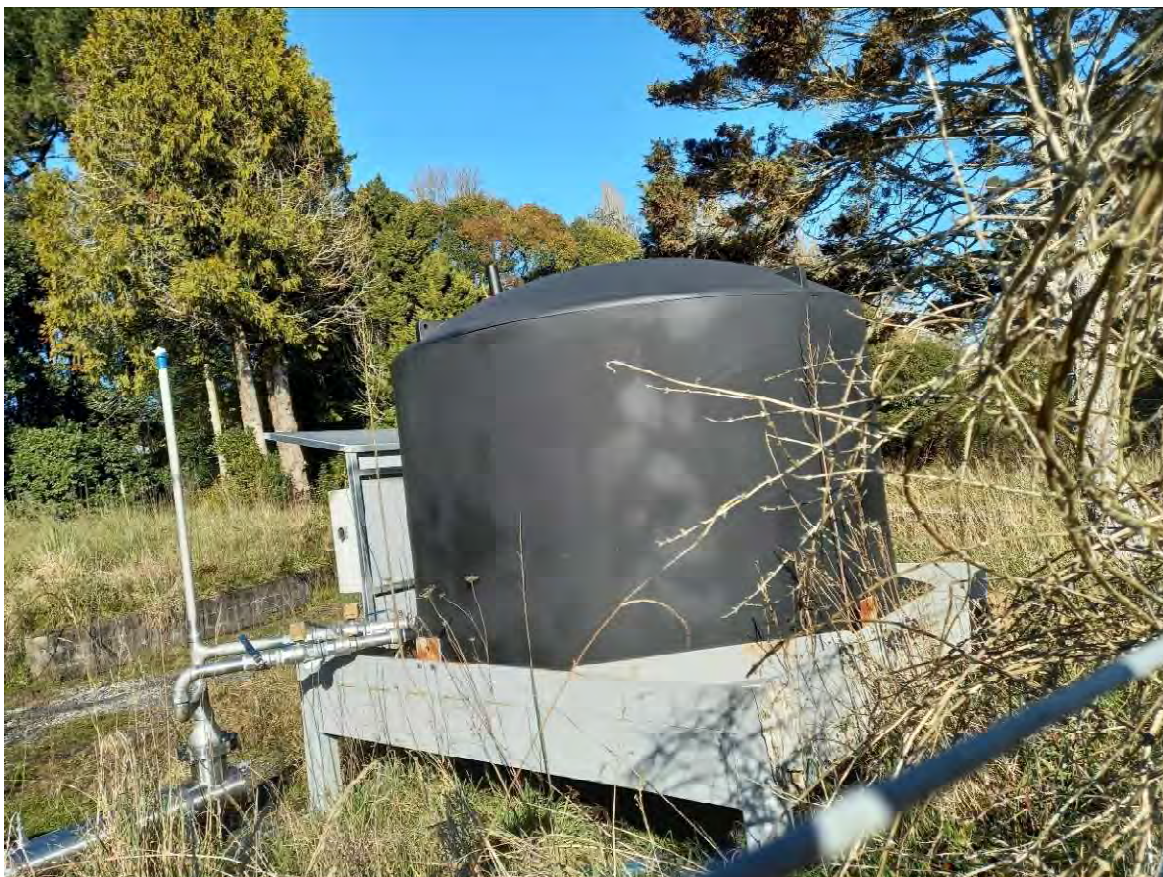
**Figure 22: Redundant UV Treatment Plant**

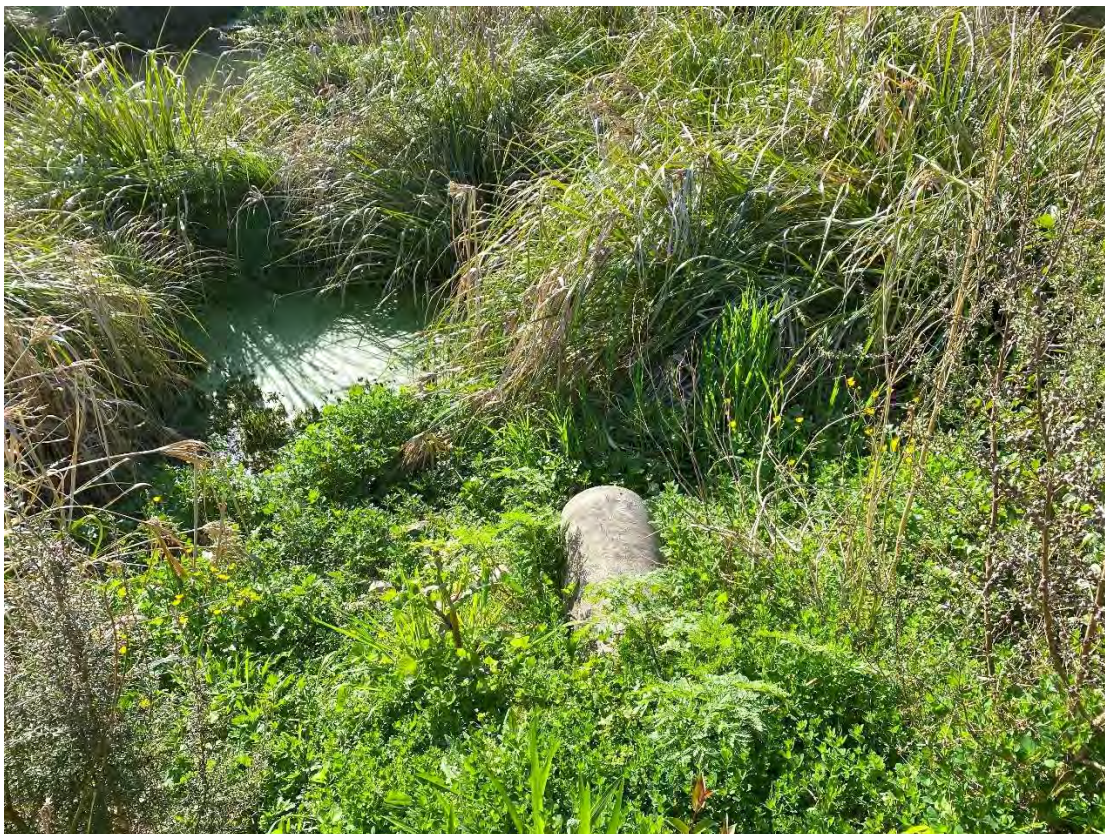
**Figure 23: Outfall Pipe**

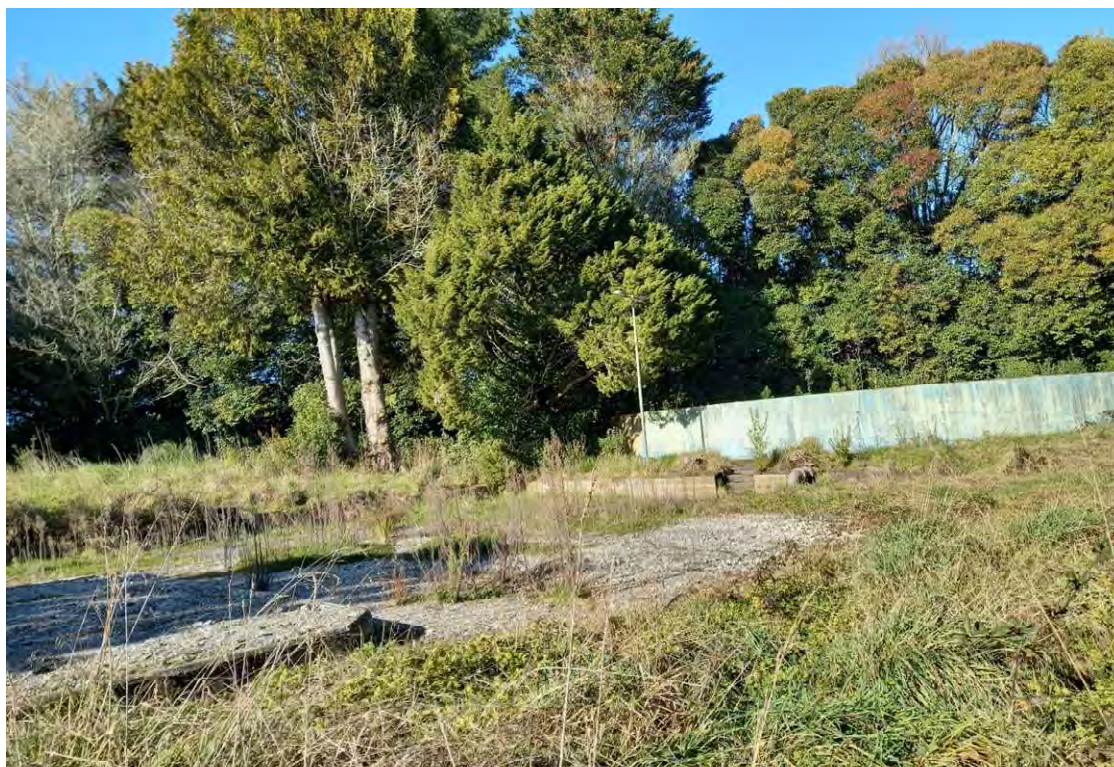
**Figure 25: Remove trickling filter (circular tank in background) and stone media (item 7).**

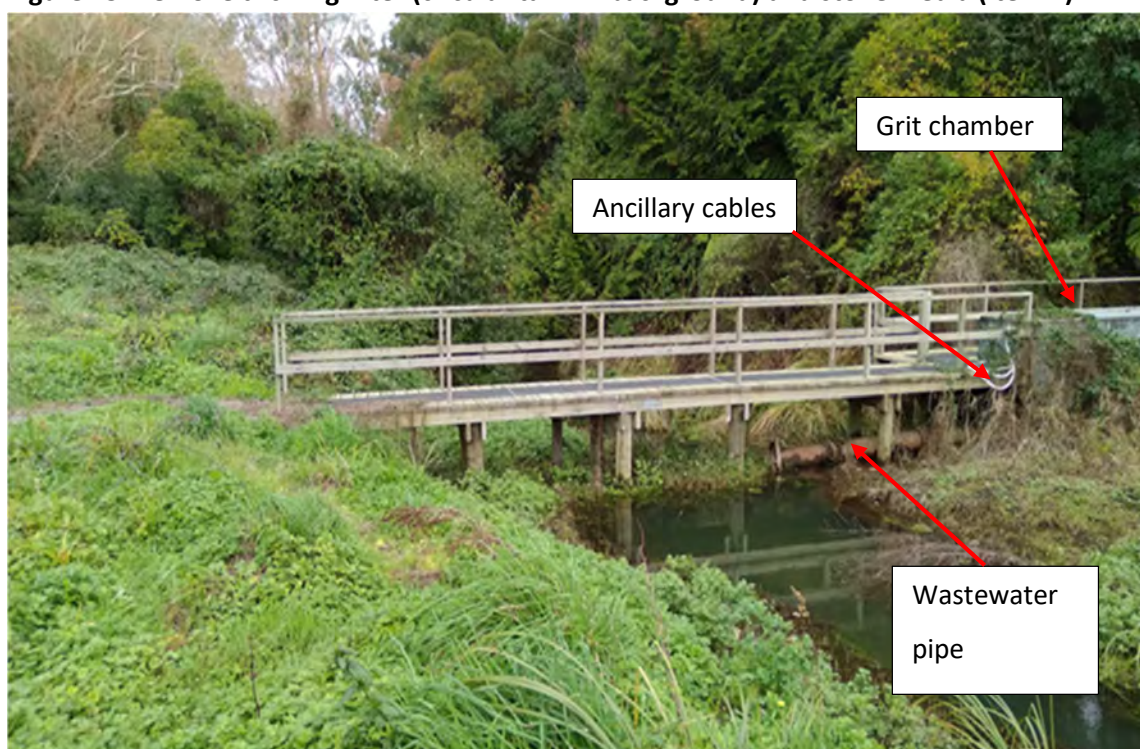
**Figure 26: Remove grit chamber on wastewater inlet line, wastewater inlet pipe strapped to footbridge, any ancillary cables/ducting, and footbridge itself (items 8-11)**

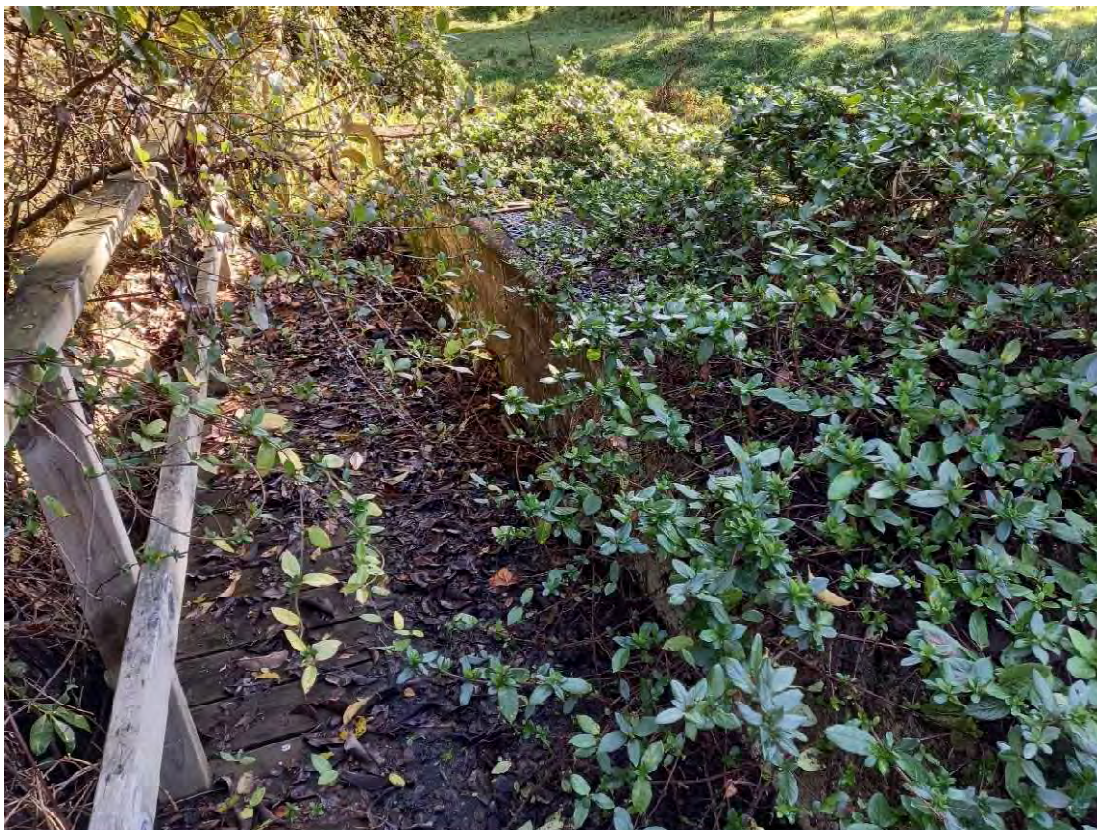
**Figure 27: Closeup of grit chamber showing concrete blockwork construction and grated metal lid (largely hidden under vegetation)**

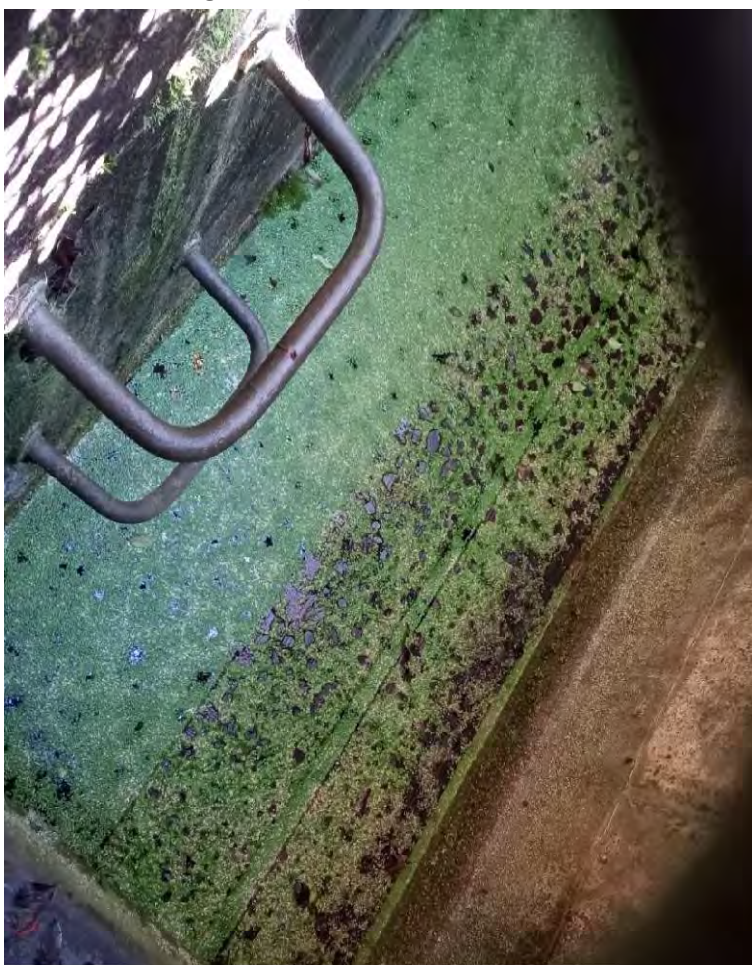
**Figure 28: Inside of grit chamber**

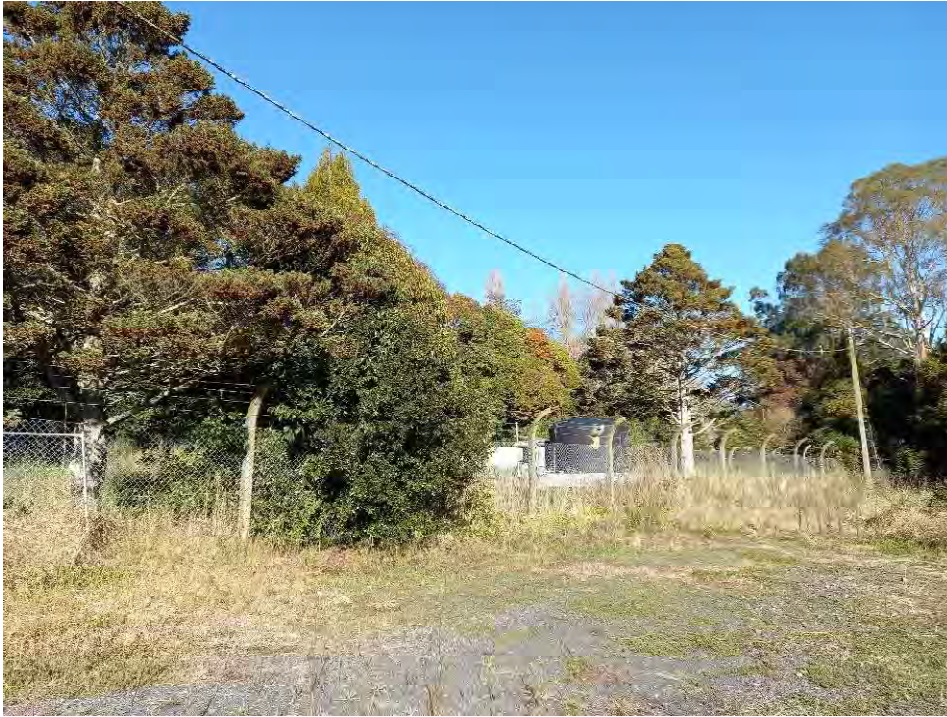
**Figure 29: Relocate perimeter fence to reduce compound size. LINZ to confirm extent**

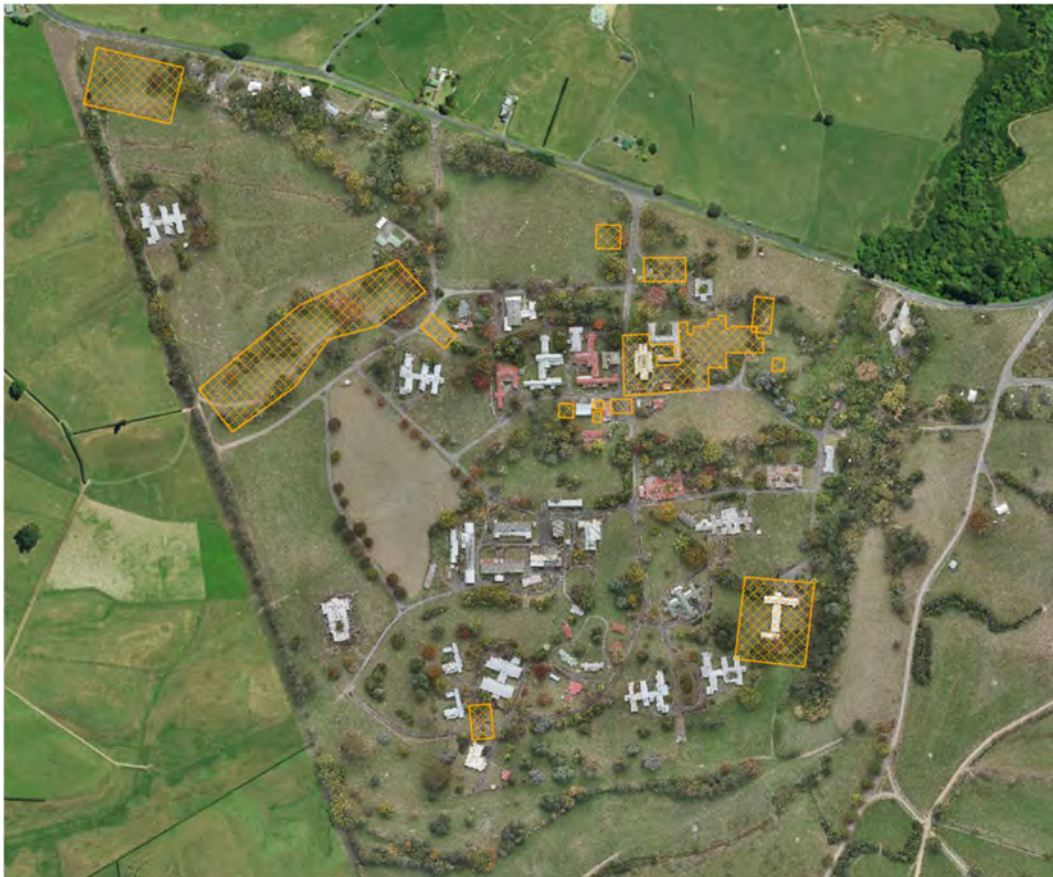
**Figure 30: Extent of Historical Building Demolition Works**

During February 2024 site investigation work, some historical demolition debris, including some asbestos sheet fragments, filament bulbs, burnt material, terracotta/earthware pipes, etc. was found in rare/minor/small quantities at variable depths ranging from near surface to up to 1.2m on the northern sides of Buildings B02 (northern side of southern arm) and B26 (directly north in carpark area). A review of historical aerial photographs identified that some buildings, or parts of buildings, have been demolished in these areas in the past. All of these areas have been investigated as part of intrusive investigations by AECOM/GHD with no significant demolition debris or contaminated soil found. Nevertheless, some fill and minor demolition debris may be found in these areas during associated demolition works, particularly during the removal of building footings/foundations and any buried services. This may also apply to the industrial area, where some discoloured fill was encountered. The extent of the historical demolition works is shown in Figure 30. The contractor should be aware of this, and advise LINZ or their nominated representative, if such fill/materials are found. Accidental discovery protocols will be triggered, if the find is significant (e.g. asbestos fragments, concentrated pockets of demolition debris.)

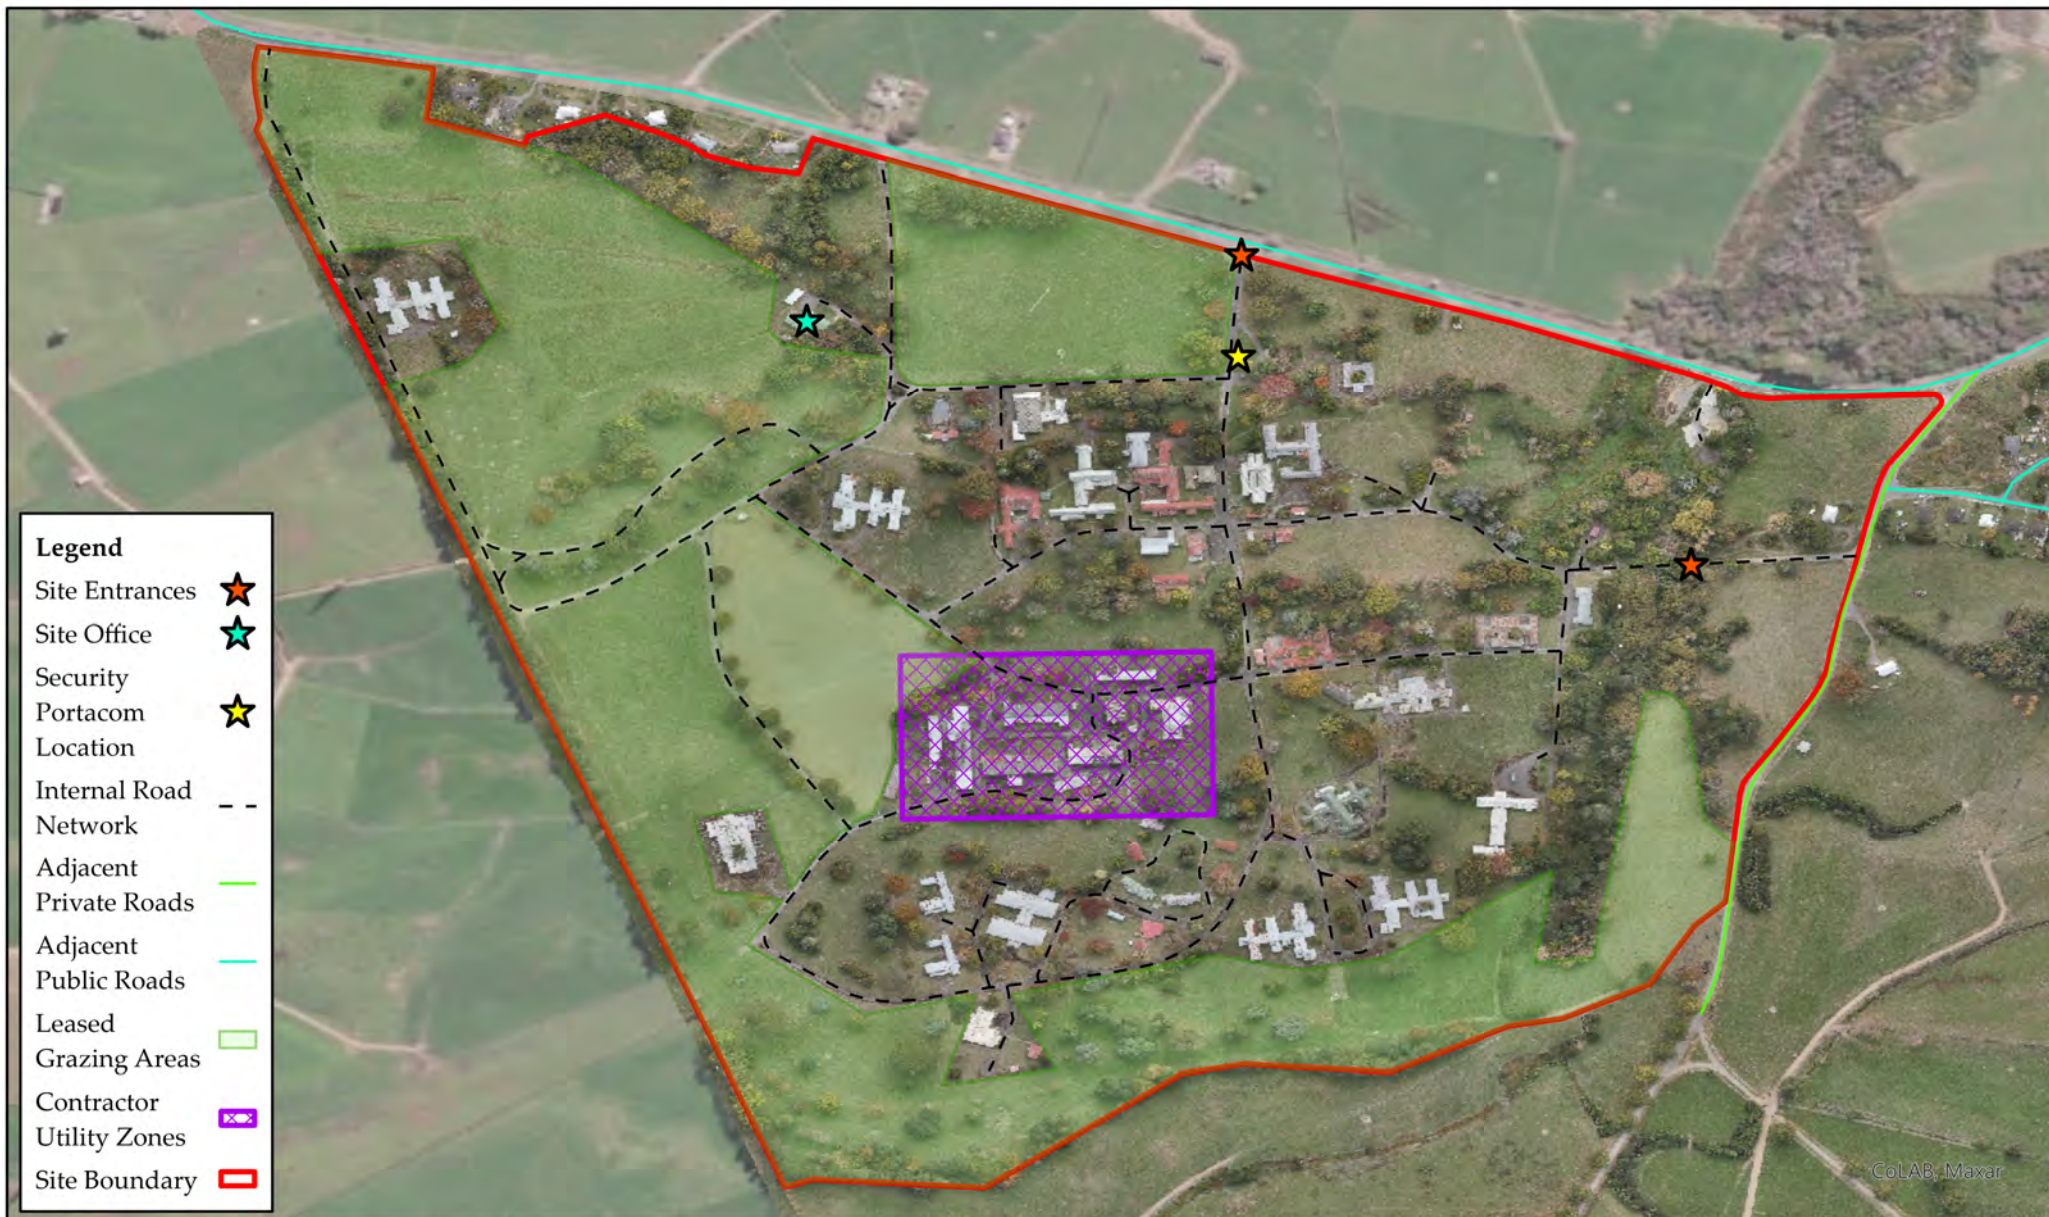
| <p><b>Fraser Thomas</b></p> <p>ENGINEERS • RESOURCE MANAGERS • SURVEYORS</p> | <p><b>G02: Site Amenities Plan</b></p> | <p>Date: 12/11/2024<br/> Figure Reference: 33205/G02<br/> Drawn by: EB<br/> Reviewed by: SF<br/> Job Number: 33205</p> <p>0 100 200 400 600</p> <p>Meters</p> | <p>N</p> |

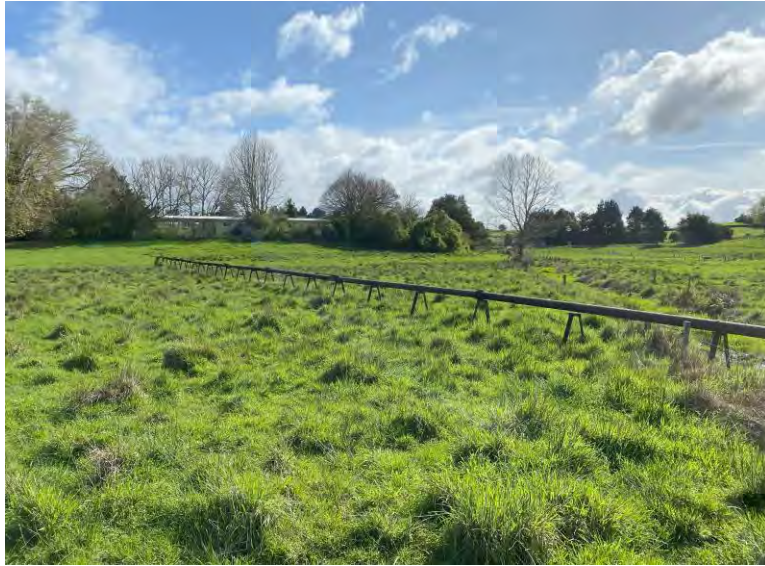
Southern pipeline with footings
