# **Appendix P     Draft Demolition, Deconstruction and Remediation Management Plan**

## **Remediation of Former Tokanui Hospital Site**

### **Assessment of Environmental Effects**

FORMER TOKANUI HOSPITAL  
DEMOLITION AND REMEDIATION  
DEMOLITION, DECONSTRUCTION & REMEDIATION  
MANAGEMENT PLAN - DRAFT

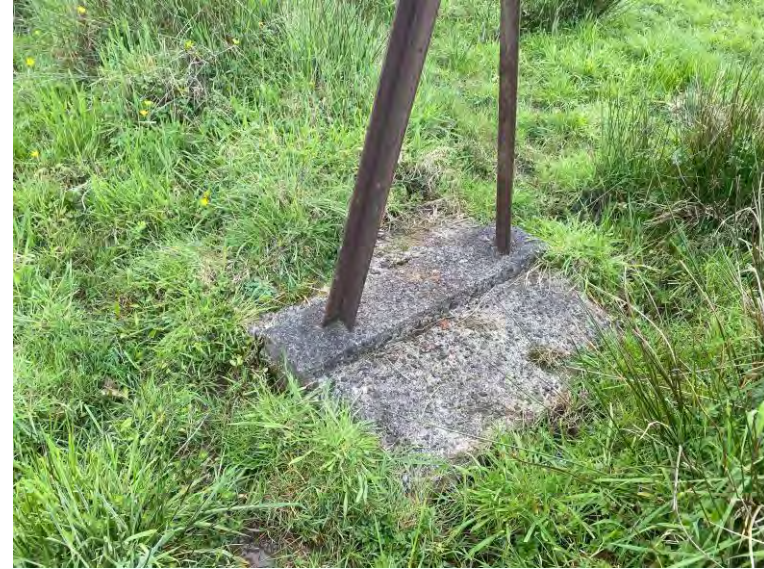
Southern pipeline footings and concrete foundation

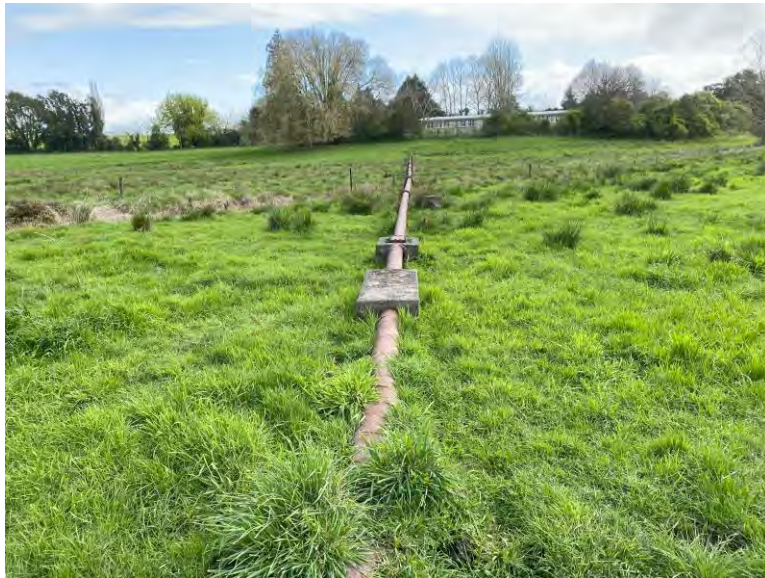
Southern pipeline with concrete casing

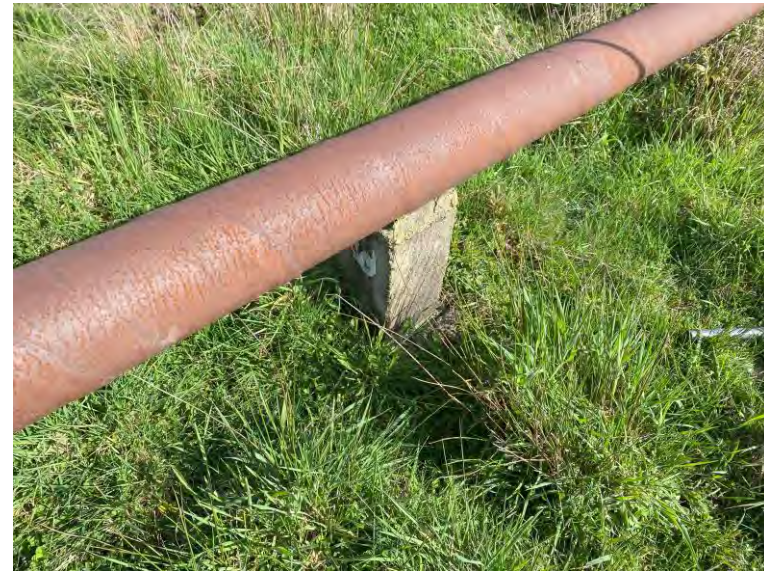
Southern pipeline with concrete pile

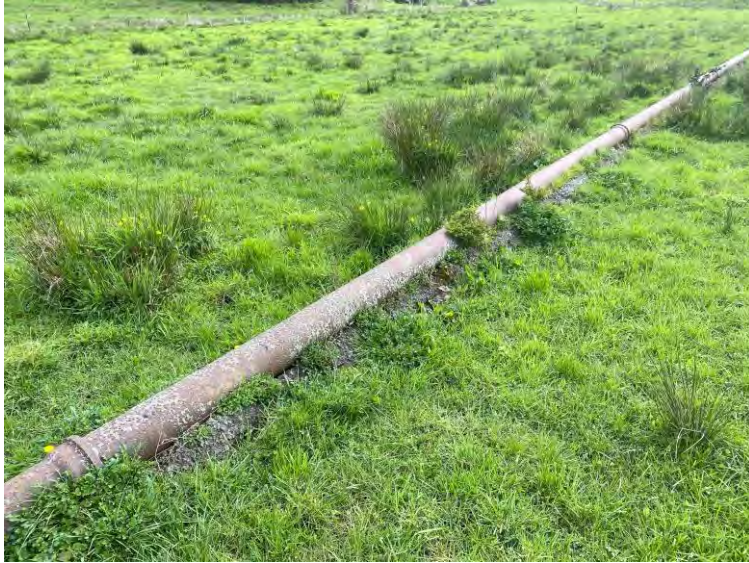
Pipeline situated on concrete foundation

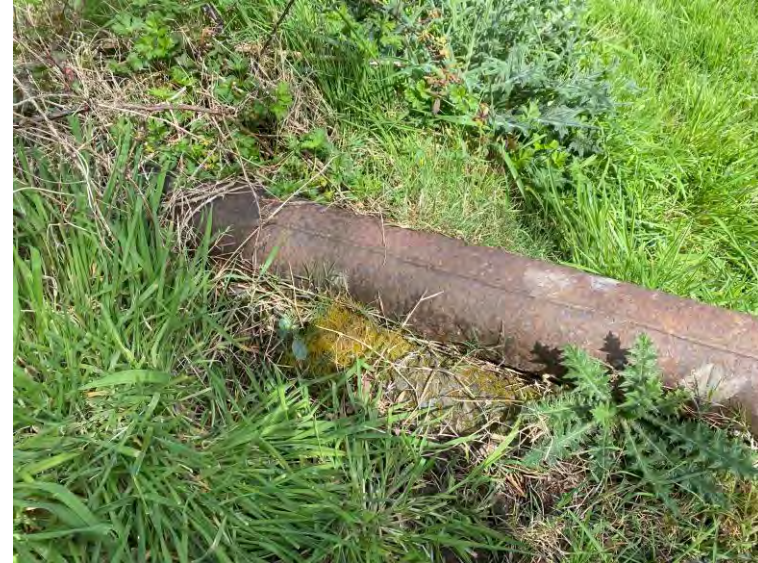
Pipeline situated on concrete foundation

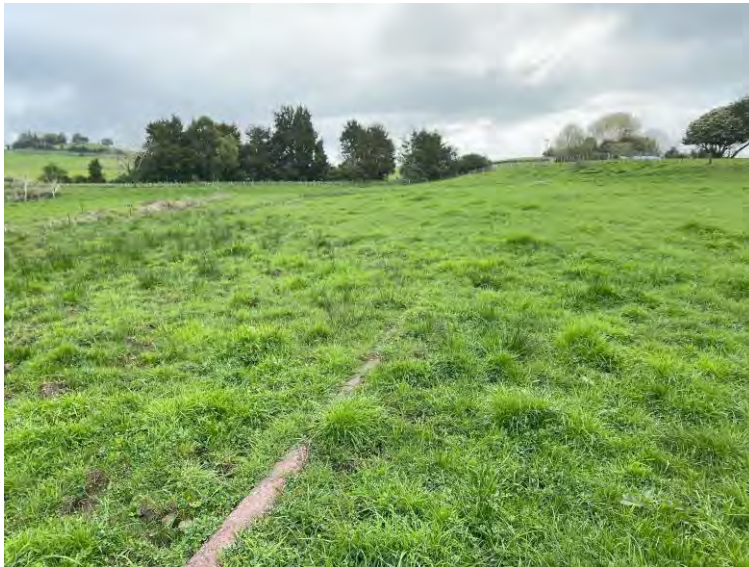
Westernmost pipeline below ground level

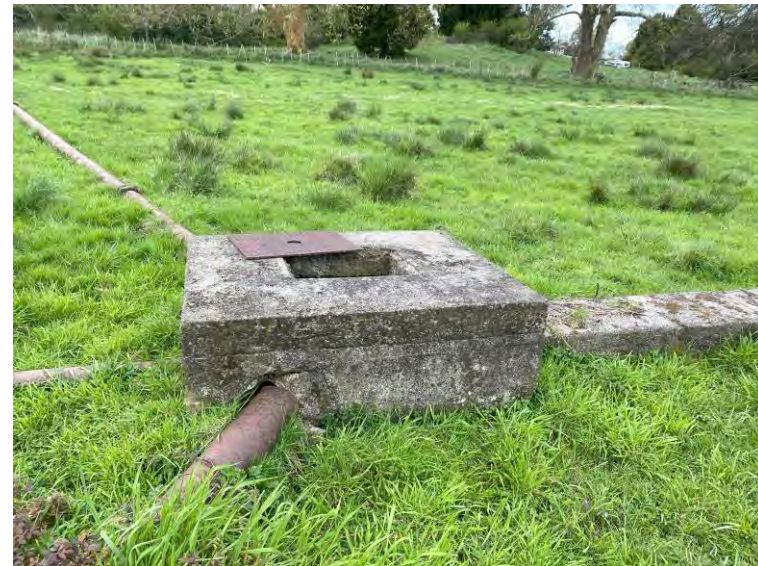
Concrete chamber connecting all four pipelines

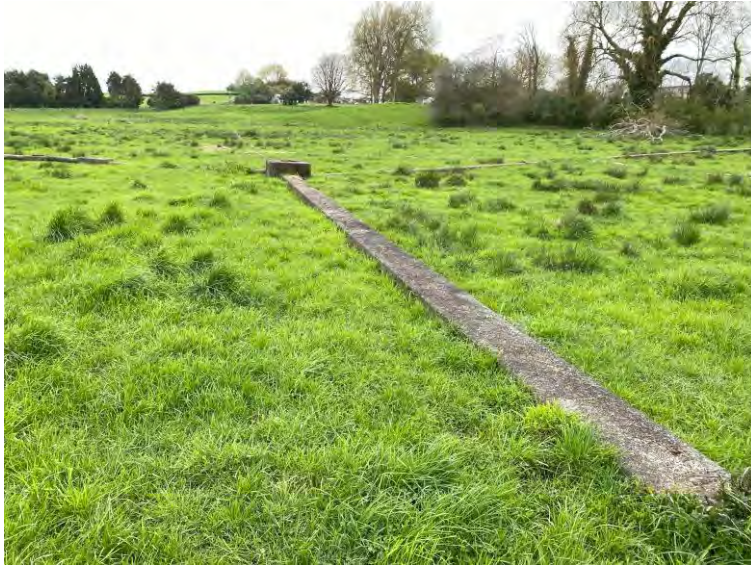
Eastern pipeline within concrete chamber

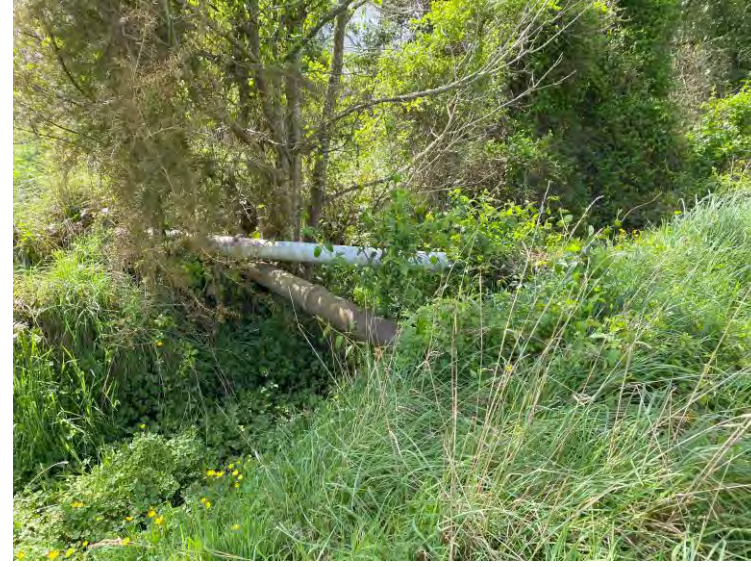
Additional pipeline underlying eastern pipeline

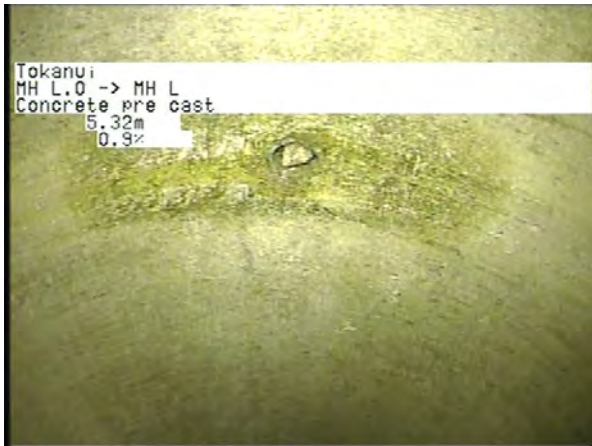
MH L.0 To MH  
L\_bc5c82b4-6374-44e7-a6f7-cb496a6223fa\_20230328\_122801\_777.jpg, 00:01:23, 5.32m

| 1:550 | m + | OC | Observation | MPEG | Photo | Score |
|---|---|---|---|---|---|---|
| | 5.32 | S02 CF | Construction feature at 12 o'clock, start / Lateral connection | 00:01:23 | MH L.0 To MH L_bc5c82b | |

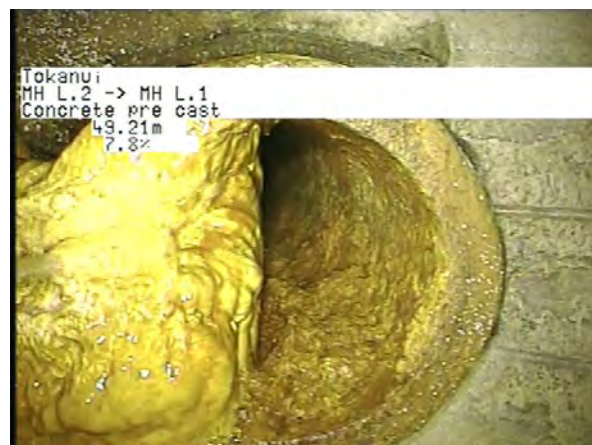
| Comments | | | | | | |
|---|---|---|---|---|---|---|
| | 49.21 | LXL | Lateral problem, large defect at 9 o'clock / Signs of ground water | 00:13:47 | MH L.2 To<br>MH<br>L.1_f1743 | 30 |

MH L.2 To MH  
 L.1\_f1743155-69ae-4a14-957b-195c700051c6\_20230328\_11  
 5338\_028.jpg, 00:13:47, 49.21m

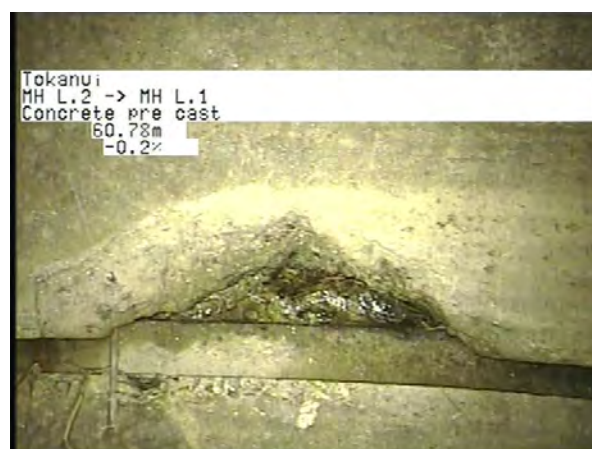
| Comments | | | | | | |
|---|---|---|---|---|---|---|
| | 60.78 | JFM | Joint faulty, medium cracking or spalling, unlikely through the pipe wall from 12 o'clock to 2 o'clock | 00:18:10 | MH L.2 To<br>MH<br>L.1_efb44 | 10 |

MH L.2 To MH  
 L.1\_efb44499-721b-4229-8c4f-42665233aa51\_20230328\_115  
 911\_584.jpg, 00:18:10, 60.78m

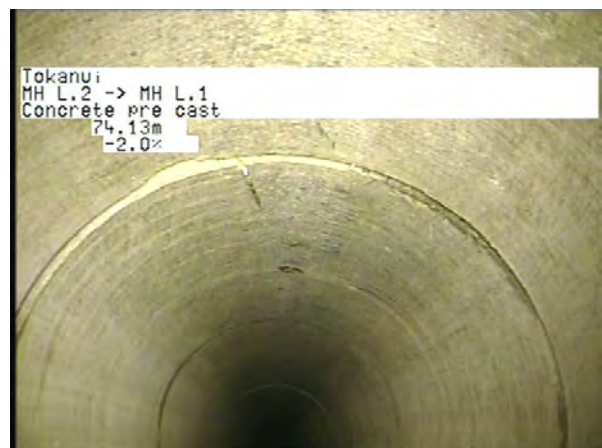
| 1:577 | m + | OC | Observation | MPEG | Photo | Score |
|---|---|---|---|---|---|---|
| | 74.13 | JFS | Joint faulty, minor cracking or spalling from 10 o'clock to 12 o'clock | 00:24:36 | MH L.2 To MH L.1_ffbfeb | 1 |

MH L.2 To MH  
L.1\_ffbfbbb-dd82-4ab3-be30-caf043b25dee\_20230328\_120645\_556.jpg, 00:24:36, 74.13m

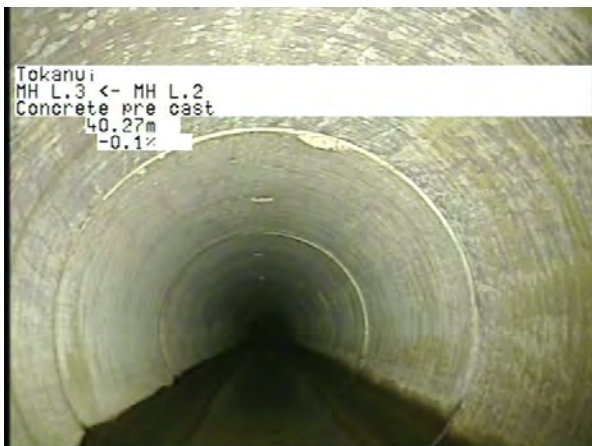
| 1:424 | m + | OC | Observation | MPEG | Photo | Score |
|---|---|---|---|---|---|---|
| | 40.27 | JFS | Joint faulty, minor cracking or spalling from 12 o'clock to 2 o'clock / tiny chip | 00:13:08 | MH L.2 To MH L.3_64599 | 1 |

MH L.2 To MH  
L.3\_64599a16-9a20-4a6e-8d0f-d6710a681735\_20230328\_140454\_459.jpg, 00:13:08, 40.27m

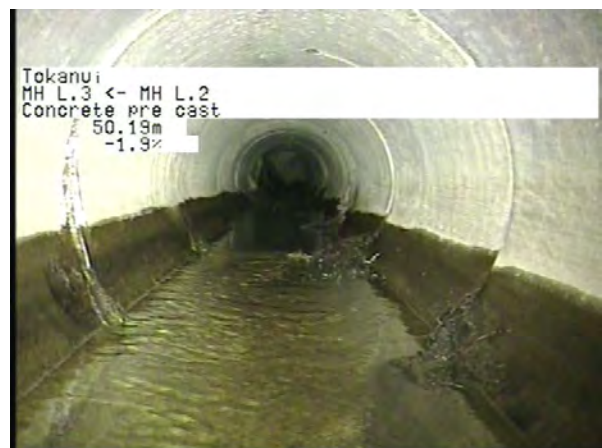
| 1:424 | m + | OC | Observation | MPEG | Photo | Score |
|---|---|---|---|---|---|---|
| | 50.19 | JFL | Joint faulty, major cracking or spalling, likely through the pipe wall from 3 o'clock to 6 o'clock / Roots protruding joint | 00:16:16 | MH L.2 To MH L.3_7a485 | 25 |

MH L.2 To MH  
L.3\_7a485f99-6caa-477c-ae76-26ec77a4d9a1\_20230328\_140843\_916.jpg, 00:16:16, 50.19m

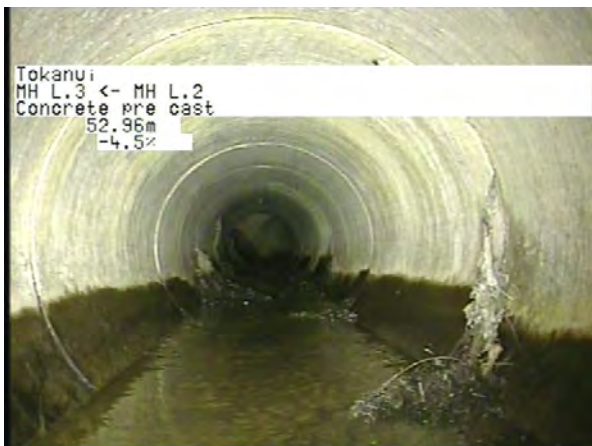
| 1:424 | m + | OC | Observation | MPEG | Photo | Score |
|---|---|---|---|---|---|---|
| | 52.96 | JFL | Joint faulty, major cracking or spalling, likely through the pipe wall from 3 o'clock to 6 o'clock / Roots protruding | 00:16:55 | MH L.2 To MH L.3_29f25 | 25 |

MH L.2 To MH  
L.3\_29f251b6-5a99-48cb-8bd7-bfa904795369\_20230328\_140942\_137.jpg, 00:16:55, 52.96m

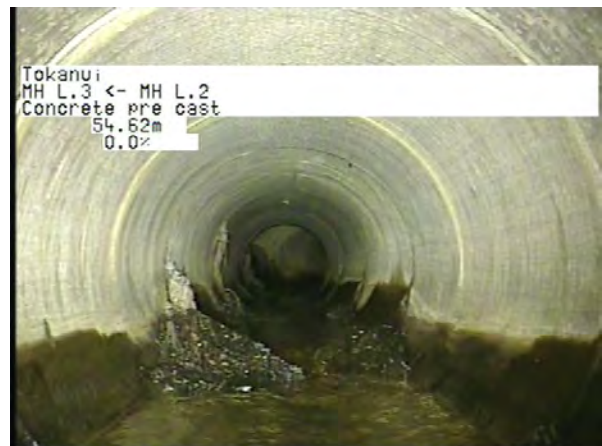
| 1:424 | m + | OC | Observation | MPEG | Photo | Score |
|---|---|---|---|---|---|---|
| | 54.62 | JFL | Joint faulty, major cracking or spalling, likely through the pipe wall from 4 o'clock to 8 o'clock / Roots protruding | 00:17:18 | MH L.2 To<br>MH<br>L.3_50faec | 25 |

MH L.2 To MH  
L.3\_50faec17-9592-40c3-b72e-967ba7ed3250\_20230328\_141021\_428.jpg, 00:17:18, 54.62m

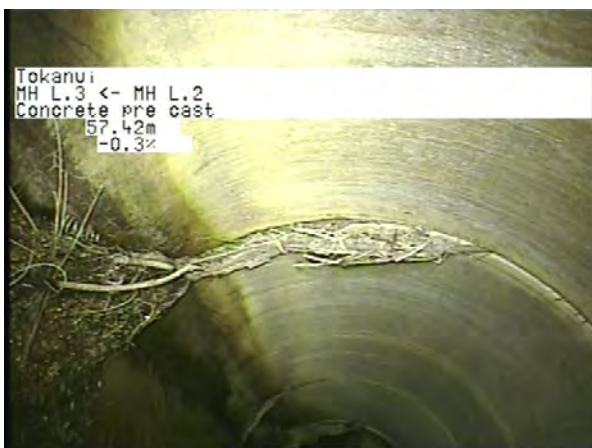
| 1:424 | m + | OC | Observation | MPEG | Photo | Score |
|---|---|---|---|---|---|---|
| | 57.42 | JFL | Joint faulty, major cracking or spalling, likely through the pipe wall from 6 o'clock to 10 o'clock / Roots protruding joint | 00:18:30 | MH L.2 To<br>MH<br>L.3_03e73 | 25 |

MH L.2 To MH  
L.3\_03e73cab-167b-4032-b96d-6a3dc889c008\_20230328\_141144\_508.jpg, 00:18:30, 57.42m

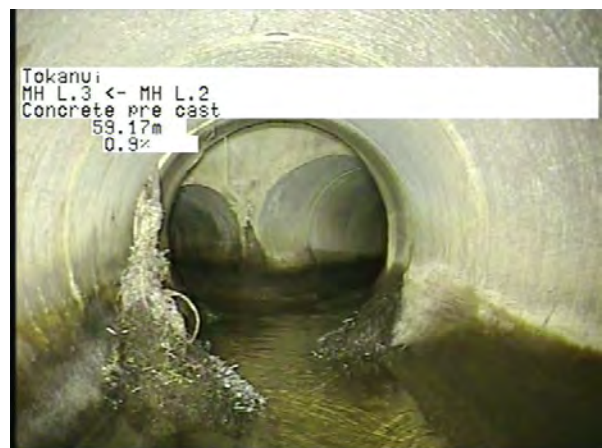
| 1:424 | m + | OC | Observation | MPEG | Photo | Score |
|---|---|---|---|---|---|---|
| | 59.17 | JFL | Joint faulty, major cracking or spalling, likely through the pipe wall from 4 o'clock to 10 o'clock / Roots protruding joints | 00:18:46 | MH L.2 To<br>MH<br>L.3_8bfc96 | 25 |

MH L.2 To MH  
L.3\_8bfc9669-19e9-44fe-be56-2918c2d705ac\_20230328\_141218\_604.jpg, 00:18:46, 59.17m

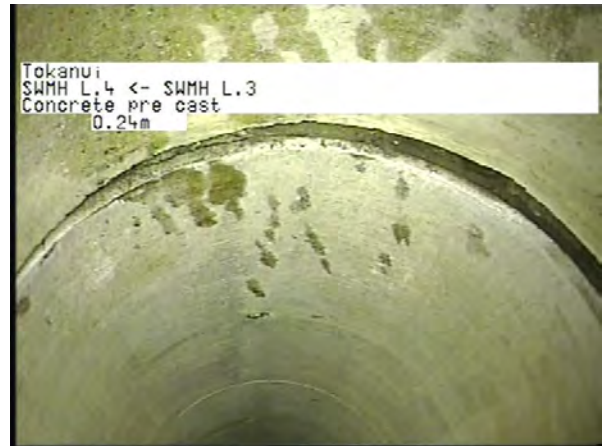
| 1:420 | m + | OC | Observation | MPEG | Photo | Score |
|---|---|---|---|---|---|---|
| | 0.24 | JFL | Joint faulty, major cracking or spalling, likely through the pipe wall from 12 o'clock to 6 o'clock | 00:01:35 | MH L.3 To MH L.4_acd75 | 25 |

MH L.3 To MH  
L.4\_acd751df-e779-47b3-9dc6-eb01e40c7129\_20230404\_09  
2932\_514.jpg, 00:01:35, 0.24m

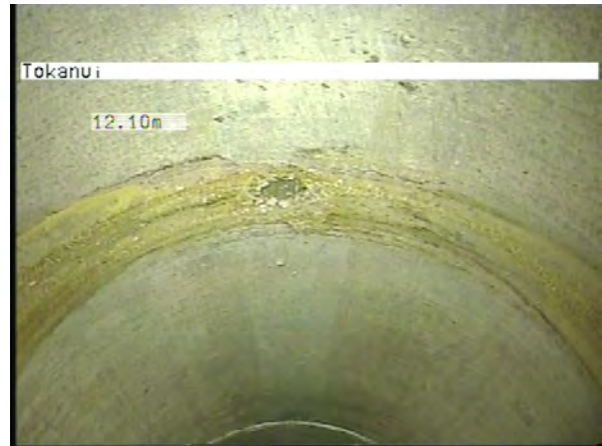
MH L.3 To MH  
L.4\_03d758d2-c9f0-4aed-bd14-6ea585a74467\_20230404\_09  
3442\_339.jpg, 00:05:27, 12.10m

| 1:420 | m + | OC | Observation | MPEG | Photo | Score |
|---|---|---|---|---|---|---|
| | 12.10 | PHS | Pipe holed, the hole has been repaired at 12 o'clock | 00:05:27 | MH L.3 To MH L.4_03d75 | 5 |

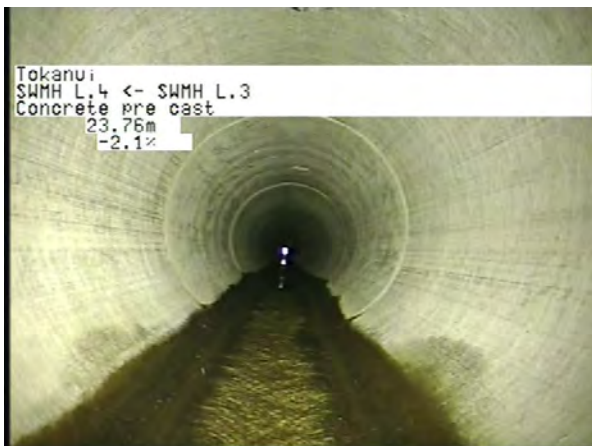
MH L.3 To MH  
L.4\_da1d5de0-ffa4-4fbd-9279-2b5495244872\_20230404\_093  
709\_030.jpg, 00:07:46, 23.76m

| 1:420 | m + | OC | Observation | MPEG | Photo | Score |
|---|---|---|---|---|---|---|
| | 23.76 | GC | General comment / General condition photo | 00:07:46 | MH L.3 To MH L.4_da1d5 | |

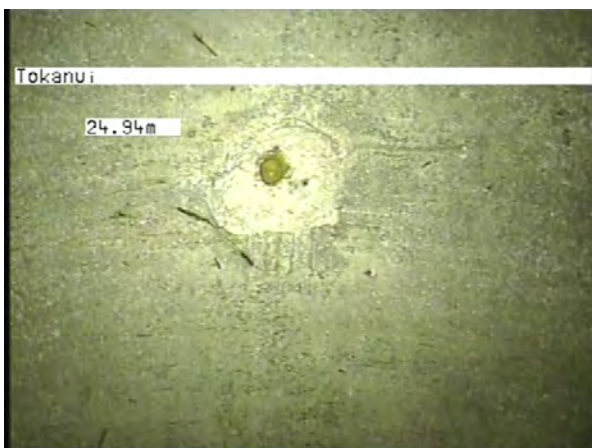
MH L.3 To MH  
L.4\_55d716a5-7160-45a6-b9e2-5e59cd11868a\_20230404\_09  
3753\_136.jpg, 00:08:19, 24.94m

| 1:420 | m + | OC | Observation | MPEG | Photo | Score |
|---|---|---|---|---|---|---|
| | 24.94 | PHS | Pipe holed, the hole has been repaired at 12 o'clock | 00:08:19 | MH L.3 To MH L.4_55d71 | 5 |

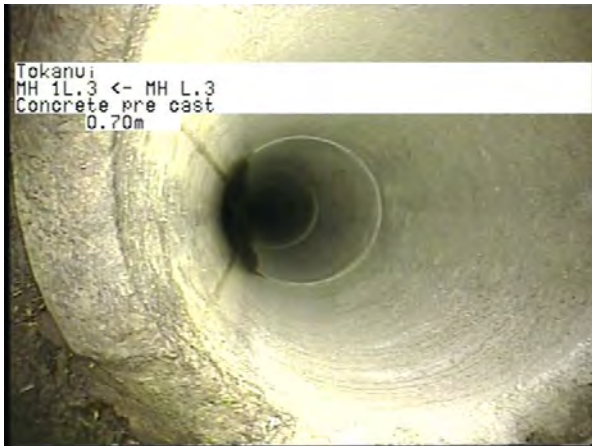
MH L.3 To MH  
 1L.3\_97d0d5ca-abb6-436f-91d0-db6672ef513a\_20230404\_10  
 2815\_967.jpg, 00:00:09, 0.70m

| Comments | | | | | | |
|---|---|---|---|---|---|---|
| | 0.70 | CF | Construction feature from 8 o'clock to 10 o'clock / Lateral connection | 00:00:09 | MH L.3 To MH 1L.3_97d0 | |

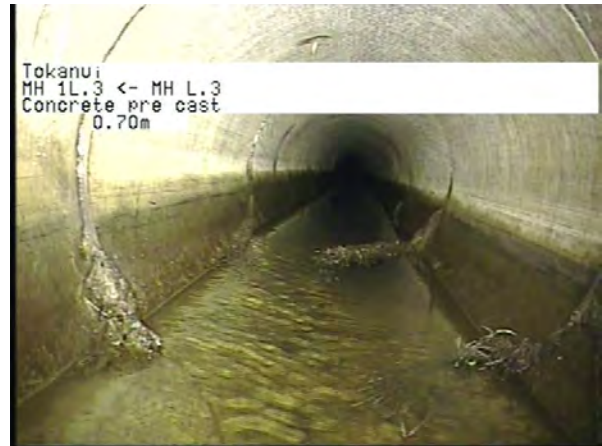
MH L.3 To MH  
 1L.3\_69bcc7ab-8059-4ba9-80e0-7c9783bc7058\_20230404\_1  
 02846\_035.jpg, 00:00:26, 0.70m

| Comments | | | | | | |
|---|---|---|---|---|---|---|
| | 0.70 | JFS | Joint faulty, minor cracking or spalling from 4 o'clock to 8 o'clock / Roots protruding joint | 00:00:26 | MH L.3 To MH 1L.3_69bc | 1 |

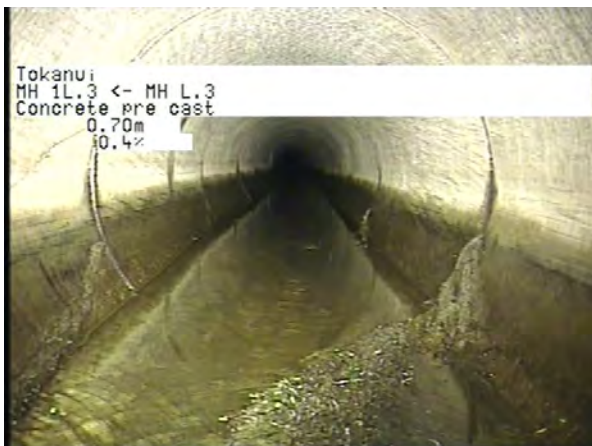
MH L.3 To MH  
 1L.3\_3b63cc1a-fda2-4980-80ac-24fcff635840\_20230404\_102  
 957\_802.jpg, 00:01:21, 0.70m

| Comments | | | | | | |
|---|---|---|---|---|---|---|
| | 0.70 | JFL | Joint faulty, major cracking or spalling, likely through the pipe wall from 4 o'clock to 8 o'clock / Roots protruding joint | 00:01:21 | MH L.3 To MH 1L.3_3b63 | 25 |

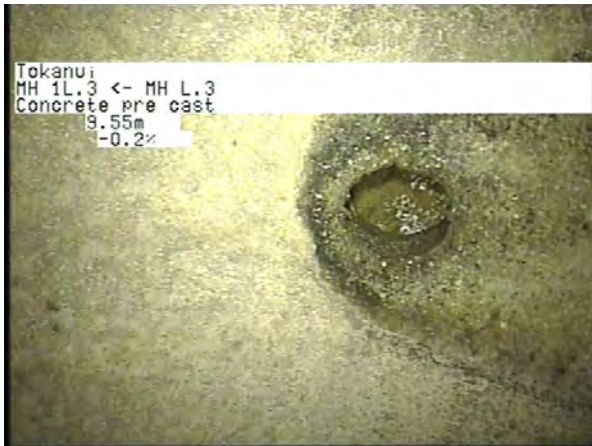
MH L.3 To MH  
1L.3\_0da7215c-217b-462b-a9d5-e333d2ba599c\_20230404\_1  
03322\_565.jpg, 00:04:14, 9.55m

| Comments | | | | | | |
|---|---|---|---|---|---|---|
| | 9.55 | PHS | Pipe holed, the hole has been repaired at 1 o'clock | 00:04:14 | MH L.3 To MH 1L.3_0da7 | 5 |

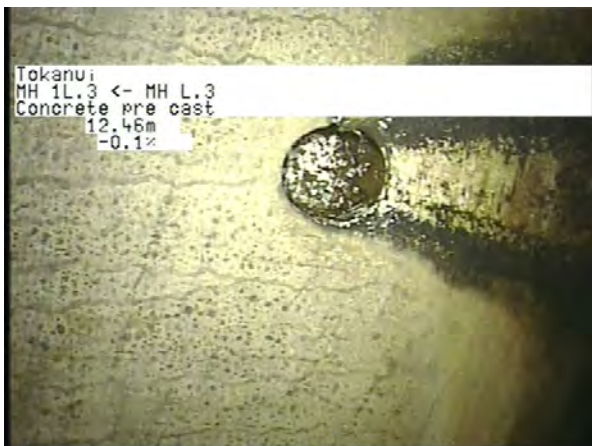
MH L.3 To MH  
1L.3\_0ecd87f5-1820-486d-8d32-f001d87cf676\_20230404\_10  
3459\_359.jpg, 00:05:33, 12.46m

| Comments | | | | | | |
|---|---|---|---|---|---|---|
| | 12.46 | PHS | Pipe holed, the hole has been repaired at 3 o'clock | 00:05:33 | MH L.3 To MH 1L.3_0ecd | 5 |

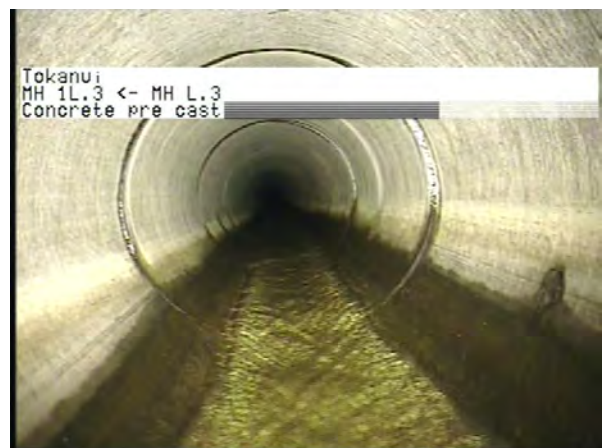
MH L.3 To MH  
1L.3\_79684a4b-7a56-4f34-bb87-7320c1fda5e1\_20230404\_10  
3648\_439.jpg, 00:06:59, 17.57m

| Comments | | | | | | |
|---|---|---|---|---|---|---|
| | 17.57 | PHS | Pipe holed, the hole has been repaired at 4 o'clock | 00:06:59 | MH L.3 To MH 1L.3_7968 | 5 |

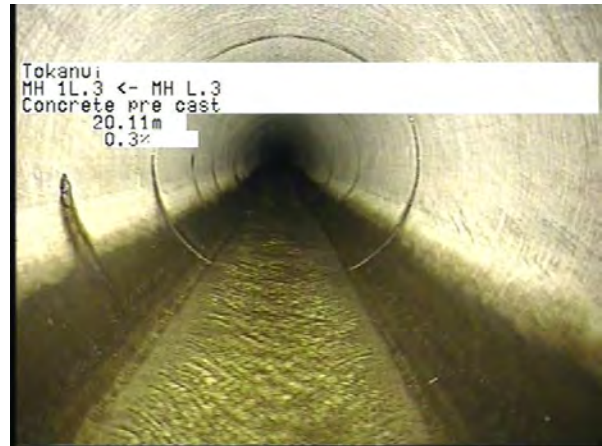
MH L.3 To MH  
 1L.3\_0be531a1-51f3-4133-92f4-60a50cd26c59\_20230404\_10  
 3749\_262.jpg, 00:07:37, 20.11m

| Comments | | | | | | |
|---|---|---|---|---|---|---|
| | 20.11 | PHS | Pipe holed, the hole has been repaired from 7 o'clock to 9 o'clock / Lifting eyes seeping water | 00:07:37 | MH L.3 To MH 1L.3_0be5 | 5 |

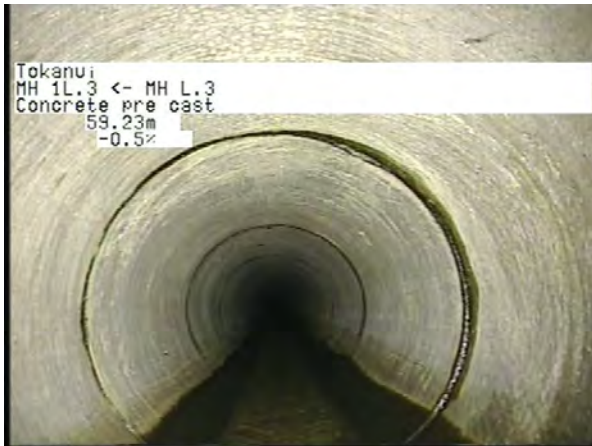
| 1:384 | m + | OC | Observation | MPEG | Photo | Score | | | |
|---|---|---|---|---|---|---|---|---|---|
| | 59.23 | JFS | Joint faulty, minor cracking or spalling from 12 o'clock to 11 o'clock | 00:16:48 | MH L.3 To MH 1L.3_dbe0 | 1 | | | |

MH L.3 To MH  
1L.3\_dbe0252b-adad-401c-83c7-f555bd97aa7f\_20230404\_10  
4742\_860.jpg, 00:16:48, 59.23m

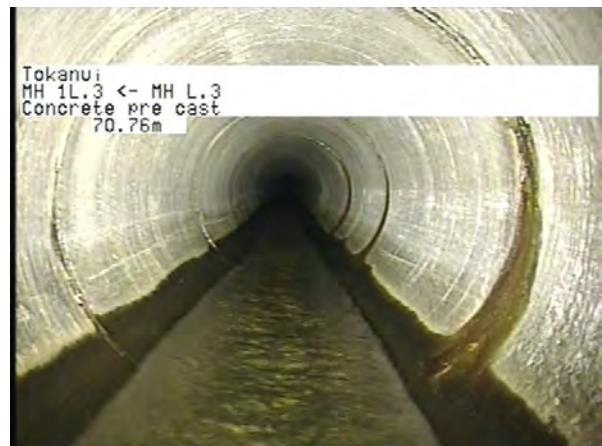
| 1:384 | m + | OC | Observation | MPEG | Photo | Score | | | |
|---|---|---|---|---|---|---|---|---|---|
| | 70.76 | JFS | Joint faulty, minor cracking or spalling from 12 o'clock to 11 o'clock | 00:19:02 | MH L.3 To MH 1L.3_f6aac | 1 | | | |

MH L.3 To MH  
1L.3\_f6aac0d2-7d14-4cab-8a2d-18d16530992b\_20230404\_1  
05033\_365.jpg, 00:19:02, 70.76m

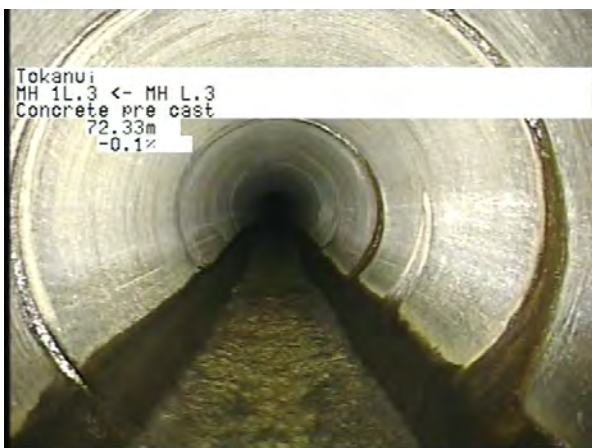
| 1:384 | m + | OC | Observation | MPEG | Photo | Score | | | |
|---|---|---|---|---|---|---|---|---|---|
| | 72.33 | JFS | Joint faulty, minor cracking or spalling from 1 o'clock to 7 o'clock | 00:19:20 | MH L.3 To MH 1L.3_a86f | 1 | | | |

MH L.3 To MH  
1L.3\_a86f57e8-f424-4cfb-9c0b-d81d8fead7d5\_20230404\_105  
058\_071.jpg, 00:19:20, 72.33m

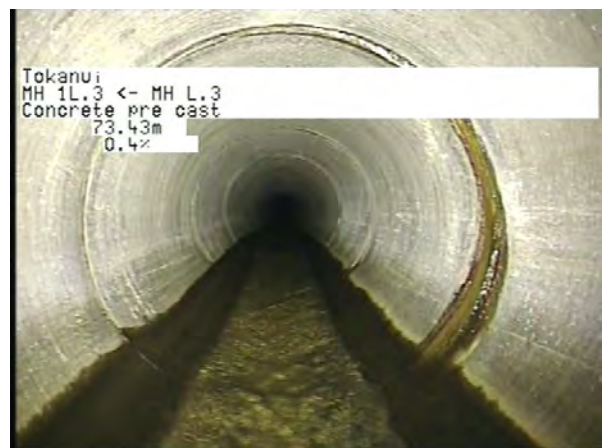
| 1:384 | m + | OC | Observation | MPEG | Photo | Score | | | |
|---|---|---|---|---|---|---|---|---|---|
| | 73.43 | JFS | Joint faulty, minor cracking or spalling from 2 o'clock to 5 o'clock | 00:19:33 | MH L.3 To MH 1L.3_8679 | 1 | | | |

MH L.3 To MH  
1L.3\_86797a0e-c2d7-4d35-8631-55ad125fb115\_20230404\_1  
05120\_199.jpg, 00:19:33, 73.43m

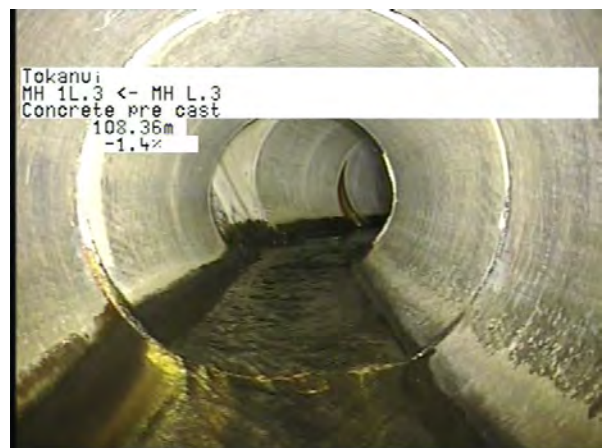
| 1:384 | m + | OC | Observation | MPEG | Photo | Score | | | |
|---|---|---|---|---|---|---|---|---|---|
| | 108.36 | JFM | Joint faulty, medium cracking or spalling, unlikely through the pipe wall from 5 o'clock to 9 o'clock | 00:28:35 | MH L.3 To MH 1L.3_0e40 | 10 | | | |

MH L.3 To MH  
1L.3\_0e402055-9531-471c-a05a-3fd09f339a5d\_20230404\_11  
0136\_057.jpg, 00:28:35, 108.36m

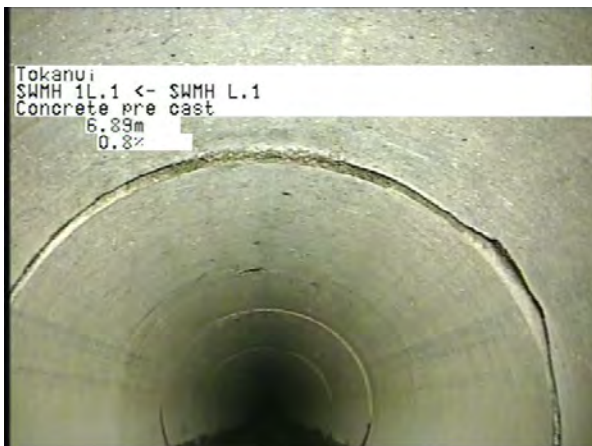
| Comments | | | | | | |
|---|---|---|---|---|---|---|
| | 6.89 | JFS | Joint faulty, minor cracking or spalling from 2 o'clock to 3 o'clock | 00:02:55 | MH L.1 To MH 1L.1_d7dd | 1 |

MH L.1 To MH  
1L.1\_d7ddc1f8-ff6b-4066-9a3e-e9ac1c07d5db\_20230404\_12  
0247\_678.jpg, 00:02:55, 6.89m

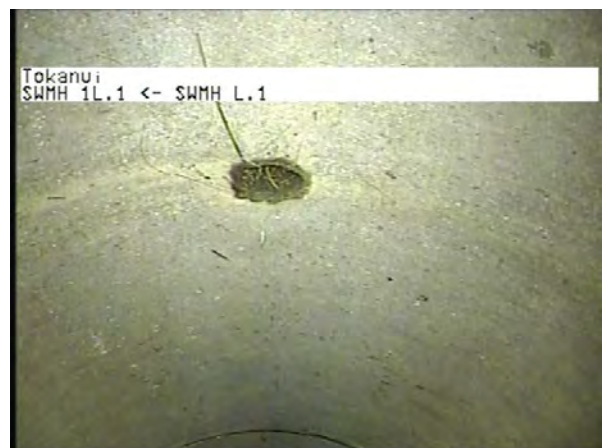
| Comments | | | | | | |
|---|---|---|---|---|---|---|
| | 13.68 | PHS | Pipe holed, the hole has been repaired at 12 o'clock | 00:05:09 | MH L.1 To MH 1L.1_7328 | 5 |

MH L.1 To MH  
1L.1\_7328faf1-e9fd-4b70-b36d-d89065e11fd0\_20230404\_120  
532\_852.jpg, 00:05:09, 13.68m

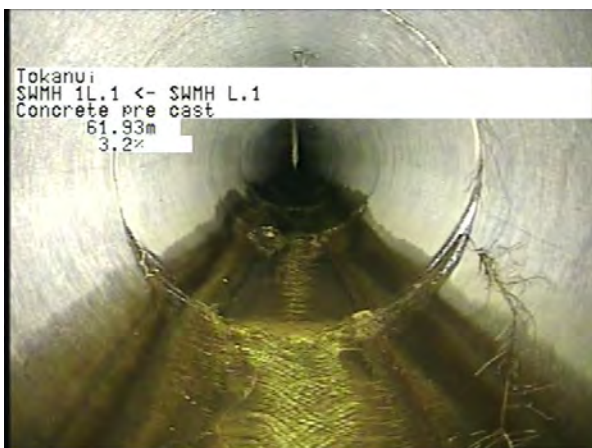
| 1:460 | m + | OC | Observation | MPEG | Photo | Score |
|---|---|---|---|---|---|---|
| | 61.93 | JFL | Joint faulty, major cracking or spalling, likely through the pipe wall from 3 o'clock to 9 o'clock / Tiny root protruding | 00:16:58 | MH L.1 To MH 1L.1_3fb9 | 25 |

MH L.1 To MH  
1L.1\_3fb91a5d-147c-4c91-8f09-84a6609702d5\_20230404\_12  
1955\_441.jpg, 00:16:58, 61.93m

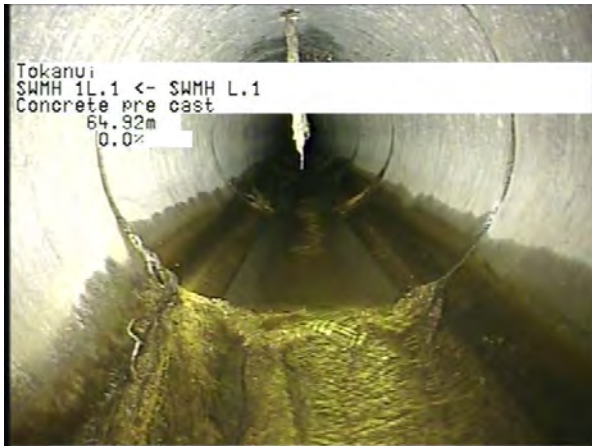
| 1:460 | m + | OC | Observation | MPEG | Photo | Score |
|---|---|---|---|---|---|---|
| | 64.92 | JFL | Joint faulty, major cracking or spalling, likely through the pipe wall from 5 o'clock to 8 o'clock / Roots protruding joint | 00:18:12 | MH L.1 To MH 1L.1_e72c | 25 |

MH L.1 To MH  
1L.1\_e72c306c-649a-4164-91a8-1ecba2a48658\_20230404\_1  
22145\_992.jpg, 00:18:12, 64.92m

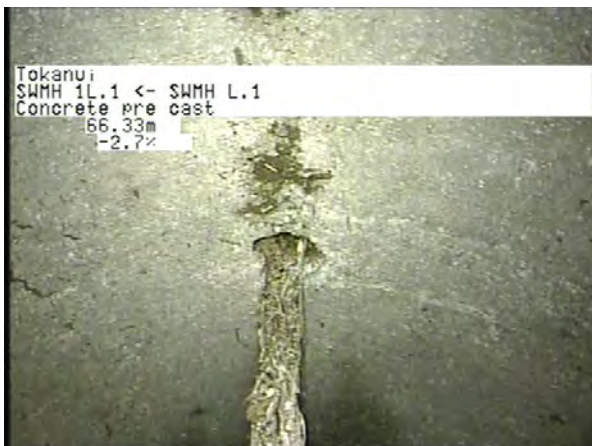
| 1:460 | m + | OC | Observation | MPEG | Photo | Score |
|---|---|---|---|---|---|---|
| | 66.33 | PHS | Pipe holed, the hole has been repaired at 12 o'clock | 00:18:41 | MH L.1 To MH 1L.1_418a | 5 |

MH L.1 To MH  
1L.1\_418a2c01-9d84-4963-b087-1e3aebd9728b\_20230404\_1  
22238\_777.jpg, 00:18:41, 66.33m

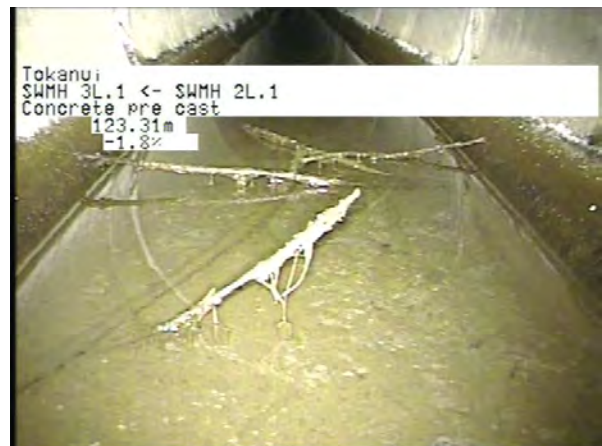
MH 2L.1 To MH  
3L.1\_94e435f8-c298-4f98-a11a-c86148ee5e35\_20230406\_12  
3602\_149.jpg, 00:35:20, 123.31m

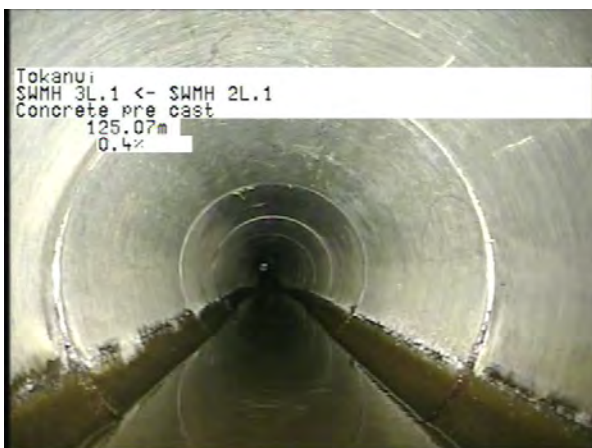
MH 2L.1 To MH  
3L.1\_b04a8d02-70fb-47fd-ac87-52fbed3a7acc\_20230406\_12  
3636\_380.jpg, 00:35:46, 125.07m

| 1:459 | m + | OC | Observation | MPEG | Photo | Score |
|---|---|---|---|---|---|---|
| | 125.07 | GC | General comment / General condition photo | 00:35:46 | MH 2L.1<br>To MH<br>3L.1_b04a | |

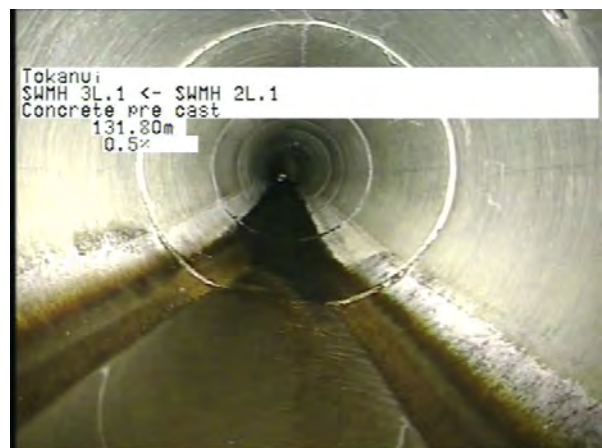
MH 2L.1 To MH  
3L.1\_0fb4beae-e805-4480-b9f5-c4db597143a4\_20230406\_12  
3805\_012.jpg, 00:37:05, 131.80m

| 1:459 | m + | OC | Observation | MPEG | Photo | Score |
|---|---|---|---|---|---|---|
| | 131.80 | GC | General comment / General condition photo | 00:37:05 | MH 2L.1<br>To MH<br>3L.1_0fb4 | |

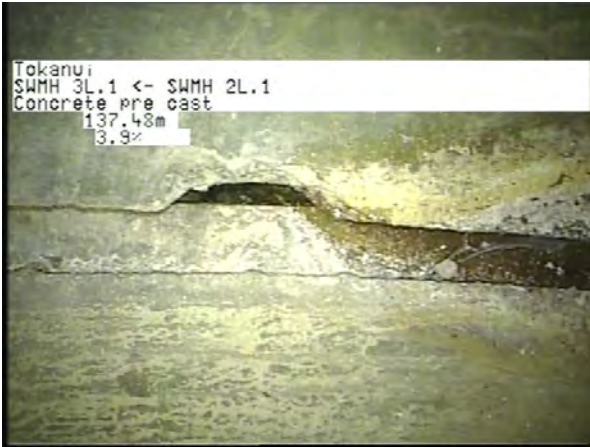
MH 2L.1 To MH  
 3L.1\_1913bf69-b4da-4470-9a33-11dee16a84c6\_20230406\_1  
 23908\_637.jpg, 00:38:02, 137.48m

| 1:459 | m + | OC | Observation | MPEG | Photo | Score |
|---|---|---|---|---|---|---|
| | 137.48 | JFS | Joint faulty, minor cracking or spalling at 3 o'clock | 00:38:02 | MH 2L.1<br>To MH<br>3L.1_1913 | 1 |

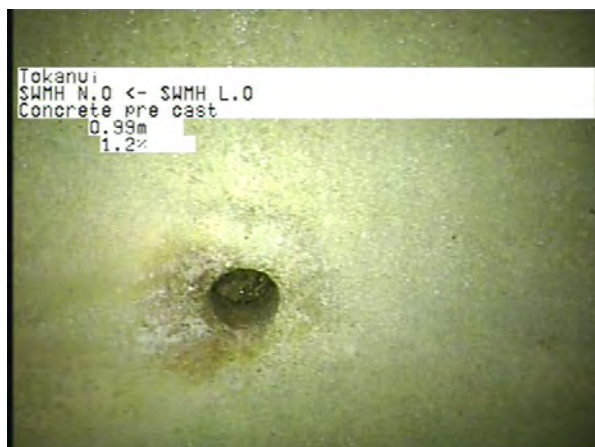
MH L.0 To MH  
N.O\_d86cde5e-42e8-4368-8579-a99ad8755ca5\_20230406\_15  
2537\_334.jpg, 00:00:25, 0.99m

| Comments | | | | | | |
|---|---|---|---|---|---|---|
| | 0.99 | S01 PHS | Pipe holed, the hole has been repaired at 12 o'clock, start / Lifting eyes faulty, seeping water | 00:00:25 | MH L.0 To MH N.0_d86cd | |

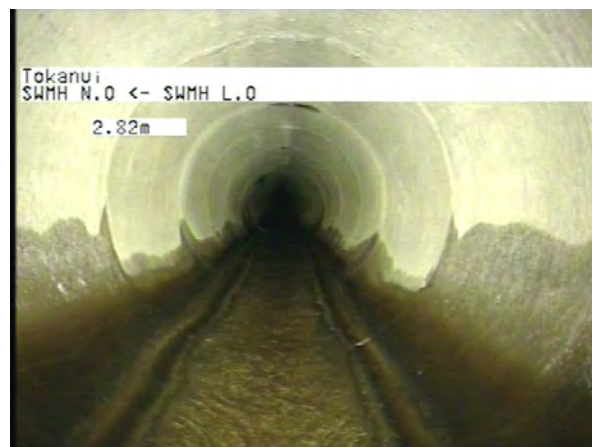
MH L.0 To MH  
N.O\_bcd2da46-5308-4325-944e-bce3e7c063da\_20230406\_15  
2657\_067.jpg, 00:01:39, 2.82m

| Comments | | | | | | |
|---|---|---|---|---|---|---|
| | 2.82 | S02 DGS | Debris greasy, small, clear diameter is reduced by less than 10% from 5 o'clock to 7 o'clock, start | 00:01:39 | MH L.0 To MH N.0_bcd2d | |

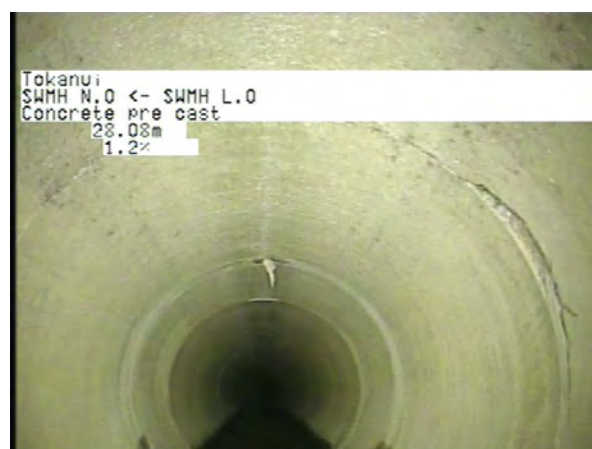
MH L.0 To MH  
N.O\_84f4b8db-3f8a-488a-96d1-36db2789082d\_20230406\_15  
3157\_560.jpg, 00:05:59, 28.08m

| Comments | | | | | | |
|---|---|---|---|---|---|---|
| | 28.08 | JFS | Joint faulty, minor cracking or spalling from 1 o'clock to 3 o'clock | 00:05:59 | MH L.0 To MH N.0_84f4b | 1 |

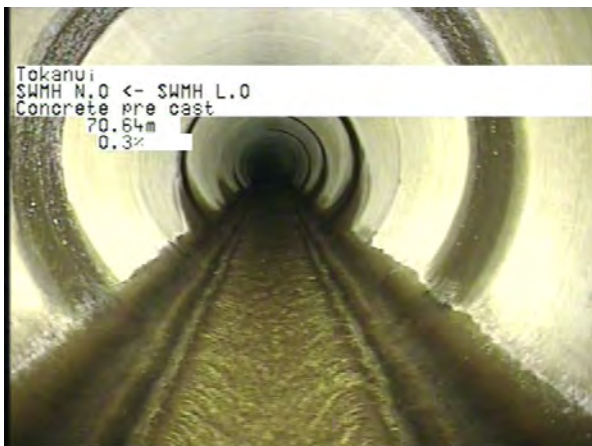
MH L.0 To MH  
N.0\_6219bdfc-dab6-4dde-a1e5-6f34164f0dbe\_20230406\_153916\_073.jpg, 00:12:16, 70.64m

| Comments | | | | | | |
|---|---|---|---|---|---|---|
| | 70.64 | GC | General comment / General condition photo | 00:12:16 | MH L.0 To MH N.0_6219b | |

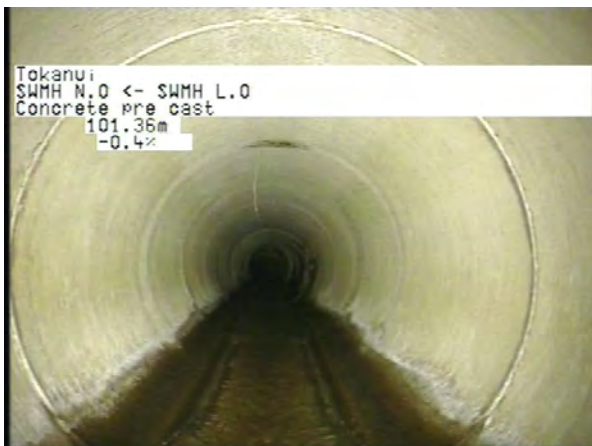
MH L.0 To MH  
N.O\_64ca1a11-fbb4-4cfc-bda9-5df4a1b661a4\_20230406\_154  
533\_385.jpg, 00:17:13, 101.36m

| 1:611 | m + | OC | Observation | MPEG | Photo | Score |
|---|---|---|---|---|---|---|
| | 101.36 | GC | General comment / General condition photo | 00:17:13 | MH L.0 To MH N.0_64ca1 | |

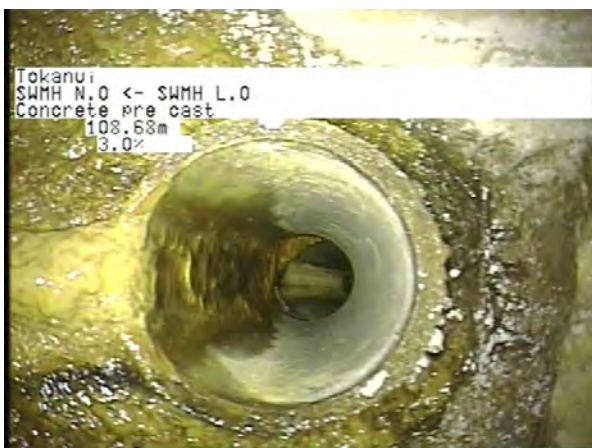
| 1:611 | m + | OC | Observation | MPEG | Photo | Score |
|---|---|---|---|---|---|---|
| | 108.68 | LXL | Lateral problem, large defect at 3 o'clock / Ground water seeping through lateral | 00:18:04 | MH L.0 To MH N.0_1c3a9 | 30 |

MH L.0 To MH  
N.O\_1c3a9508-21c5-4743-abf8-5b709a7b9879\_20230406\_15  
4647\_322.jpg, 00:18:04, 108.68m

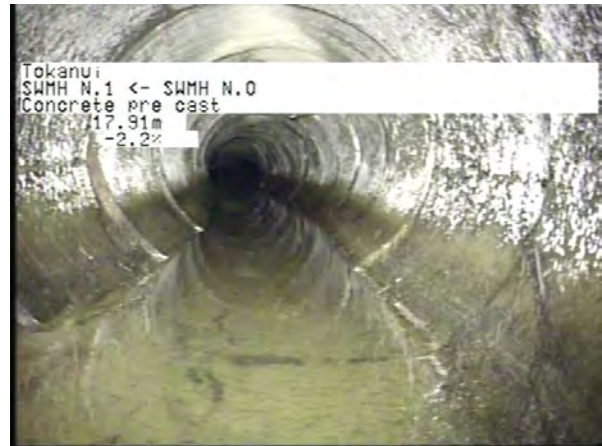
| 1:301 | m + | OC | Observation | MPEG | Photo | Score |
|---|---|---|---|---|---|---|
| | 17.91 | JFL | Joint faulty, major cracking or spalling, likely through the pipe wall from 3 o'clock to 5 o'clock / Roots protruding joint | 00:04:59 | MH N.0 To MH N.1_3eac6 | 25 |

MH N.0 To MH  
N.1\_3eac6d58-c56f-4066-8242-dc9fa803d092\_20230406\_155620\_357.jpg, 00:04:59, 17.91m

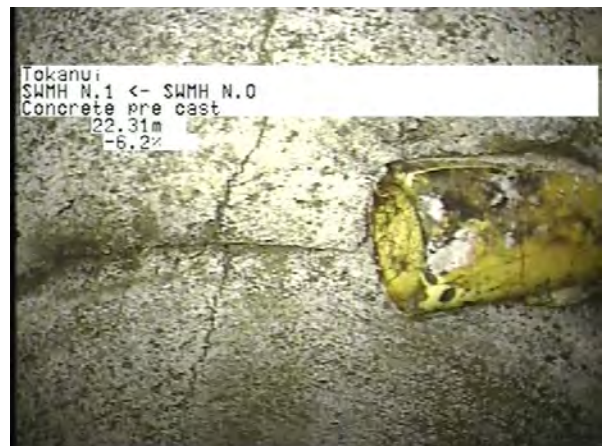
| 1:301 | m + | OC | Observation | MPEG | Photo | Score |
|---|---|---|---|---|---|---|
| | 22.31 | CMS | Cracks multiple, small, visible but not open from 11 o'clock to 1 o'clock | 00:06:08 | MH N.0 To MH N.1_33e43 | 10 |

MH N.0 To MH  
N.1\_33e4370a-b819-4c5e-9fc3-591f345c4d96\_20230406\_155748\_522.jpg, 00:06:08, 22.31m

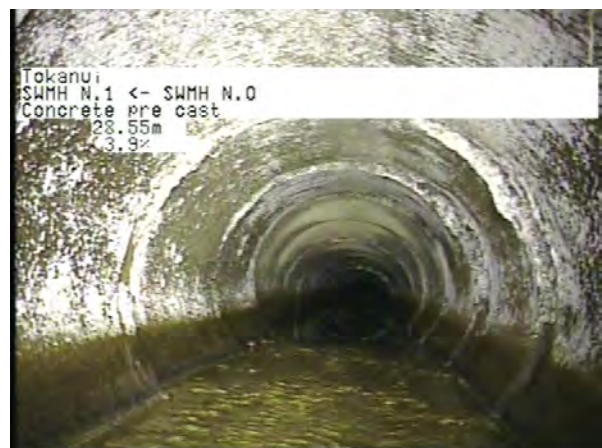
| 1:301 | m + | OC | Observation | MPEG | Photo | Score |
|---|---|---|---|---|---|---|
| | 28.55 | JFS | Joint faulty, minor cracking or spalling from 12 o'clock to 11 o'clock / All joints | 00:07:27 | MH N.0 To MH N.1_d9756 | 1 |

MH N.0 To MH  
N.1\_d975649e-4ba4-4fbc-9259-76ecd8d5261e\_20230406\_155927\_210.jpg, 00:07:27, 28.55m

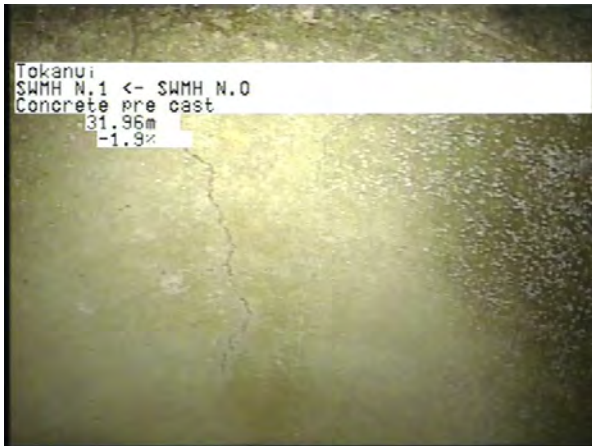
| 1:301 | m + | OC | Observation | MPEG | Photo | Score |
|---|---|---|---|---|---|---|
| | 31.96 | CLS | Crack longitudinal, small, visible but not open at 12 o'clock | 00:07:54 | MH N.0 To MH N.1_30d38 | 3 |

MH N.0 To MH  
N.1\_30d3853e-2439-4199-8db5-d60147d27aa8\_20230406\_160002\_120.jpg, 00:07:54, 31.96m

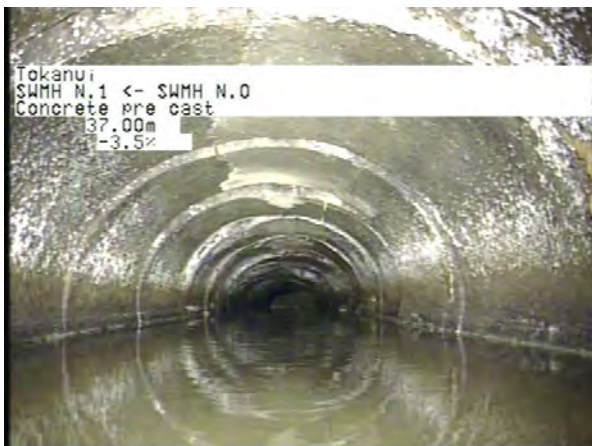
| 1:301 | m + | OC | Observation | MPEG | Photo | Score |
|---|---|---|---|---|---|---|
| | 37.00 | JFS | Joint faulty, minor cracking or spalling from 12 o'clock to 11 o'clock / All joints | 00:09:07 | MH N.0 To MH N.1_b35e9 | 1 |

MH N.0 To MH  
N.1\_b35e9991-e497-44ad-afd6-10aac7df1d05\_20230406\_160131\_447.jpg, 00:09:07, 37.00m

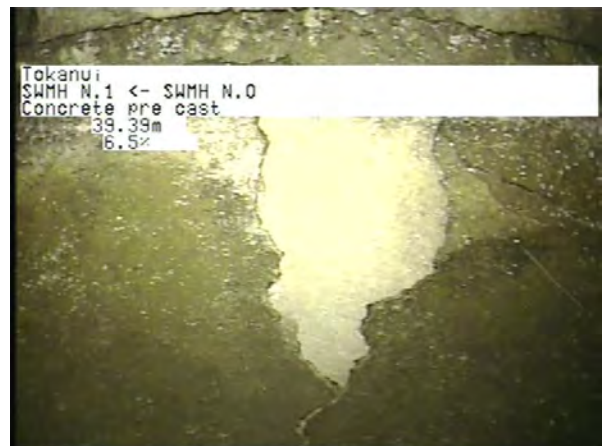
| | 39.39 | PBM | Pipe broken, damage extends 10% - 25% of circumference, displaced by less than half the pipe wall thickness from 11 o'clock to 1 o'clock | 00:10:07 | MH N.0 To MH N.1_f2864f | 30 |

MH N.0 To MH  
N.1\_f2864fbd-5ed4-43ba-949d-37f8b8cb9dbd\_20230406\_160238\_511.jpg, 00:10:07, 39.39m

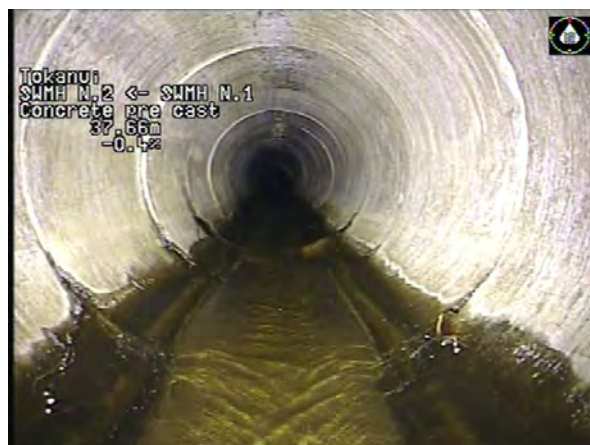
| 1:461 | m + | OC | Observation | MPEG | Photo | Score |
|---|---|---|---|---|---|---|
| | 37.66 | JFL | Joint faulty, major cracking or spalling, likely through the pipe wall from 4 o'clock to 8 o'clock / Tiny roots protruding joint | 00:10:47 | MH N.1 To MH N.2_df2cdf | 25 |

MH N.1 To MH  
N.2\_df2cdf52-89b8-443e-a250-bfb9ad9ce134\_20230424\_095  
759\_488.jpg, 00:10:47, 37.66m

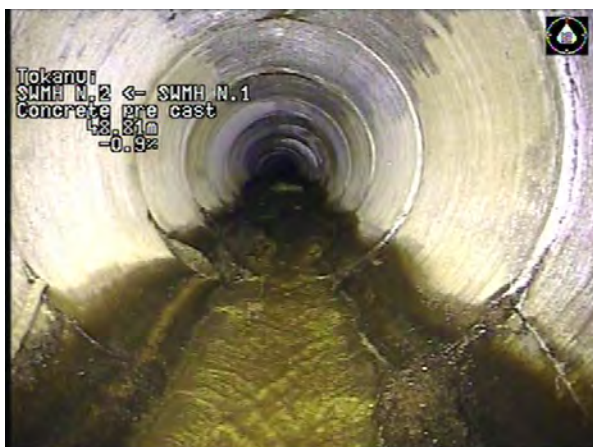
| 1:461 | m + | OC | Observation | MPEG | Photo | Score |
|---|---|---|---|---|---|---|
| | 48.81 | JFL | Joint faulty, major cracking or spalling, likely through the pipe wall from 4 o'clock to 8 o'clock / Roots protruding | 00:12:40 | MH N.1 To MH N.2_7414f | 25 |

MH N.1 To MH  
N.2\_7414f722-c10b-4872-ae14-51277d6b977b\_20230424\_10  
0020\_389.jpg, 00:12:40, 48.81m

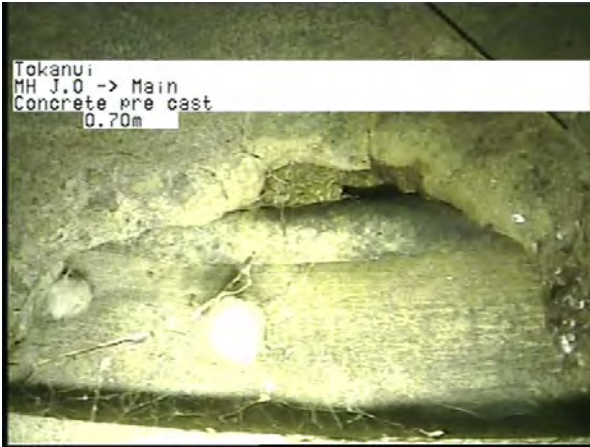
CP J.0 To  
Main\_4ca91f64-afc5-4da9-9724-3b39ad6651b7\_20230327\_1  
33602\_285.jpg, 00:00:20, 0.70m

| 1:50 | m + | OC | Observation | MPEG | Photo | Score |
|---|---|---|---|---|---|---|
| | 0.70 | JFL | Joint faulty, major cracking or spalling, likely through the pipe wall from 1 o'clock to 3 o'clock / Seal visible | 00:00:20 | CP J.0 To Main_4ca91f64-afc5- | 25 |

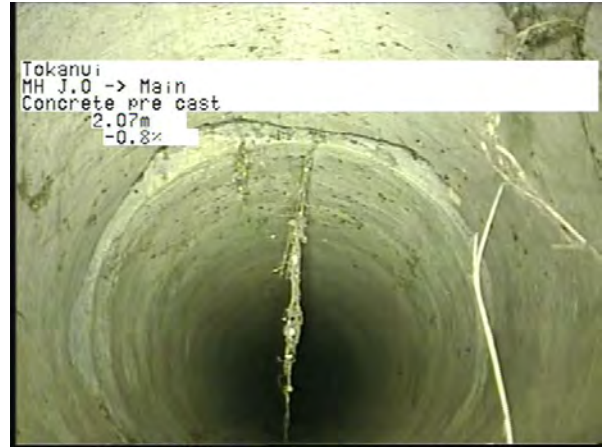
CP J.0 To  
Main\_7587a93c-4c5c-4505-bc90-22155f335ad2\_20230327\_1  
33718\_936.jpg, 00:01:30, 2.07m

| 1:50 | m + | OC | Observation | MPEG | Photo | Score |
|---|---|---|---|---|---|---|
| | 2.07 | JFM | Joint faulty, medium cracking or spalling, unlikely through the pipe wall from 8 o'clock to 12 o'clock | 00:01:30 | CP J.0 To Main_7587a93c-4c5c- | 10 |

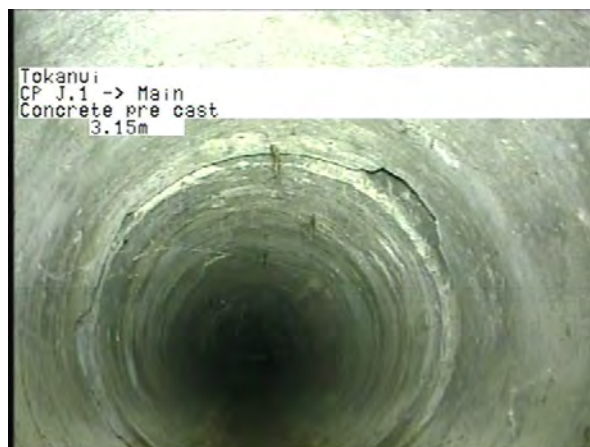
CP J.1 To  
Main\_12aa38e7-de58-49df-8560-95b462b03d59\_20230327\_125738\_184.jpg, 00:00:57, 3.15m

| 1:222 | m + | OC | Observation | MPEG | Photo | Score |
|---|---|---|---|---|---|---|
| | 3.15 | JFS | Joint faulty, minor cracking or spalling from 1 o'clock to 9 o'clock | 00:00:57 | CP J.1 To Main_12aa 38e7-de58 | 1 |
