# **Appendix P     Draft Demolition, Deconstruction and Remediation Management Plan**

## **Remediation of Former Tokanui Hospital Site**

### **Assessment of Environmental Effects**

FORMER TOKANUI HOSPITAL  
DEMOLITION AND REMEDIATION  
DEMOLITION, DECONSTRUCTION & REMEDIATION  
MANAGEMENT PLAN - DRAFT

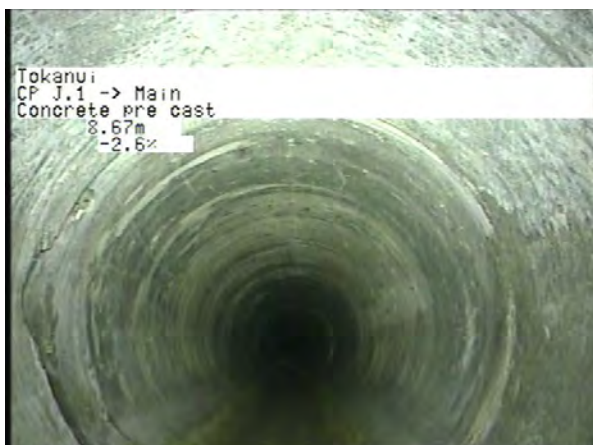
CP J.1 To  
Main\_5be21a3c-ac2a-4955-96c5-c1514c1df63f\_20230327\_125954\_613.jpg, 00:03:06, 8.67m

| 1:222 | m + | OC | Observation | MPEG | Photo | Score |
|---|---|---|---|---|---|---|
| | 8.67 | JFS | Joint faulty, minor cracking or spalling from 8 o'clock to 10 o'clock | 00:03:06 | CP J.1 To Main_5be2 1a3c-ac2a | 1 |

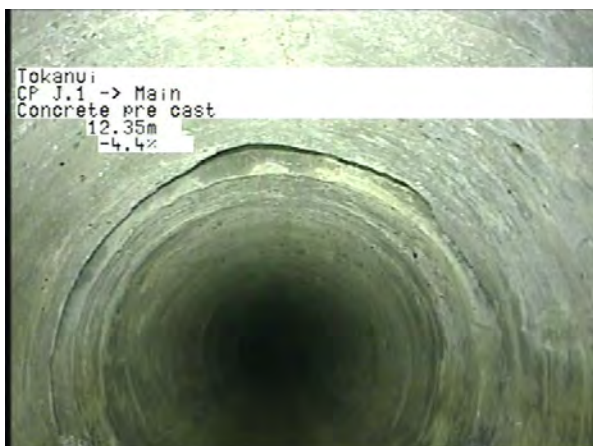
CP J.1 To  
Main\_04e528a1-f5c8-42f0-929d-68fad9dbd7fa\_20230327\_130139\_352.jpg, 00:04:35, 12.35m

| 1:222 | m + | OC | Observation | MPEG | Photo | Score |
|---|---|---|---|---|---|---|
| | 12.35 | JFS | Joint faulty, minor cracking or spalling from 11 o'clock to 1 o'clock | 00:04:35 | CP J.1 To Main_04e5 28a1-f5c8- | 1 |

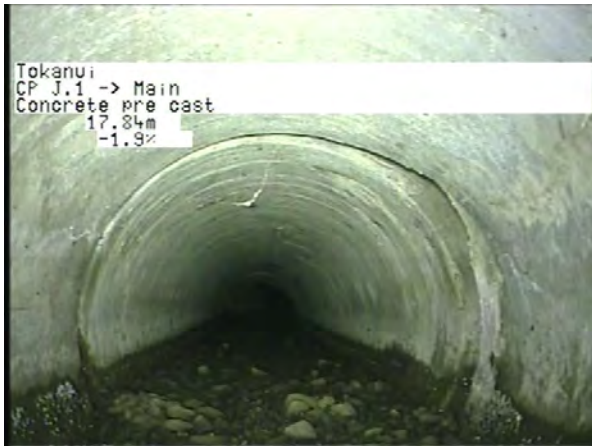
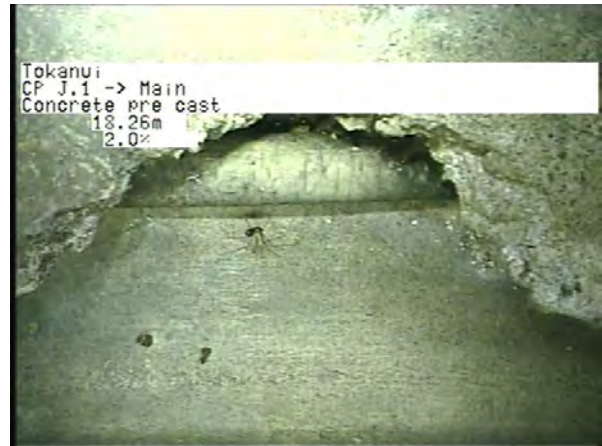
CP J.1 To  
Main\_43ea1813-f2e4-433a-a272-e674b921a434\_20230327\_1  
30251\_161.jpg, 00:05:38, 17.84m

| 1:222 | m + | OC | Observation | MPEG | Photo | Score |
|---|---|---|---|---|---|---|
| | 17.84 | JFL | Joint faulty, major cracking or spalling, likely through the pipe wall from 1 o'clock to 3 o'clock / Seal visible | 00:05:38 | CP J.1 To Main_43ea 1813-f2e4- | 25 |

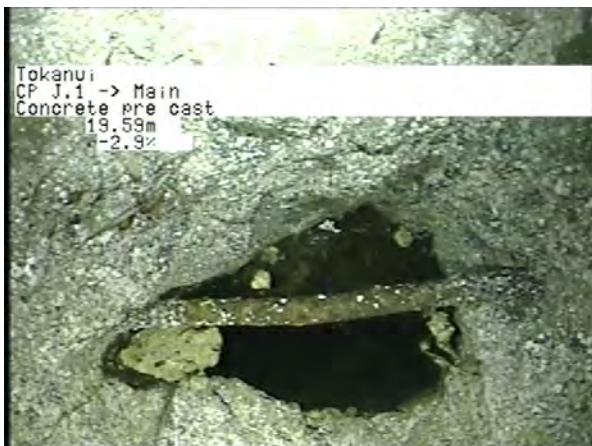
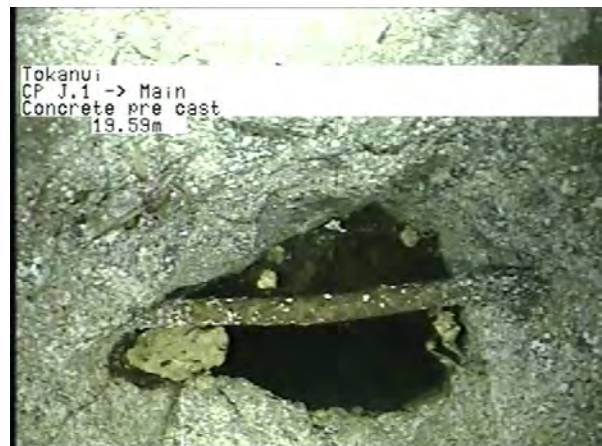
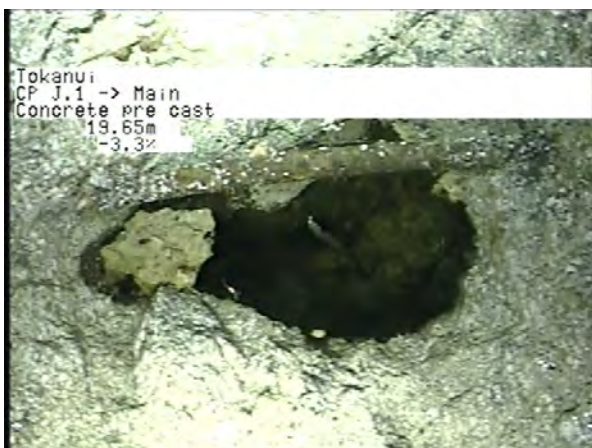
CP J.1 To  
Main\_26ed628b-415c-43c6-8de6-75aa20e6f7b0\_20230327\_1  
30356\_181.jpg, 00:06:33, 19.59m

| 1:222 | m + | OC | Observation | MPEG | Photo | Score |
|---|---|---|---|---|---|---|
| | 19.59 | PHM | Pipe holed, the hole is up to 20% of the pipe circumference and has not been repaired from 11 o'clock to 1 o'clock | 00:06:33 | CP J.1 To Main_26ed 628b-415c | 25 |

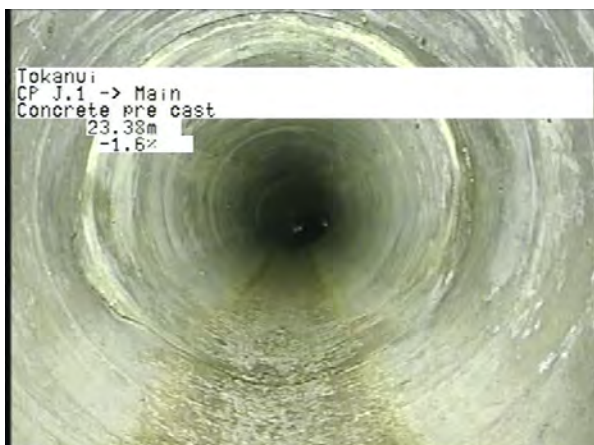
CP J.1 To  
Main\_d7b5f459-51b5-438e-8b58-3e1d4f671a4d\_20230327\_1  
30837\_353.jpg, 00:08:32, 23.38m

| 1:222 | m + | OC | Observation | MPEG | Photo | Score |
|---|---|---|---|---|---|---|
| | 23.38 | JFS | Joint faulty, minor cracking or spalling from 7 o'clock to 9 o'clock | 00:08:32 | CP J.1 To Main_d7b5 f459-51b5- | 1 |

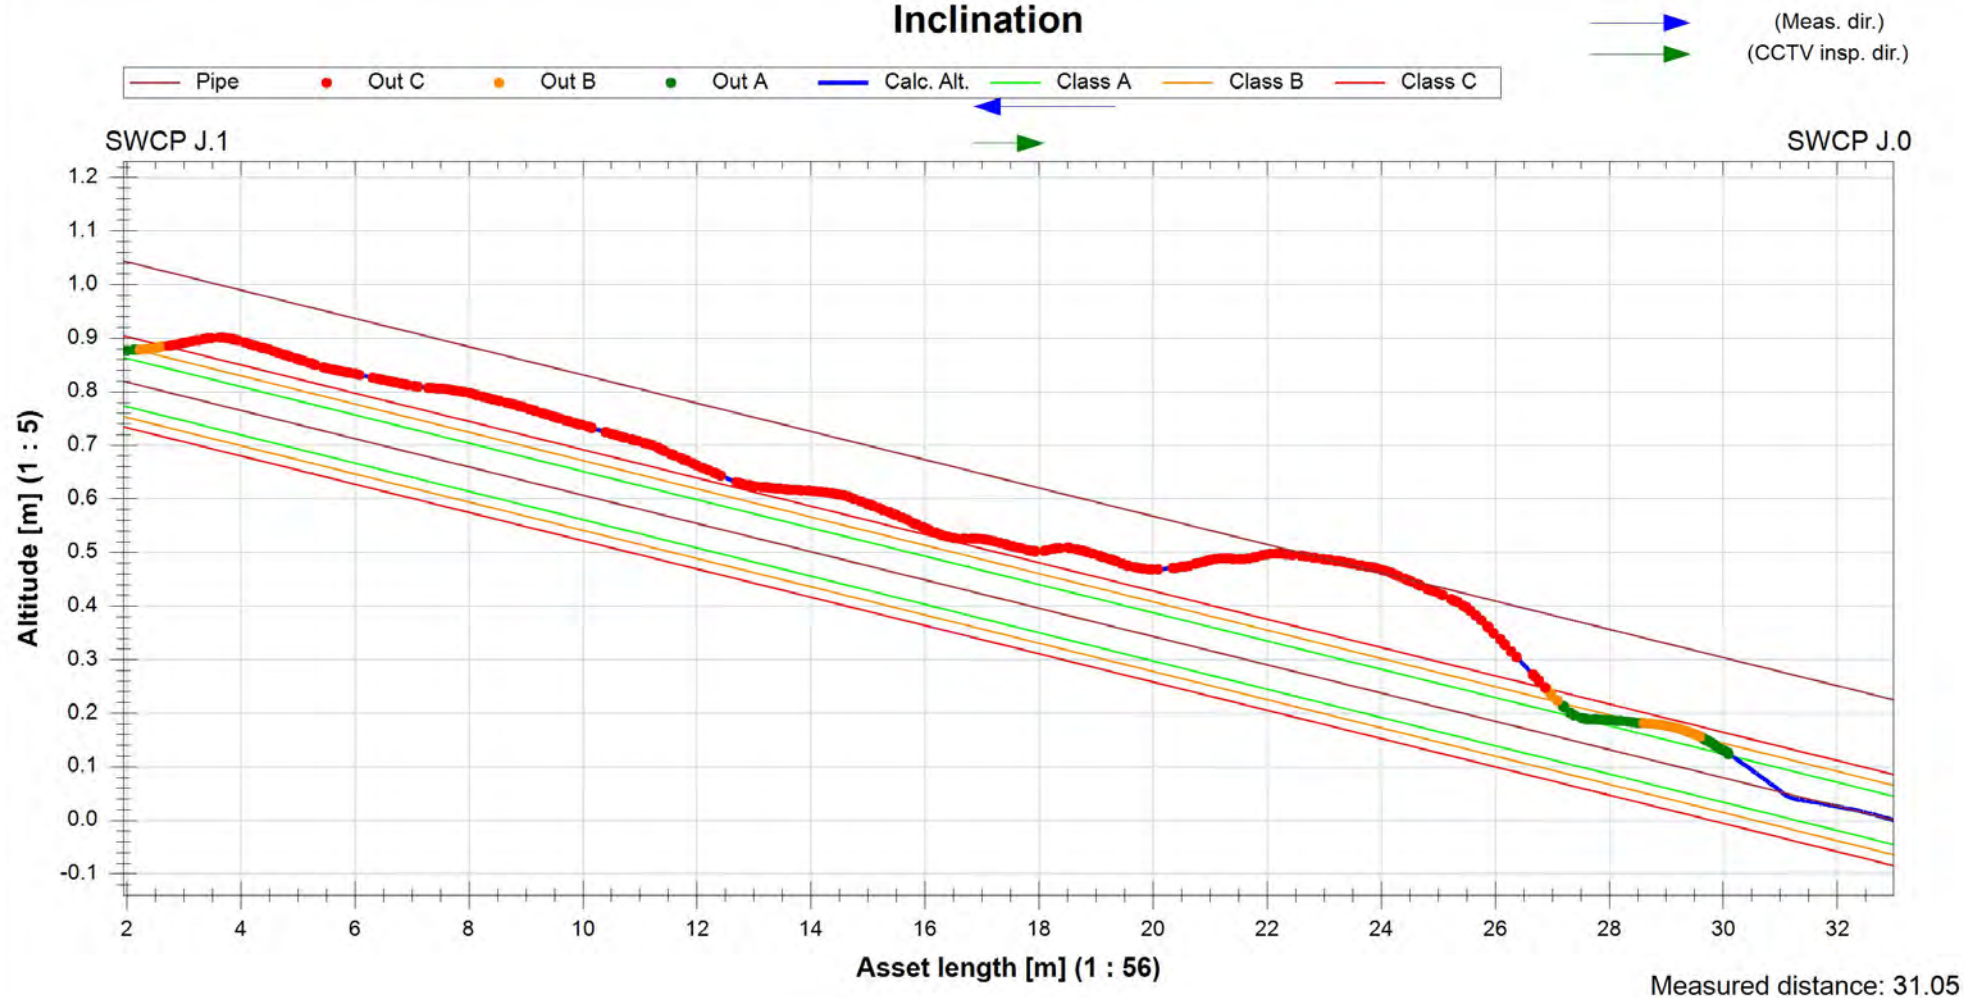
### Inclination

| Asset No.<br>CP J.1 To CP J,0 | Date<br>27/03/2023 | Time<br>12:56 pm | Operator<br>CST Group | Town or Suburb<br>Tokanui | Road | Setup<br>Upstream node | Surveyed Length<br>31.05 m |
| Shape<br>Circular pipe | Dia/Height<br>225 mm | Width<br>225 mm | U/S Node<br>SWCP J.1 | D/S Node<br>SWCP J.0 | Start altitude<br>0.000 m | End altitude<br>0.876 m | Measured Inc<br>-2.822 % |
