**RE: Information Requested – LU/0231/24 & LU/0232/24 Former Tokanui  
Psychiatric Hospital**

FORMER TOKANUI HOSPITAL  
DEMOLITION AND REMEDIATION  
DEMOLITION, DECONSTRUCTION & REMEDIATION  
MANAGEMENT PLAN - DRAFT

Toitū Te Whenua Land Information New Zealand  
 Demolition Management Plan  
 Former Tokanui Hospital Demolition and Remediation Project  
 Tokanui  
 Te Awamutu

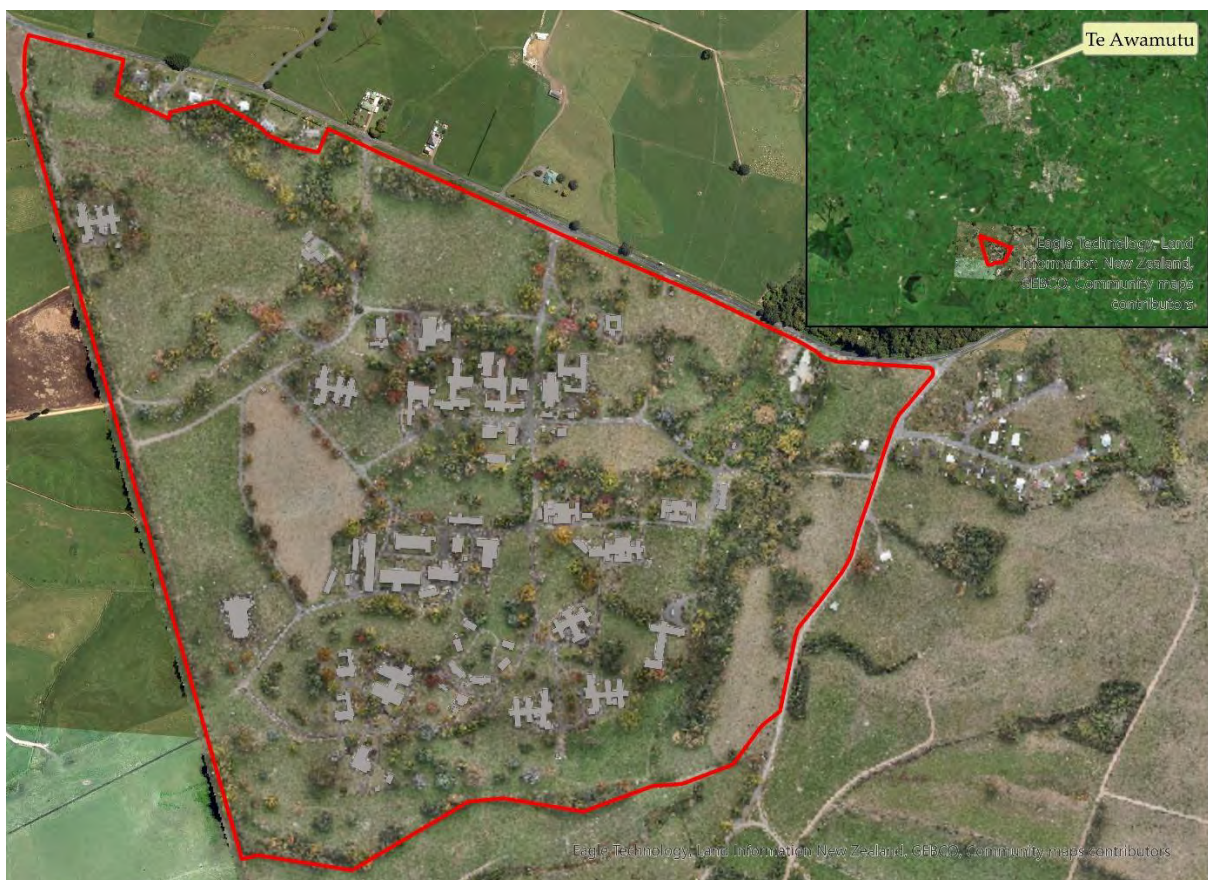
**Figure 1: Site location and extent**

The former Tokanui Hospital (the Site) was a psychiatric hospital approximately 80 hectares (ha) in area, with 76 buildings, a wastewater pump station, swimming pool, eight substations, a closed landfill (also referred to as the 'existing disposal site') and substantial roading and underground infrastructure and services. The site location and extent is shown in Figure 1

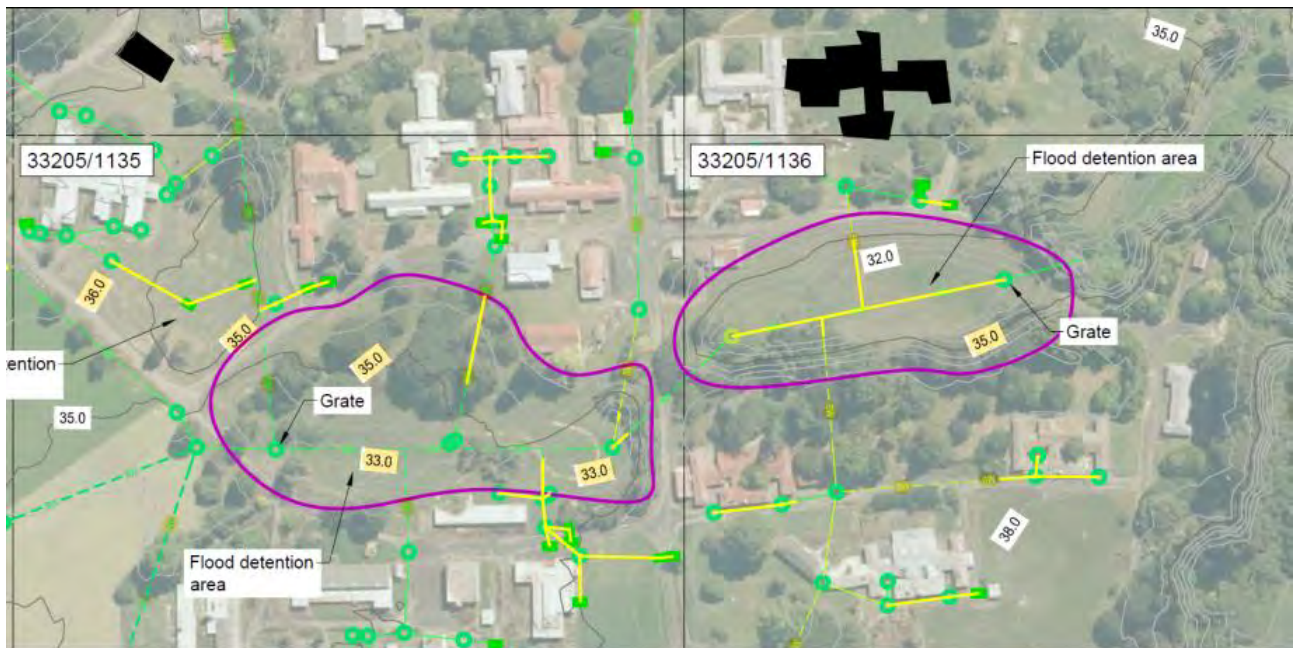
**Figure 2: Likely Extent of Pre- and Post-demolition works CCTV of Trunk Stormwater System**

LINZ will undertake CCTV of the trunk stormwater line pre- and post-demolition works to check for any damage to this network caused by the contractor. The extent of the CCTV survey will be confirmed by LINZ but is likely to go from grate to grate in Figure 2, as this is the main area where it is considered possible damage to the trunk line may occur.

The contractor shall be responsible for repairing any damage to the trunk system, or removing any debris washed into this line from the MH removal and backfilling, attributed to their activities, based on the CCTV survey results.

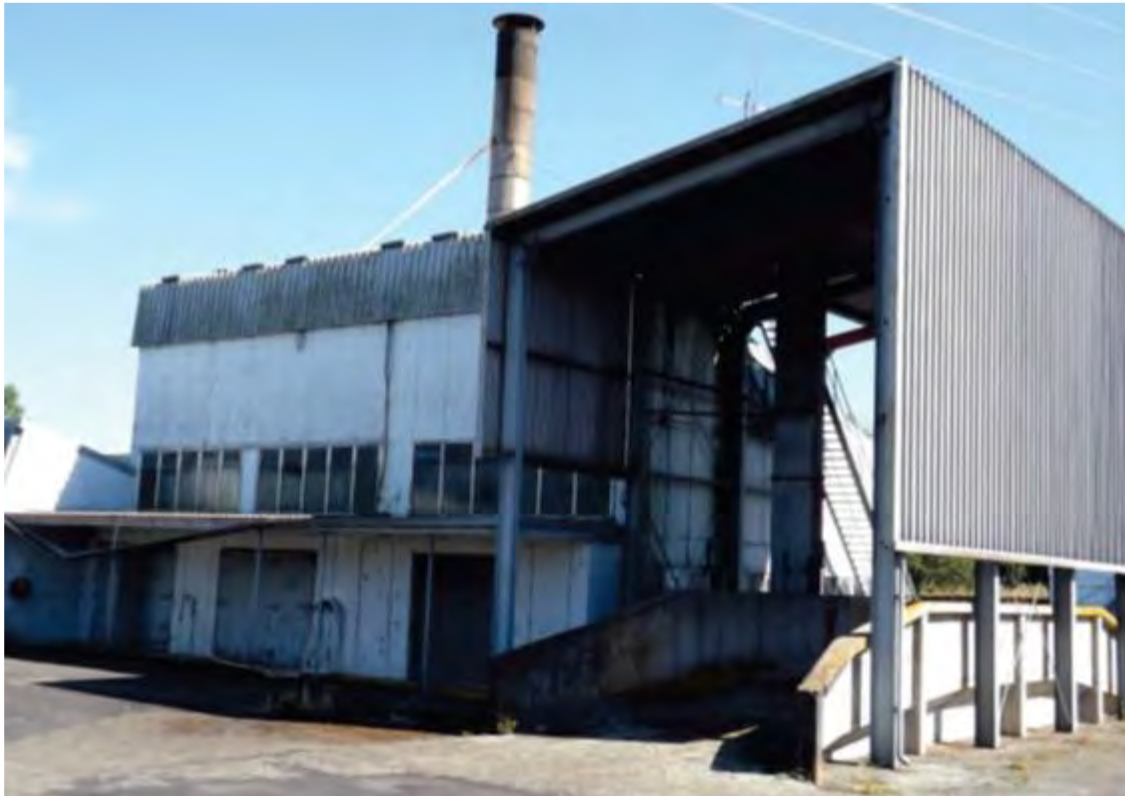
**Figure 3: Boiler House**

The boiler house (B68) is shown in Figure 3.

- Three large diameter metal chimneys to 15-20m above ground level stabilised with tie wires attached to main building.

- Slab-on-grade ground floor. Assumed pad bases to columns and strip footings to masonry walls.

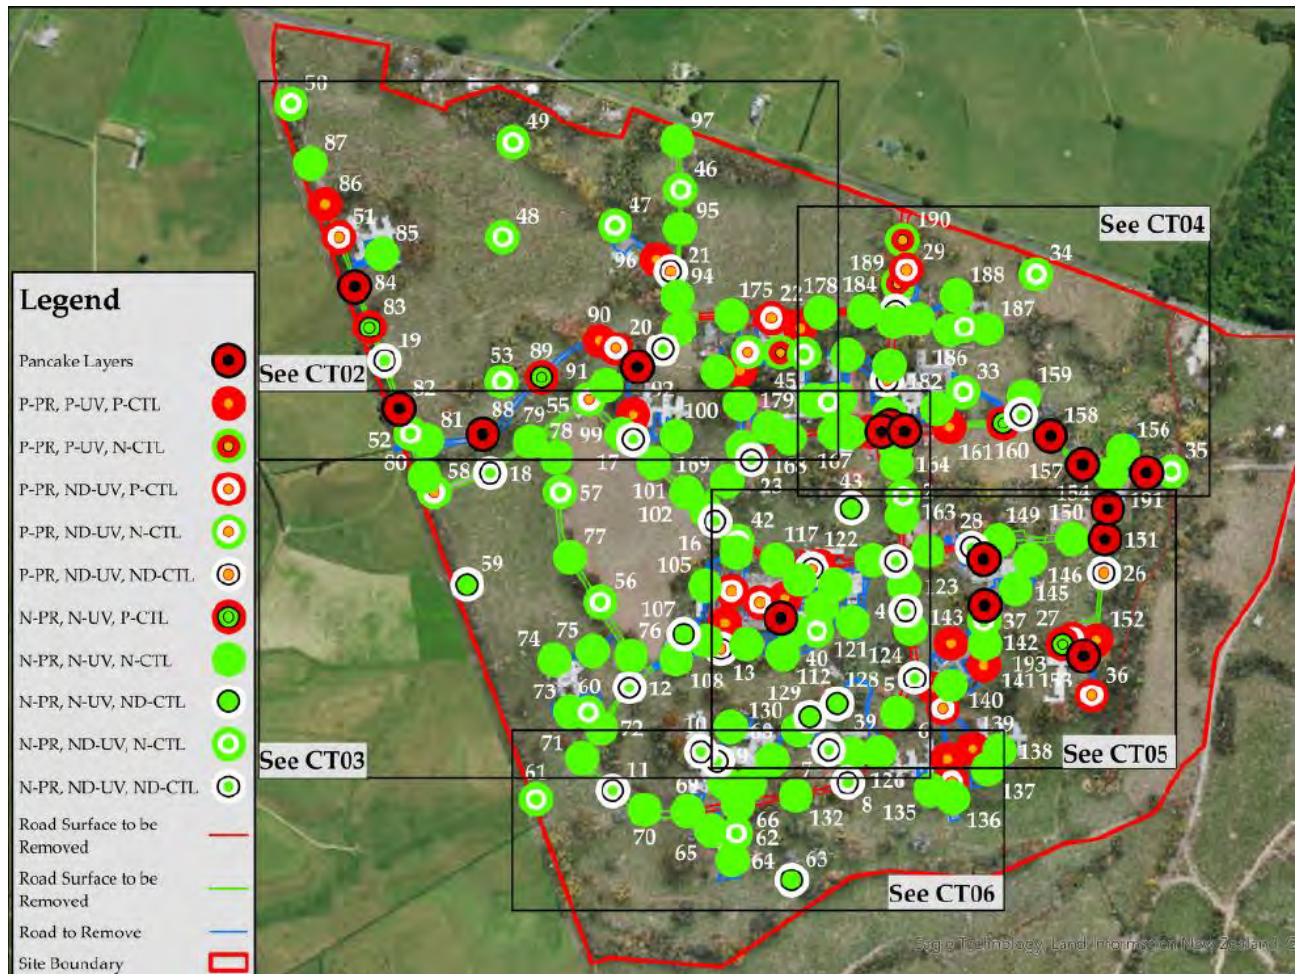
**Figure 9: Coal Tar Road Surface (Paving) Overall Sampling Plan**

FTL subsequently undertook several more in-depth investigations of both the road construction and for coal tar in the paving, basecourse and subbase roading layers, using a multiple lines of evidence approach

involving a combination of paint tests, UV light fluorescence and laboratory testing to better determine the horizontal and vertical extent of coal tar content in the roading pavement layer and the underlying basecourse and subbase. The results of this investigation are reported on separately in the FTL Coal Tar Intrusive Investigation Report (September 2025). Figure 9 shows the sampling plan for the road surface (pavement) layers, to give an understanding of the sampling density undertaken.

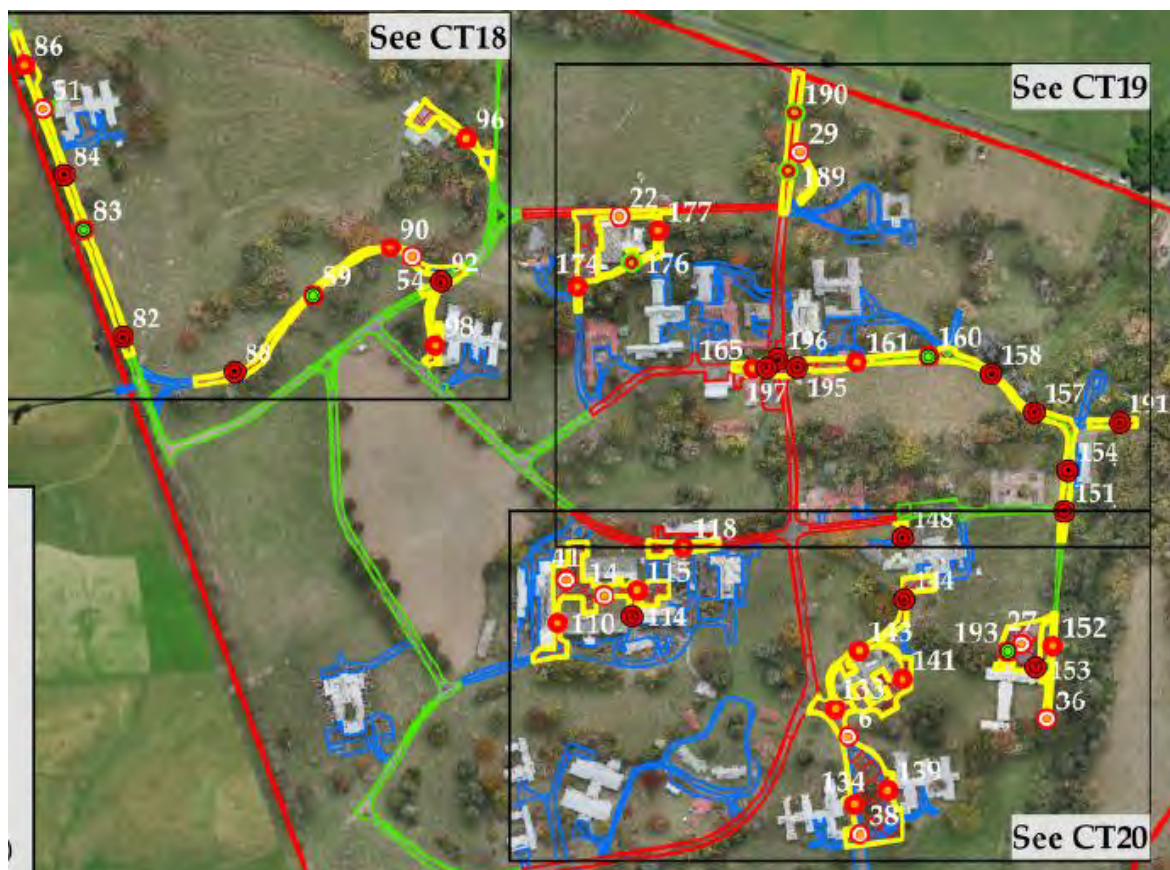
Coal tar is present across all three road network colours and roading layers. The majority of the coal tar, in terms of areal coverage, is in the surface pavement layers, with the areas with coal tar decreasing in the basecourse and further decreasing in the subbase. A conservative approach has been taken here, in that the entire basecourse and subbase depth profile has been assumed to contain coal tar, based on either a positive paint test and UV reaction or a positive lab result from a single test of these layers at each location. Given these layers are typically significantly thicker than the paving layer, this results in reasonable quantities of coal tar being calculated to be present in both the basecourse and subbase. Furthermore, there are localised areas of the site where multiple ‘top ups’ of the basecourse and pavement have been done over the years, forming a “pancake” roading structure. Figures 10, 11 and 12 show the areal distribution of coal tar in the paving, basecourse and subbase layers.

Figure 10: Coal Tar in Roading Surface (Paving) Location Plan – yellow polygons

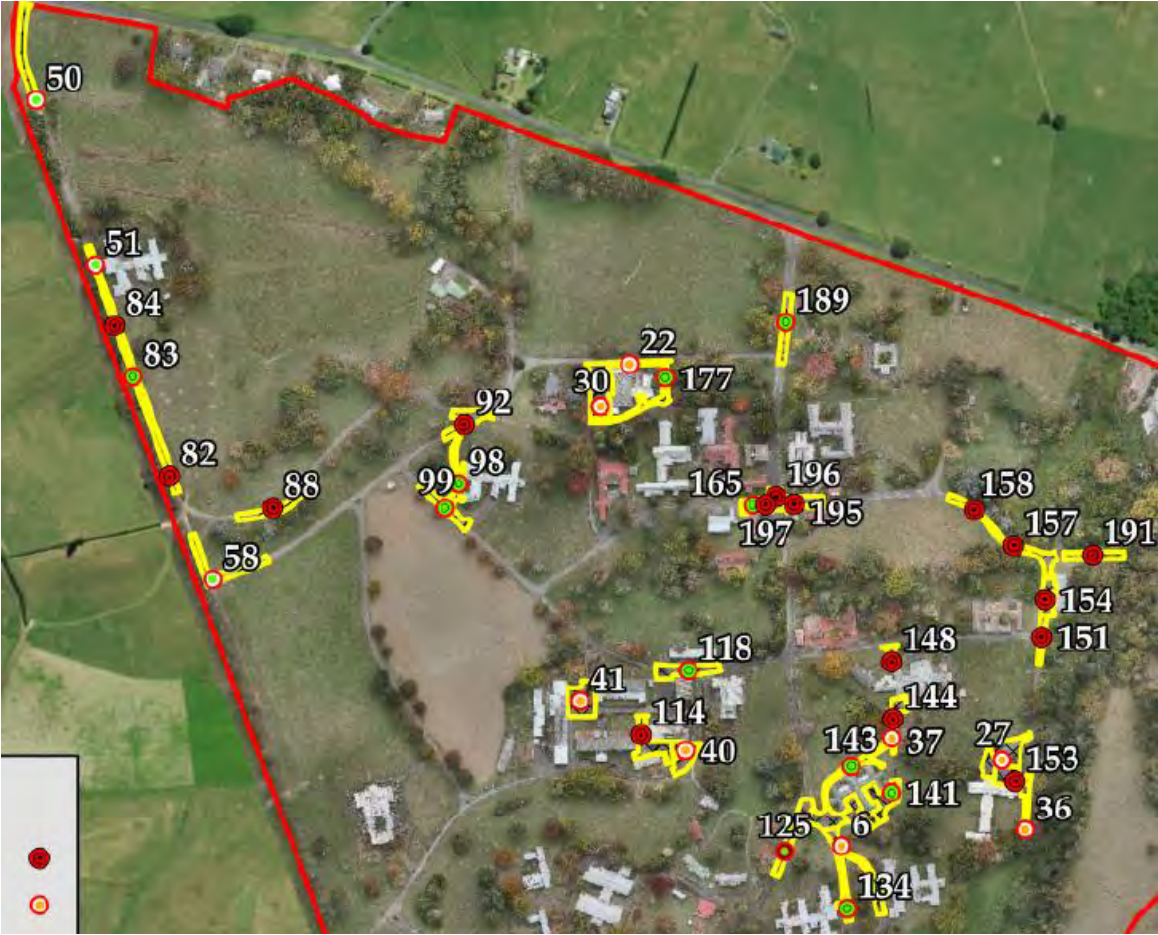
Figure 11: Coal Tar in Roding Basecourse Location Plan – Yellow Polygons

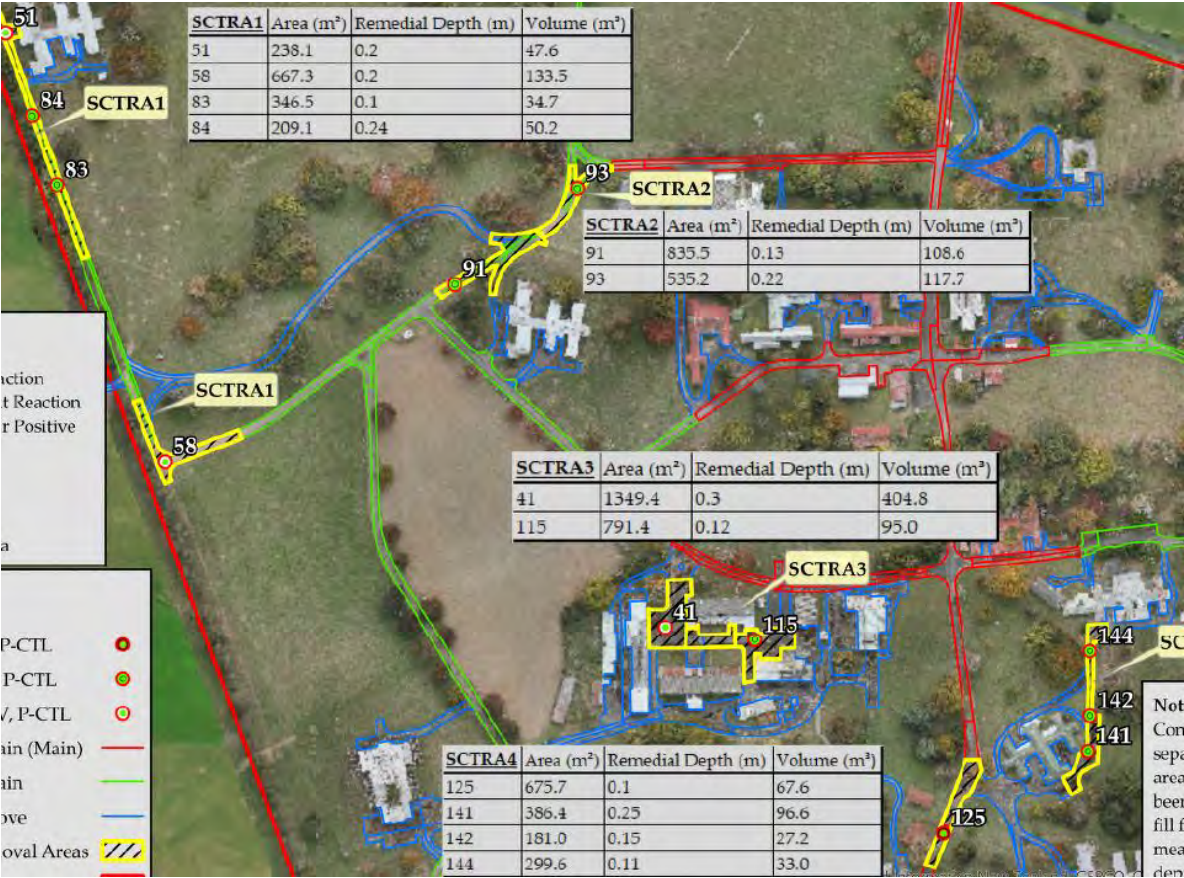
Figure 12: Coal Tar in Roding SubBase Location Plan – Yellow Polygons

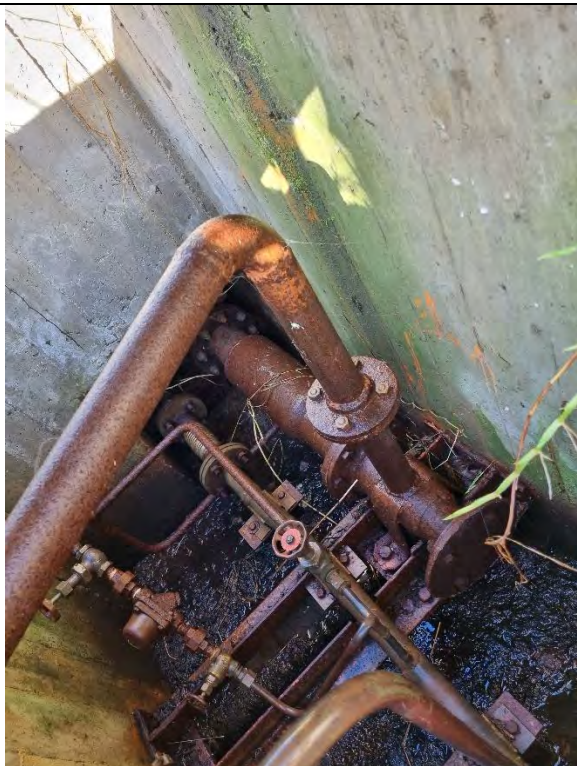
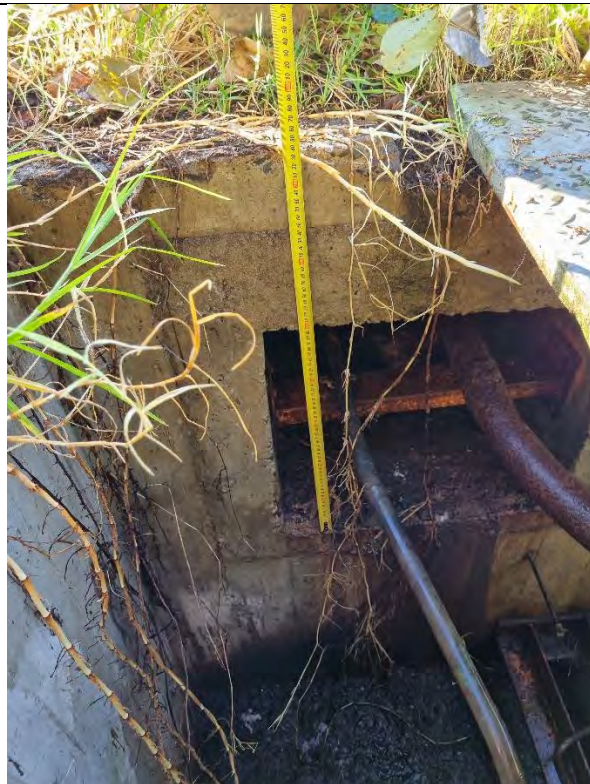
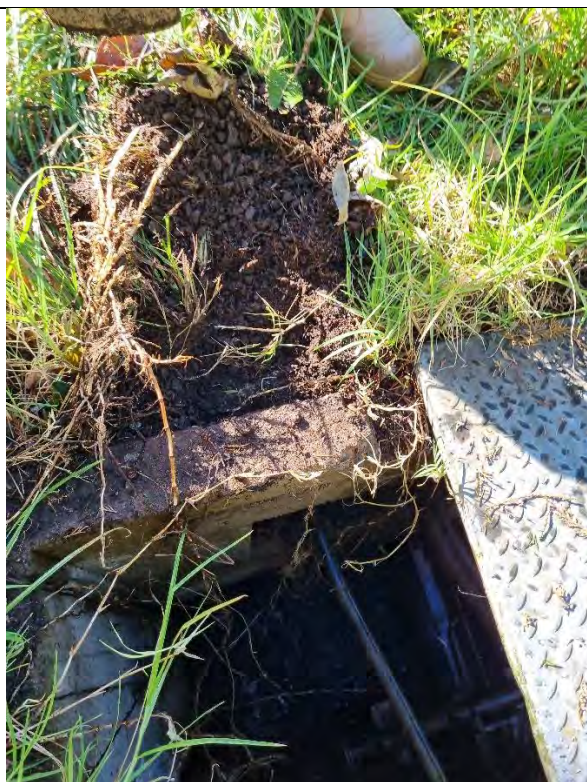
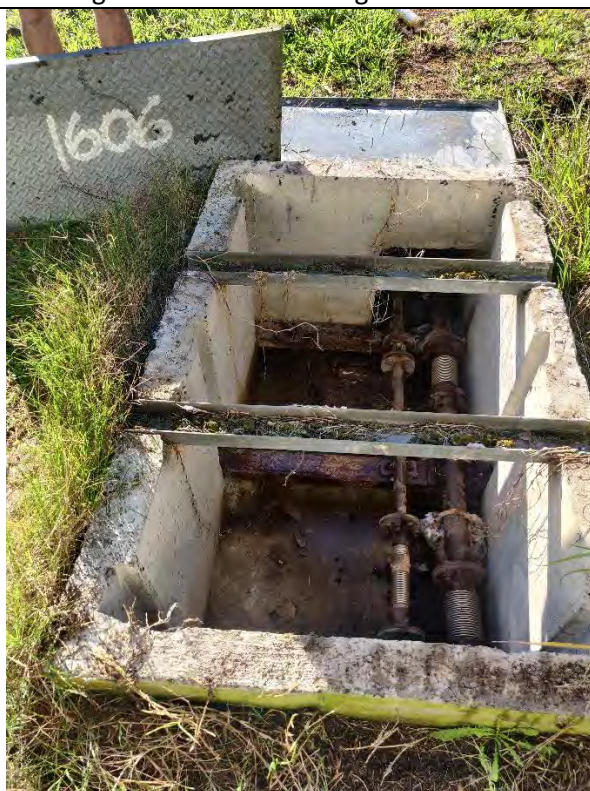
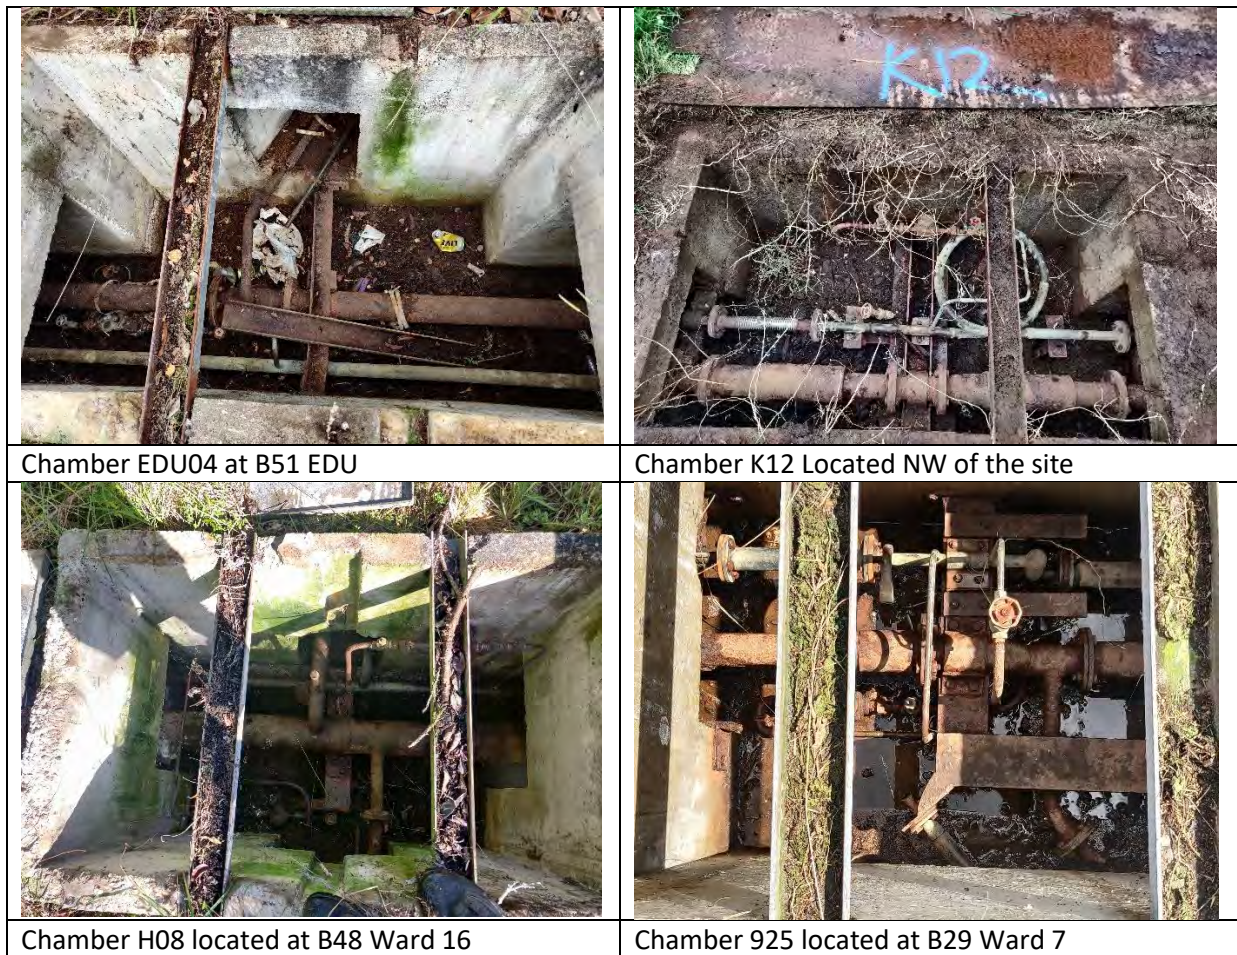
**Figure 13: Representative Photos of the Concrete Ducting System**

Based on historical plans, composition of the steam lines was generally ungalvanized mild steel of either medium or heavy grade. The return condensate lines were copper. In some areas there was a third pipe, conveying hot water pipes, but some drawings refer to this as “to be removed”. Bronze anchors and guides for the condensate pipes are referred to on some drawings. Pipe sizes are shown as varying from 1.5” to 2.5” (38-63mm for condensate) and 2”-6” (50-150mm) for steam. The pipe system includes significant numbers of valves, anchors, brackets and guides. Cover over the concrete ducting varies but is around 400mm on the drawings reviewed, which only cover a small part of the overall system.

Some photos of the ducting are included below for information. More details and photos are included in the Horizontal Infrastructure Report.

Chamber – LID K01 located at B55 Ward K

Chamber – LID K01 located at B55 Ward K  
showing the internal duct height as 500mm

Chamber – LID K01 showing 50mm cover where  
the duct connects to the building

Chamber 1606 at B48 Ward 16

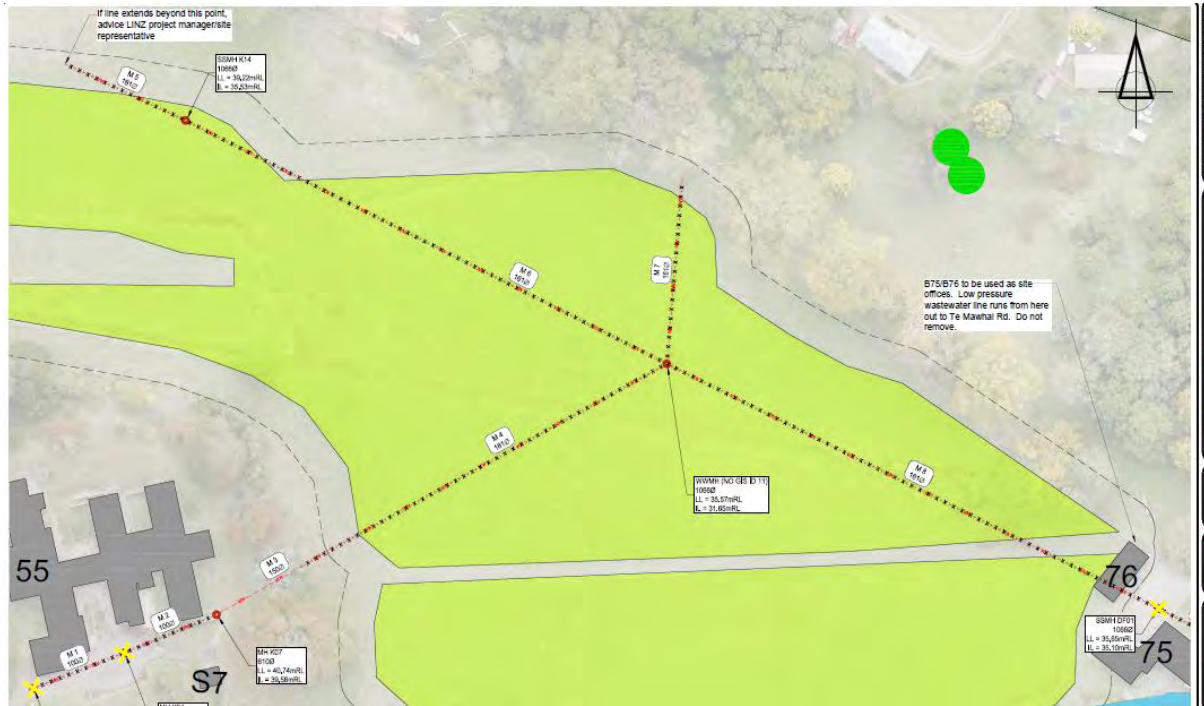
The extent of the wastewater pipeline within the NW wetland is shown in Figures 14 and 15 below.

Figure 14: Above ground wastewater lines through NW wetland area

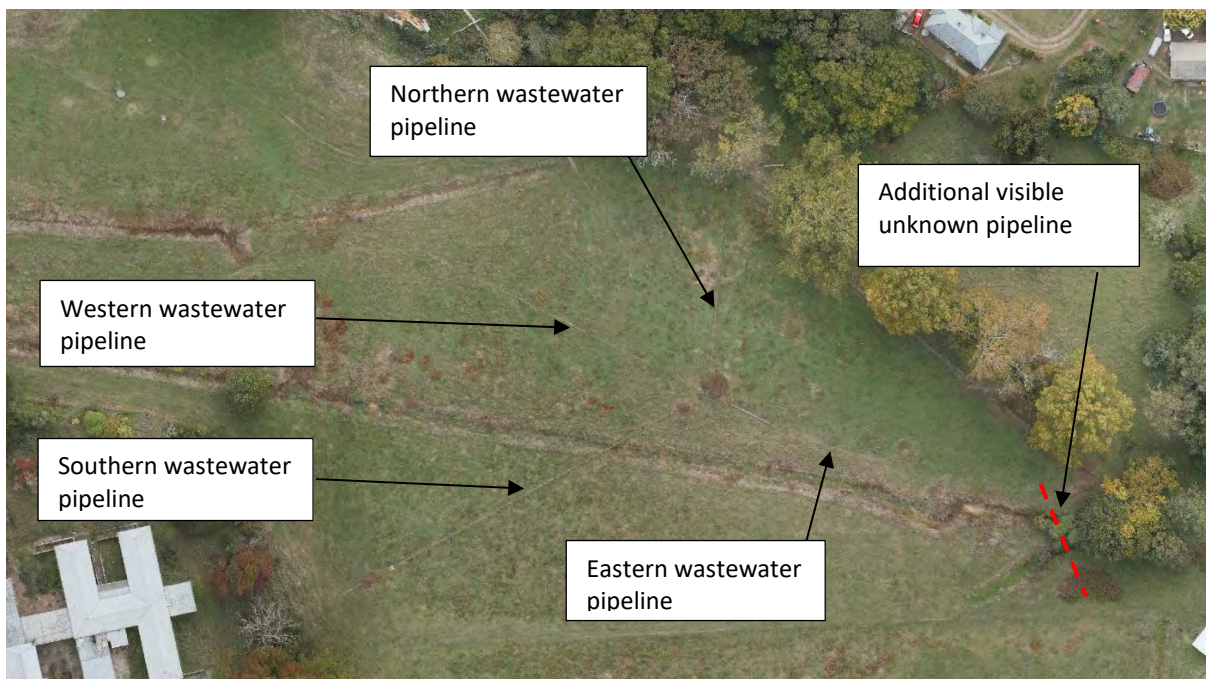
Figure 15: Visible wastewater lines in wetland area

GIS imagery (Figure 15) shows that this pipeline (approx. 150-190mm diameter) is generally above ground, with some areas covered by vegetation.

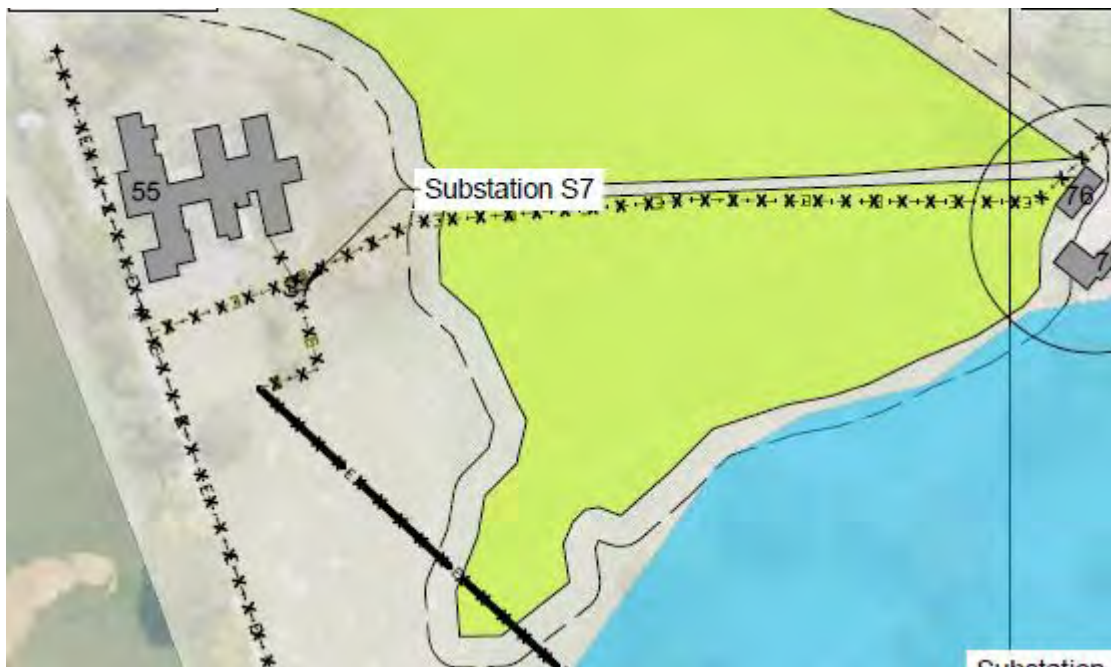
The length of power cabling through the wetland area is approximately 210m long, as shown in Figure 16 below. There is also a small section of overhead power cabling that passes through the southern tip of the wetland.

- These works will be done during an extended summer dry period to minimise the potential for damage to the wetland area.
- A small excavator (8T or 13T) will travel on swamp mats placed along the route of the cabling. The cable will be exposed at each end and then pulled out by excavator. The cabling will be cut into suitable lengths for transport and transferred by a small truck to the storage area for processing for recycling or disposal.
- This process will create a narrow trench where the cable has come out of the ground. Any displaced soil from the trench will be placed back into it and the trench topped up with topsoil and tamped down, followed by reseeding/replanting with appropriate grass/plants to match the vegetation in the wetland area.
- The swamp mats will be removed on completion of the works and any damaged vegetation areas reinstated.

Figure 16: Extent of below ground power cable and above ground power cable in wetland area.

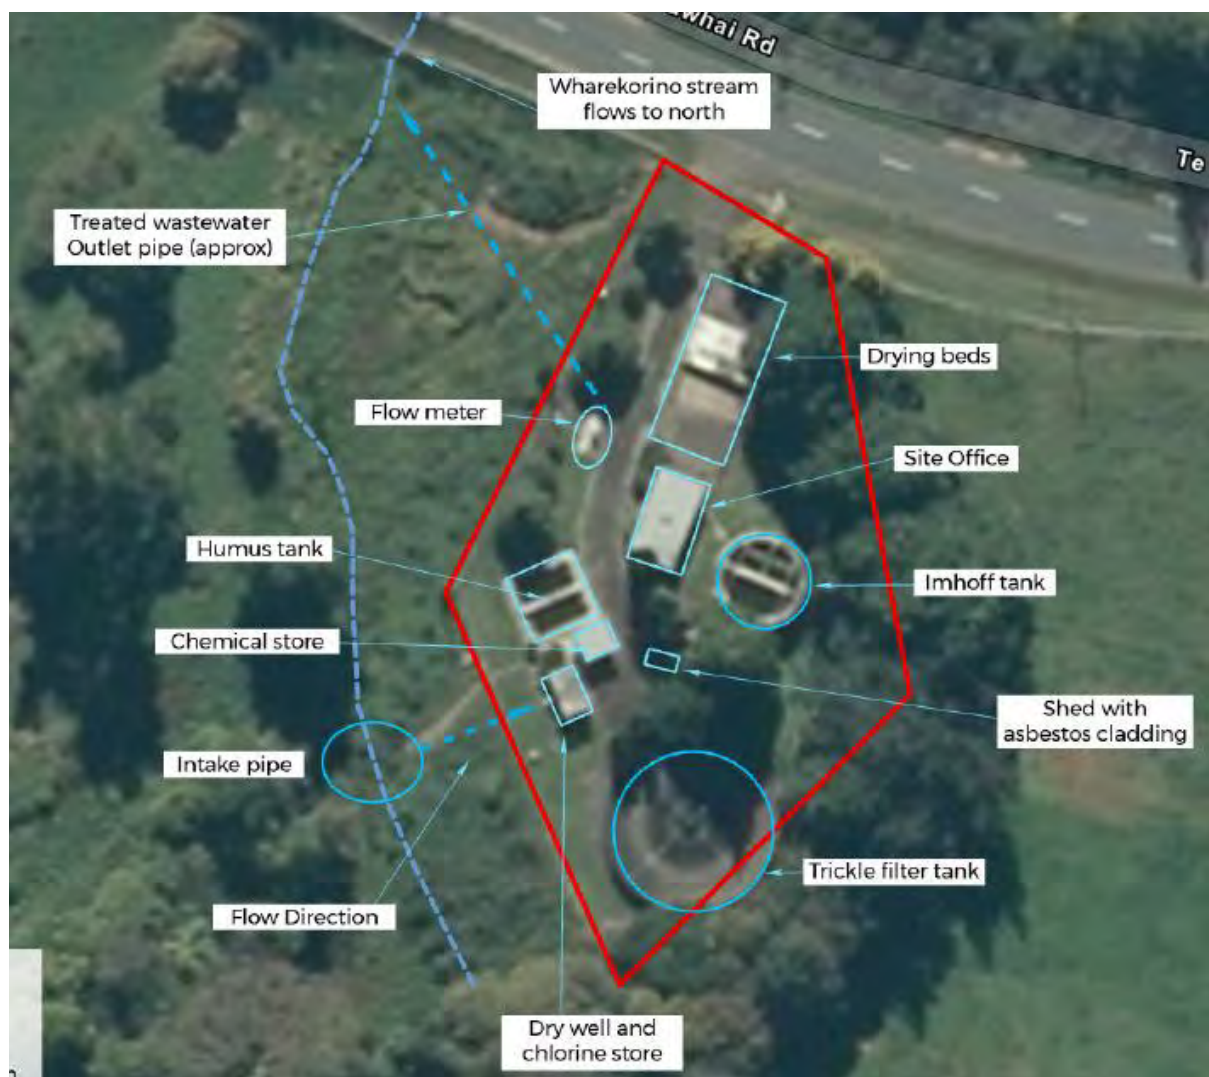
**Figure 17: Former WWTP Pre-decommissioning**

The WWTP, pre-demolition, is shown below in Figure 17.

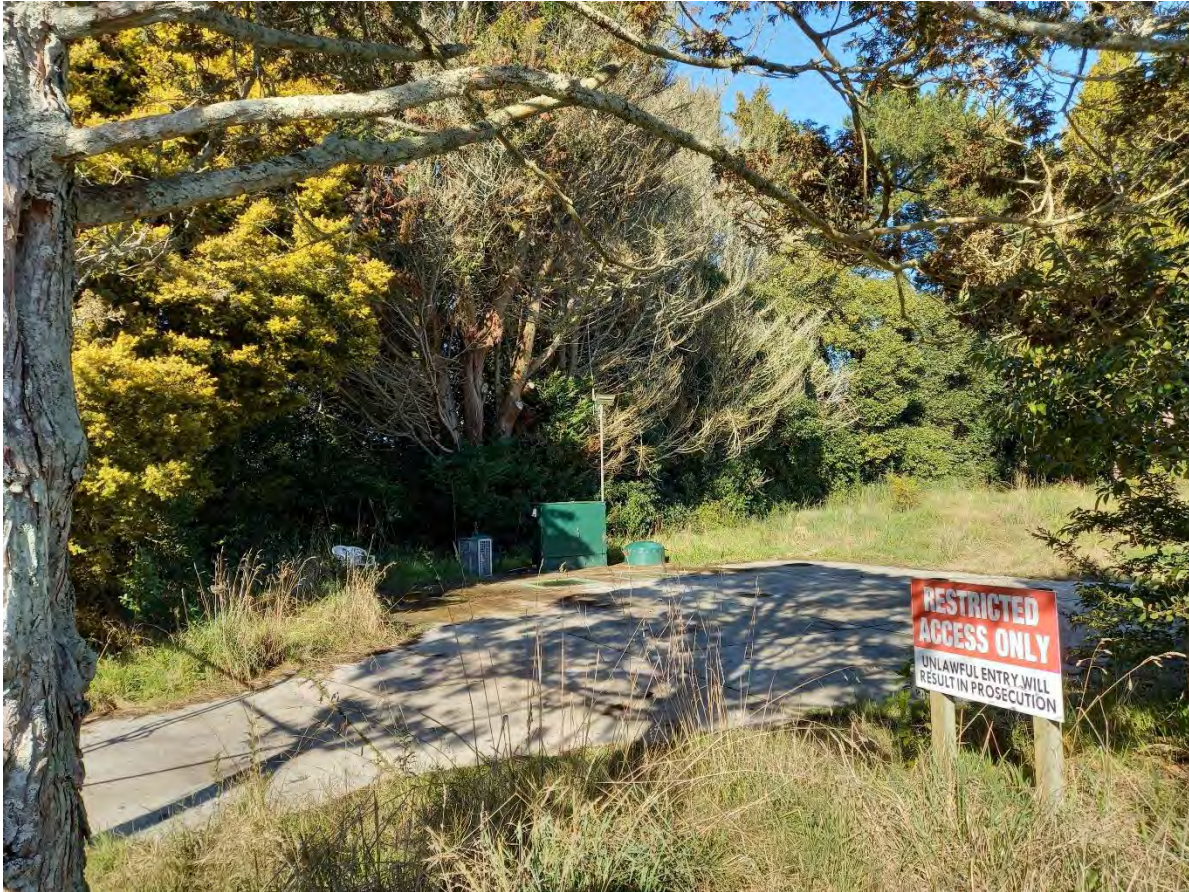
**Figure 19: New Wastewater Pump Station (in ground tanks and chambers under concrete pad)**

The WWPS system, including the concrete pad, needs to be protected from damage during further proposed demolition works in this area (item 1 in attached drawing 33205/2010).

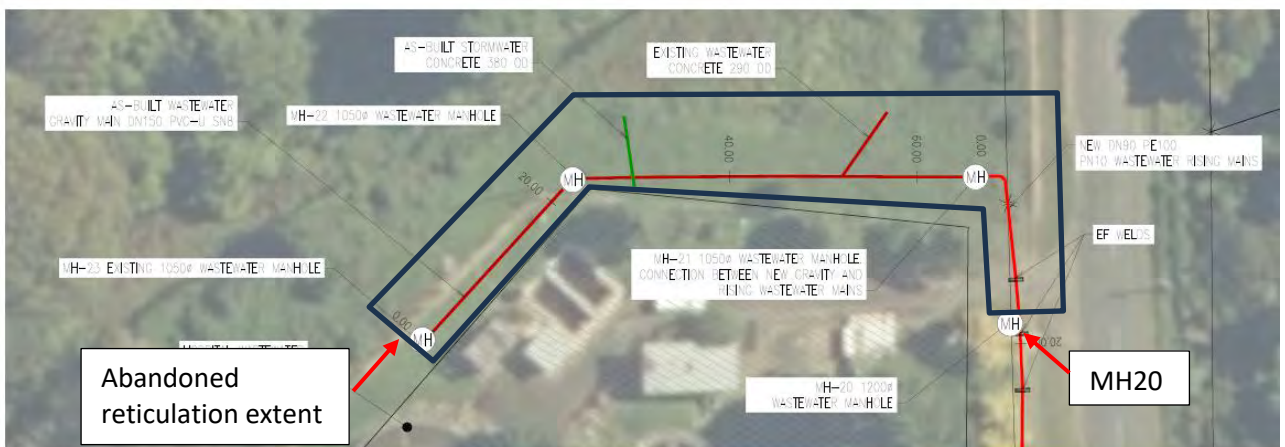
**Figure 20: Abandoned wastewater line and MHs (item 13)**

When the WWPS became operational, an existing section of wastewater rising and gravity mains from MH20 to the end of the wastewater line (MH23) was abandoned, as shown in Figure 20. This work comprises three DN150 PVC gravity pipes of total length around 67m, with three associated wastewater manholes, and a short section of 380OD stormwater pipe as shown in Figure 20. All of this pipework is less than 800mm deep, except the first 18m of wastewater pipe from MH23 towards MH22.

- Item 12: Relocate fence to reduce compound size. LINZ to confirm extent.
- Item 13: Remove wastewater pipes down to 800mm depth out to the boundary with the road reserve and remove the stormwater pipe and associated three WWMHs shown in Figure 20. Cap the line at the road reserve boundary and at each end of the wastewater pipe greater than 800mm depth from MH23 to MH22.

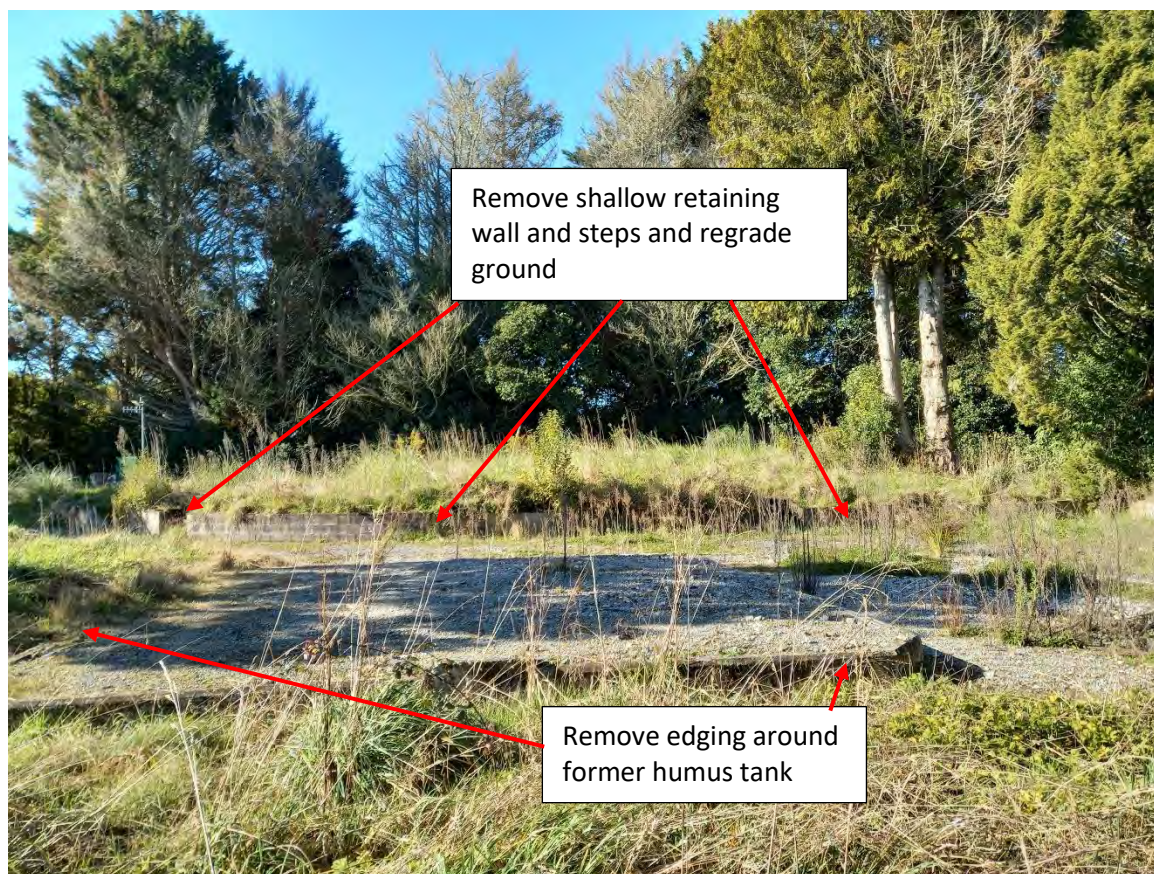
**Figure 24: Remove shallow retaining wall and steps and regrade ground (item 5); remove edging around former humus tank and regrade ground (item 6)**

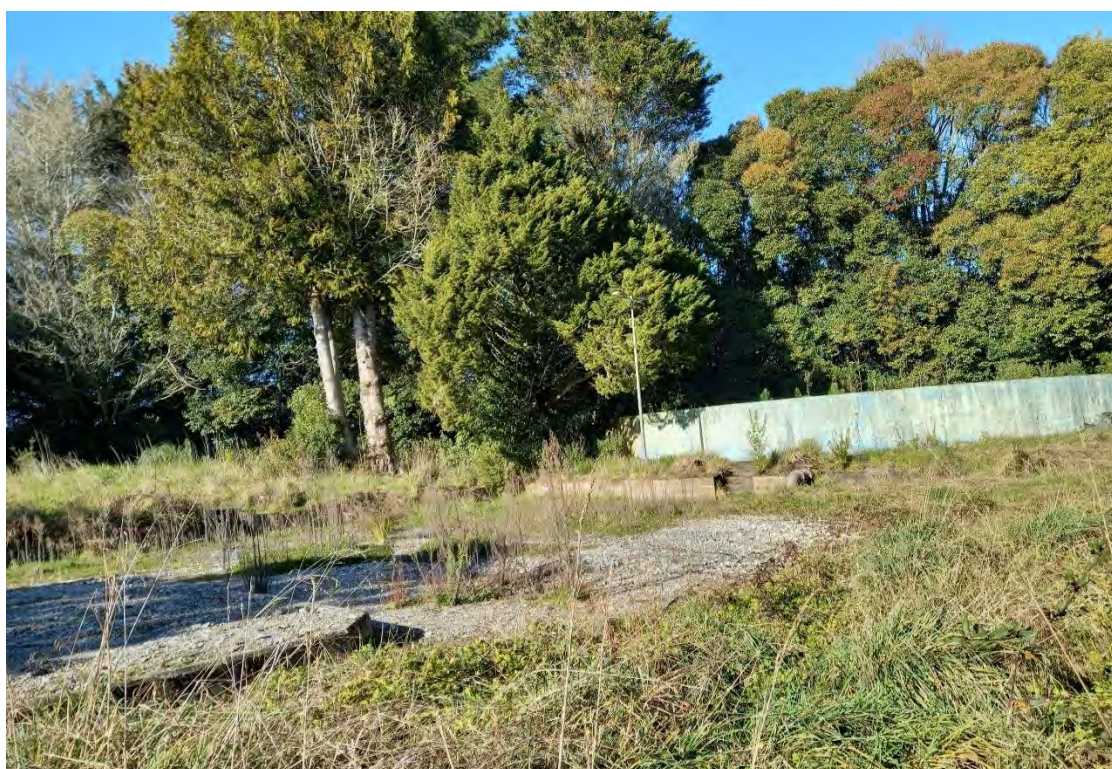
**Figure 25: Remove trickling filter (circular tank in background) and stone media (item 7).**

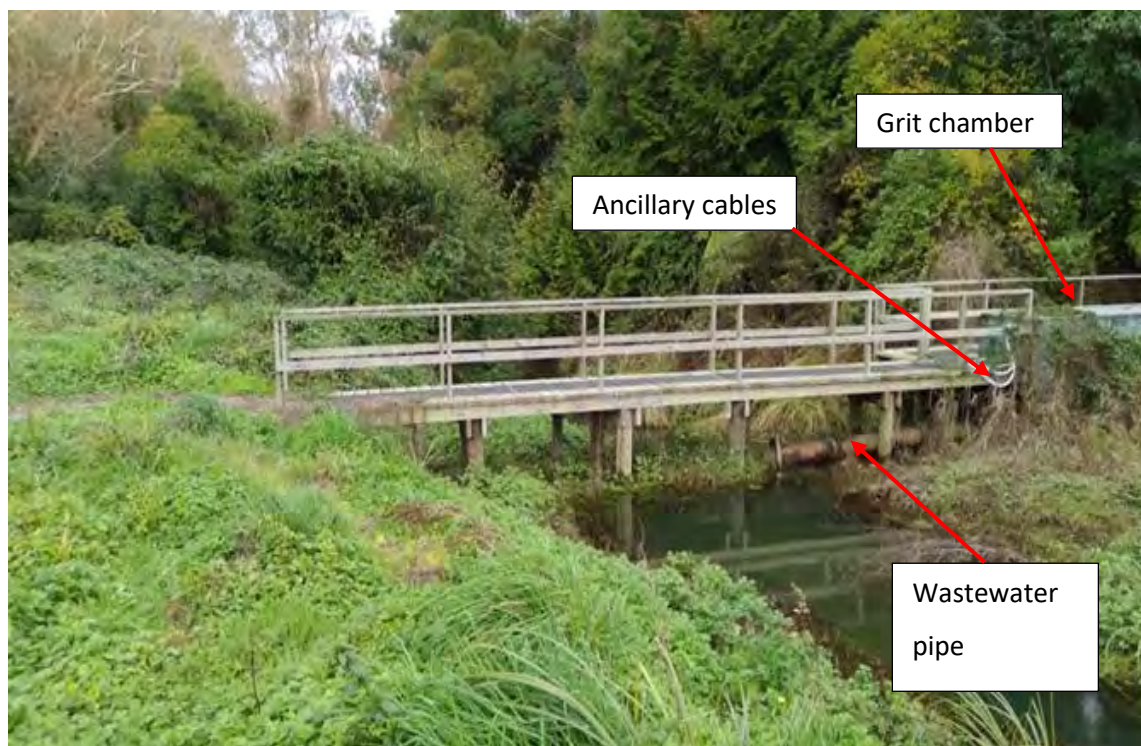
**Figure 26: Remove grit chamber on wastewater inlet line, wastewater inlet pipe strapped to footbridge, any ancillary cables/ducting, and footbridge itself (items 8-11)**

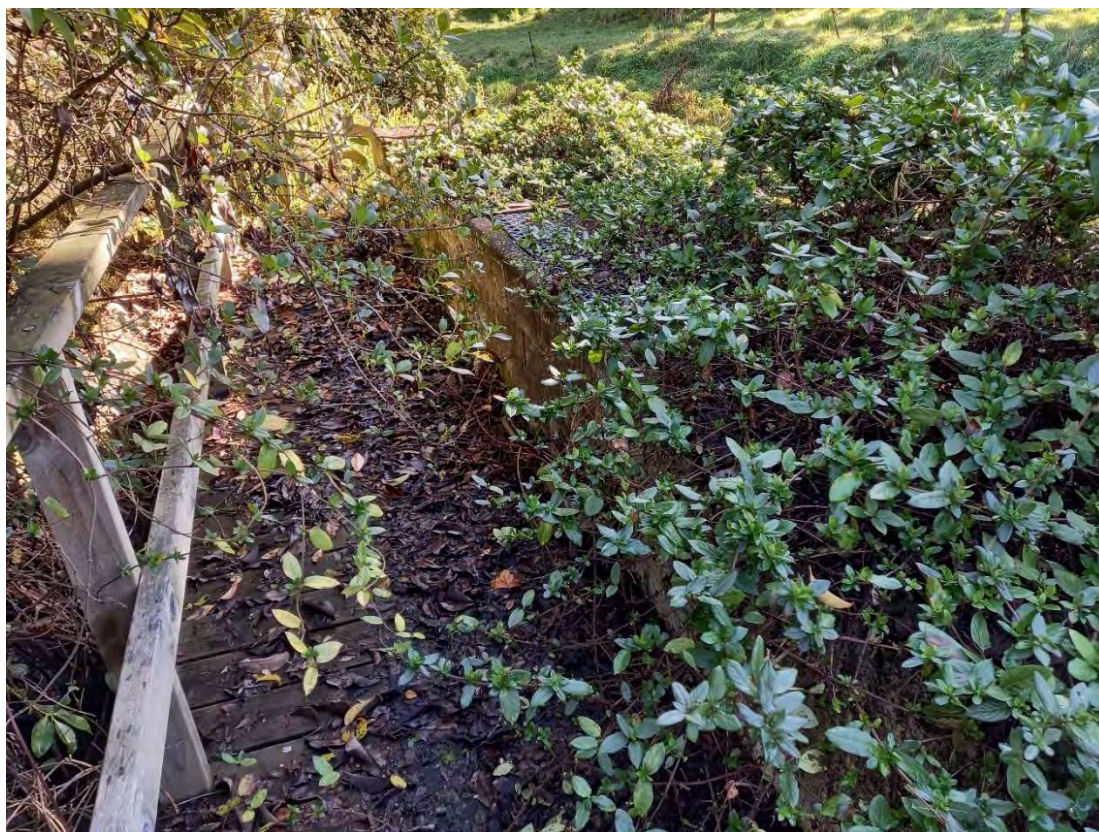
**Figure 27: Closeup of grit chamber showing concrete blockwork construction and grated metal lid (largely hidden under vegetation)**

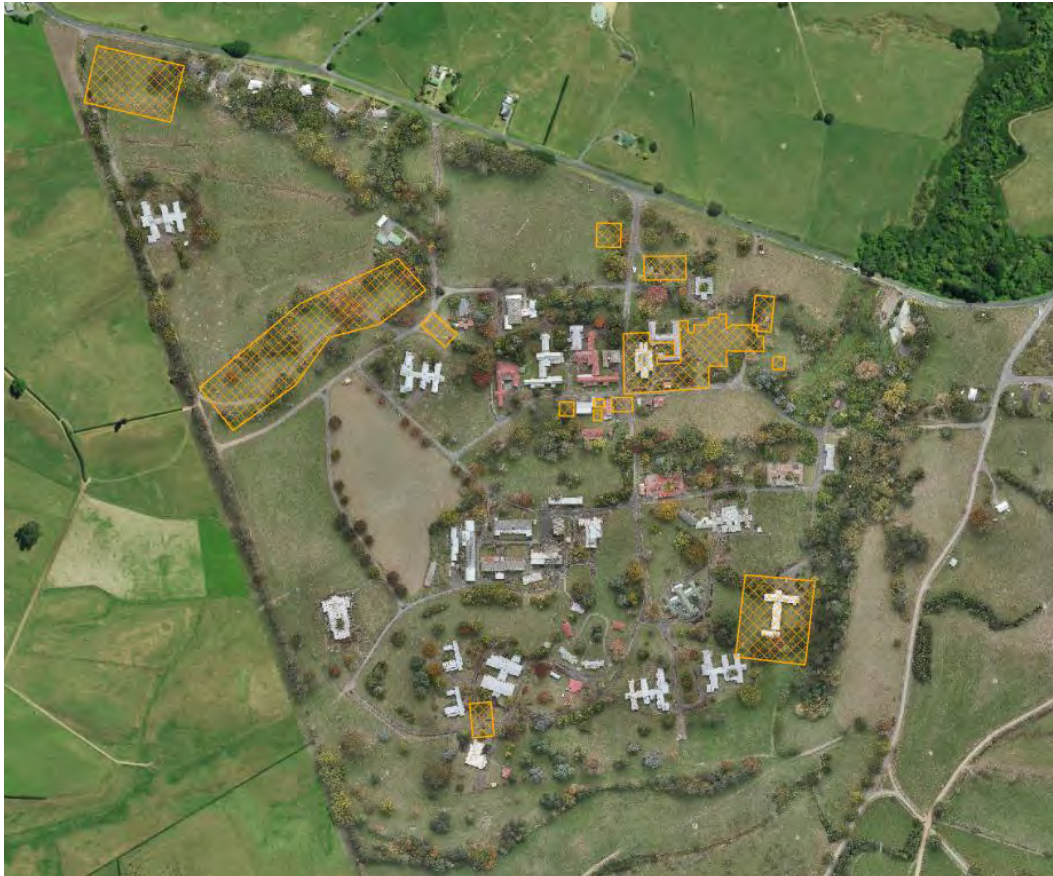
**Figure 30: Extent of Historical Building Demolition Works**

During February 2024 site investigation work, some historical demolition debris, including some asbestos sheet fragments, filament bulbs, burnt material, terracotta/earthware pipes, etc. was found in rare/minor/small quantities at variable depths ranging from near surface to up to 1.2m on the northern sides of Buildings B02 (northern side of southern arm) and B26 (directly north in carpark area). A review of historical aerial photographs identified that some buildings, or parts of buildings, have been demolished in

these areas in the past. All of these areas have been investigated as part of intrusive investigations by AECOM/GHD with no significant demolition debris or contaminated soil found. Nevertheless, some fill and minor demolition debris may be found in these areas during associated demolition works, particularly during the removal of building footings/foundations and any buried services. This may also apply to the industrial area, where some discoloured fill was encountered. The extent of the historical demolition works is shown in Figure 30. The contractor should be aware of this, and advise LINZ or their nominated representative, if such fill/materials are found. Accidental discovery protocols will be triggered, if the find is significant (e.g. asbestos fragments, concentrated pockets of demolition debris.)
