**RE: Information Requested – LU/0231/24 & LU/0232/24 Former Tokanui  
Psychiatric Hospital**

FORMER TOKANUI HOSPITAL  
DEMOLITION AND REMEDIATION  
DEMOLITION, DECONSTRUCTION & REMEDIATION  
MANAGEMENT PLAN - DRAFT

Toitū Te Whenua Land Information New Zealand  
 Demolition Management Plan  
 Former Tokanui Hospital Demolition and Remediation Project  
 Tokanui  
 Te Awamutu

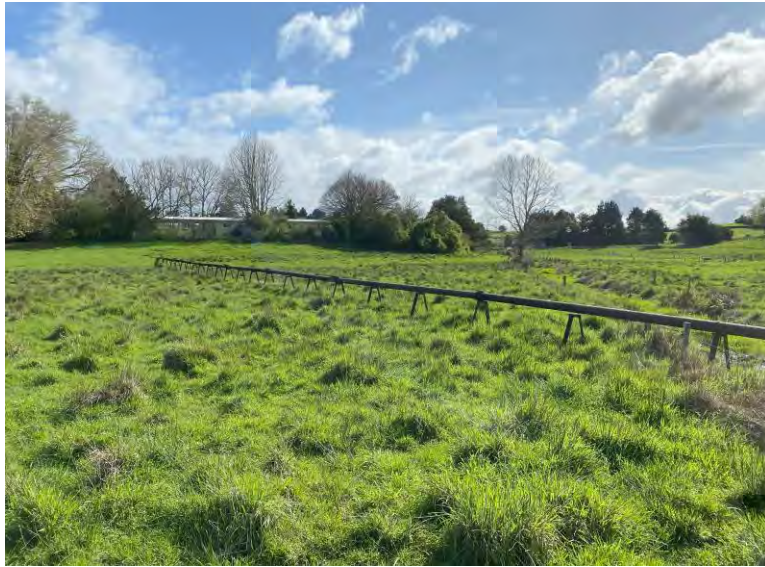
Southern pipeline with footings

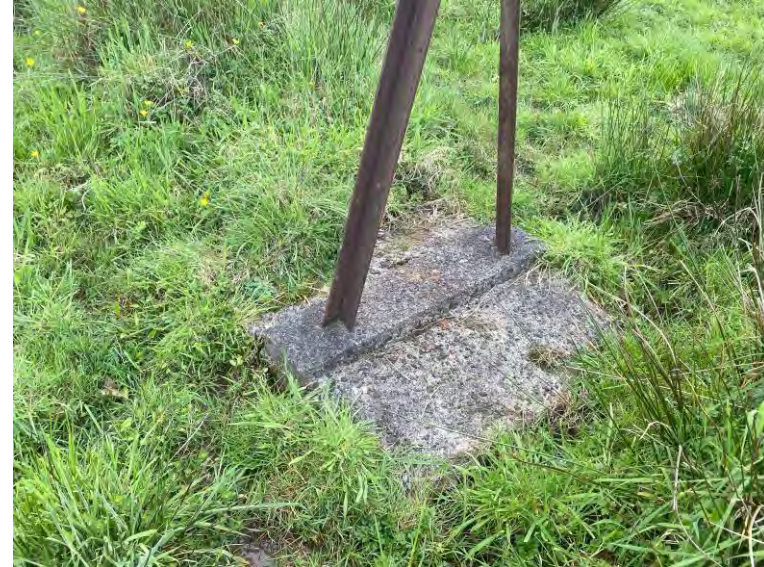
Southern pipeline footings and concrete foundation

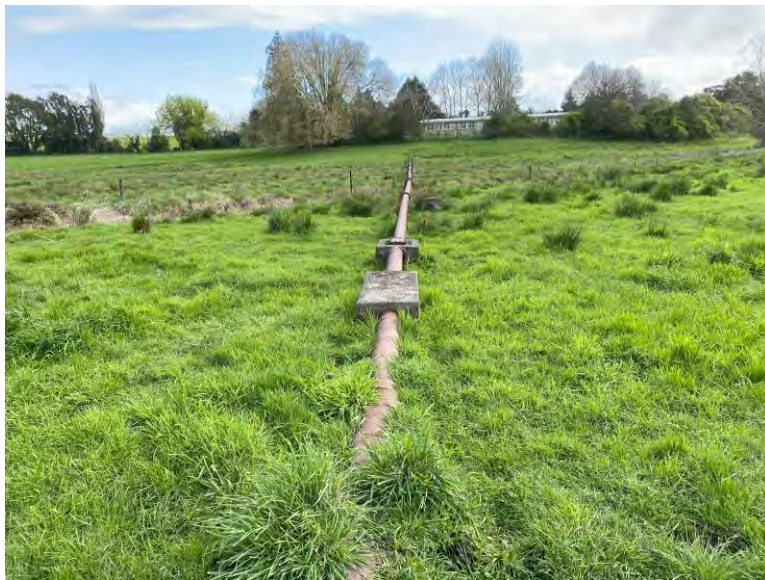
Southern pipeline with concrete casing

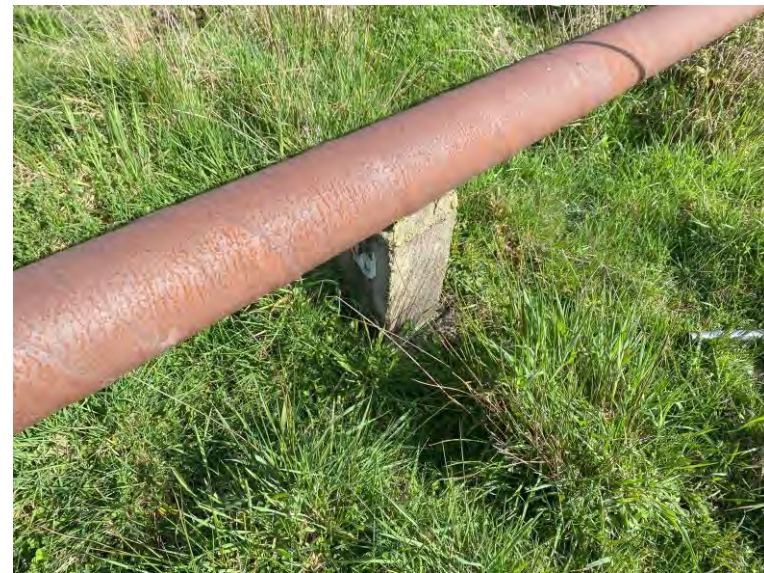
Southern pipeline with concrete pile

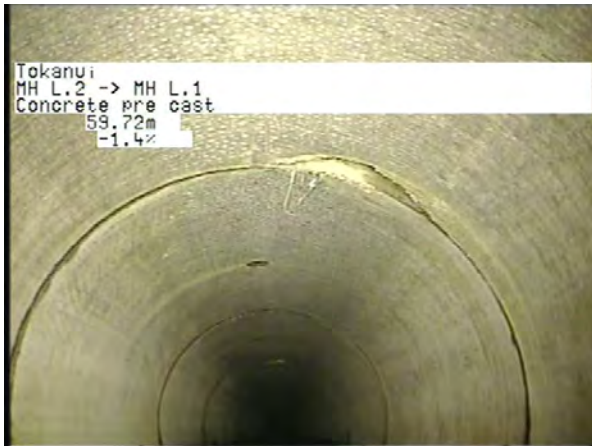
MH L.2 To MH  
L.1\_3a461e8f-6cd9-40f8-bed3-cd2fc278f286\_20230328\_120109\_510.jpg, 00:18:10, 60.78m

| Comments | | | | | | |
|---|---|---|---|---|---|---|
| | 60.78 | JFM | Joint faulty, medium cracking or spalling, unlikely through the pipe wall from 12 o'clock to 2 o'clock | 00:18:10 | MH L.2 To<br>MH<br>L.1_efb44 | 10 |

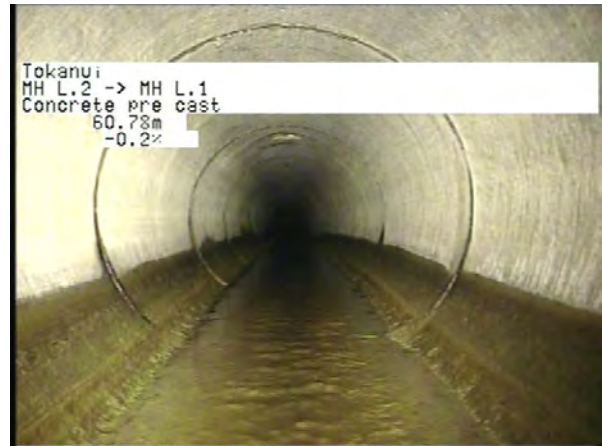
MH L.2 To MH  
L.1\_871192d3-4982-43f0-86ab-6d695a16e812\_20230328\_120028\_336.jpg, 00:18:44, 60.78m

| Comments | | | | | | |
|---|---|---|---|---|---|---|
| | 60.78 | GC | General comment / General condition photo | 00:18:44 | MH L.2 To<br>MH<br>L.1_87119 | |

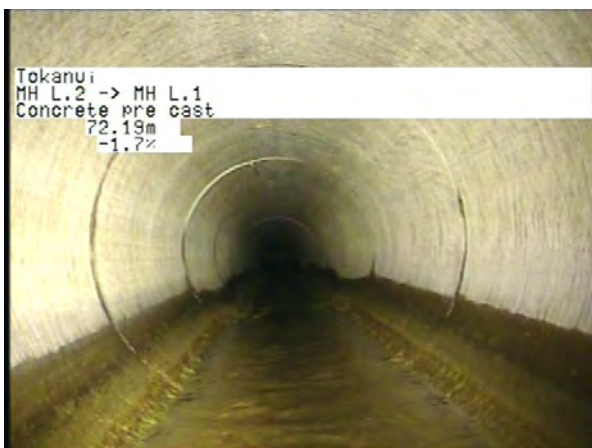
MH L.2 To MH  
L.1\_05f56b3c-4af3-4120-90a2-48c31bdc07a0\_20230328\_120519\_428.jpg, 00:23:16, 72.19m

| Comments | | | | | | |
|---|---|---|---|---|---|---|
| | 72.19 | GC | General comment / General condition photo | 00:23:16 | MH L.2 To<br>MH<br>L.1_05f56 | |

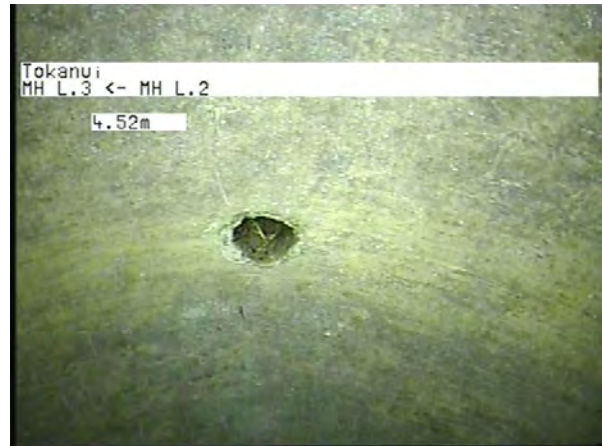
MH L.2 To MH  
L.3\_f987bf23-4756-4827-ae23-684241dcd8ca\_20230328\_134  
826\_521.jpg, 00:01:15, 4.52m

| 1:424 | m + | OC | Observation | MPEG | Photo | Score |
|---|---|---|---|---|---|---|
| | 4.52 | S01 PHS | Pipe holed, the hole has been repaired at 12 o'clock, start | 00:01:15 | MH L.2 To MH L.3_f987bf | |

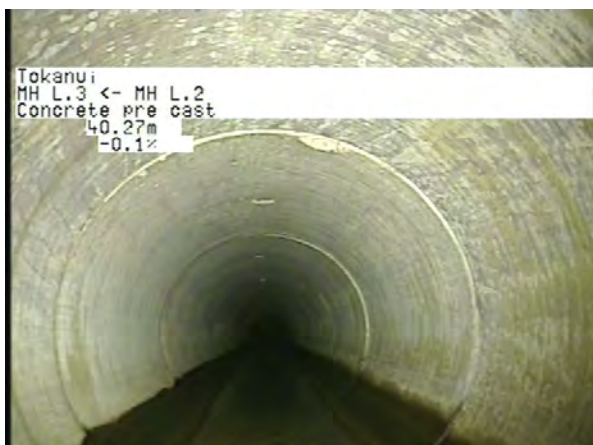
MH L.2 To MH  
L.3\_64599a16-9a20-4a6e-8d0f-d6710a681735\_20230328\_140454\_459.jpg, 00:13:08, 40.27m

| 1:424 | m + | OC | Observation | MPEG | Photo | Score |
|---|---|---|---|---|---|---|
| | 40.27 | JFS | Joint faulty, minor cracking or spalling from 12 o'clock to 2 o'clock / tiny chip | 00:13:08 | MH L.2 To MH L.3_64599 | 1 |

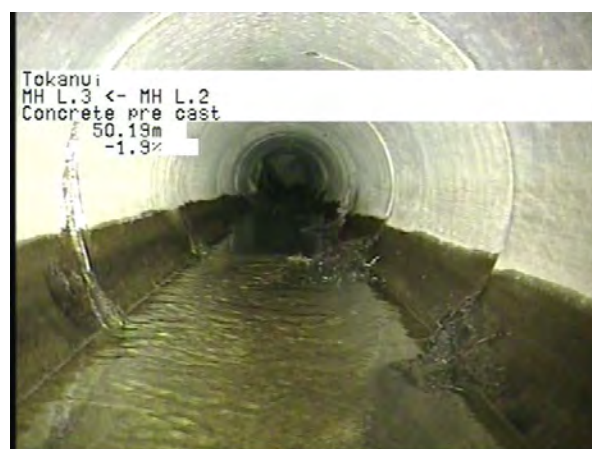
MH L.2 To MH  
L.3\_7a485f99-6caa-477c-ae76-26ec77a4d9a1\_20230328\_140843\_916.jpg, 00:16:16, 50.19m

| 1:424 | m + | OC | Observation | MPEG | Photo | Score |
|---|---|---|---|---|---|---|
| | 50.19 | JFL | Joint faulty, major cracking or spalling, likely through the pipe wall from 3 o'clock to 6 o'clock / Roots protruding joint | 00:16:16 | MH L.2 To MH L.3_7a485 | 25 |

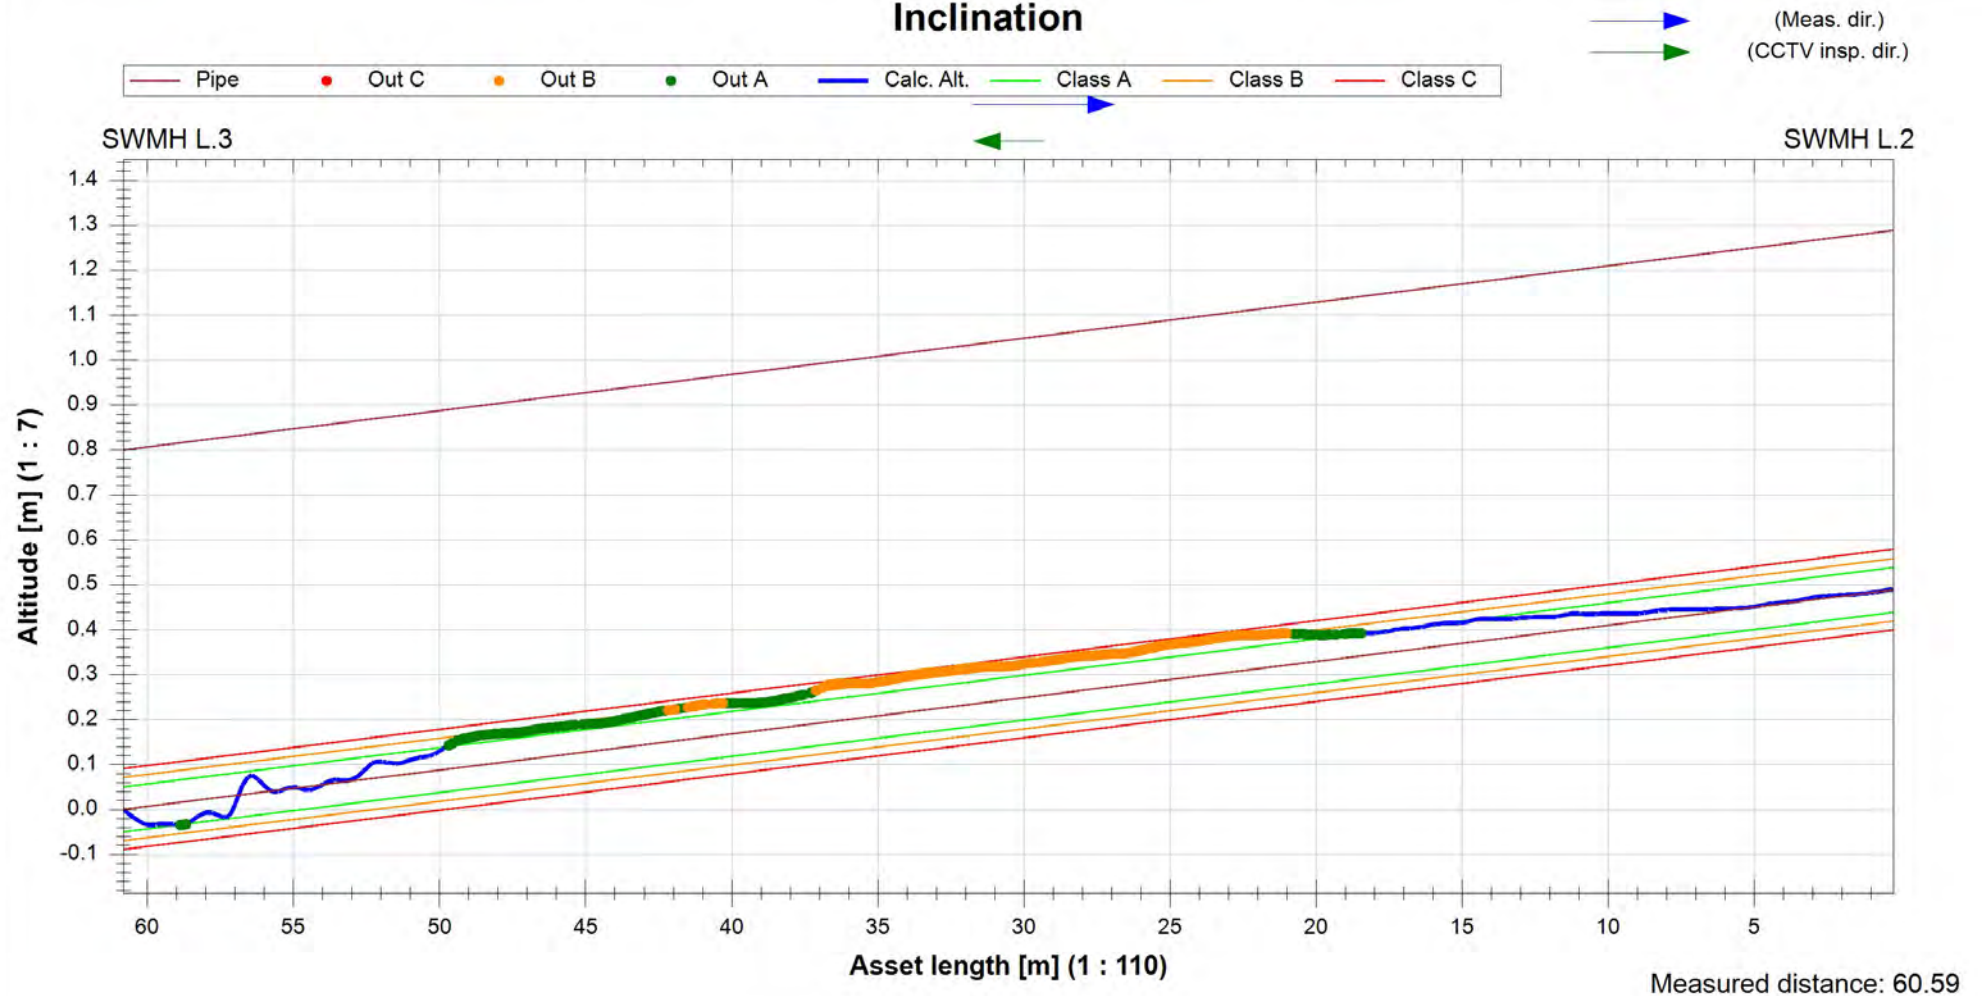
### Inclination

| <b>Shape</b><br>Circular pipe | <b>Dia/Height</b><br>800 mm | <b>Width</b><br>800 mm | <b>U/S Node</b><br>SWMH L.3 | <b>D/S Node</b><br>SWMH L.2 | <b>Start altitude</b><br>0.000 m | <b>End altitude</b><br>0.489 m | <b>Measured Inc</b><br>0.807 % |

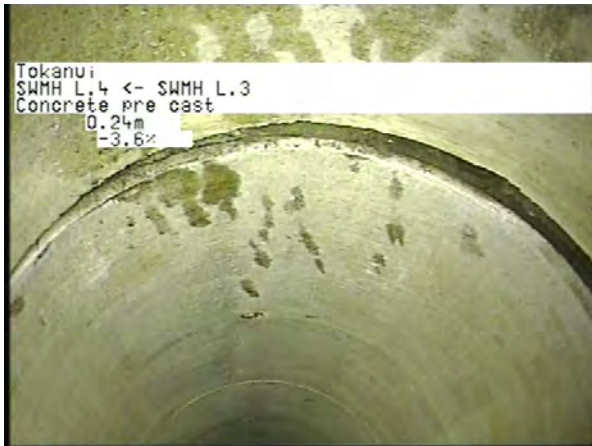
MH L.3 To MH  
L.4\_9483e21f-fbf2-4525-84ac-cde70fca9a8b\_20230404\_0929  
22\_705.jpg, 00:01:33, 0.24m

| Comments | | | | | | |
|---|---|---|---|---|---|---|
| | 0.24 | JOM | Joint open, displacement is 20mm to 40mm | 00:01:33 | MH L.3 To MH L.4_9483e | 5 |

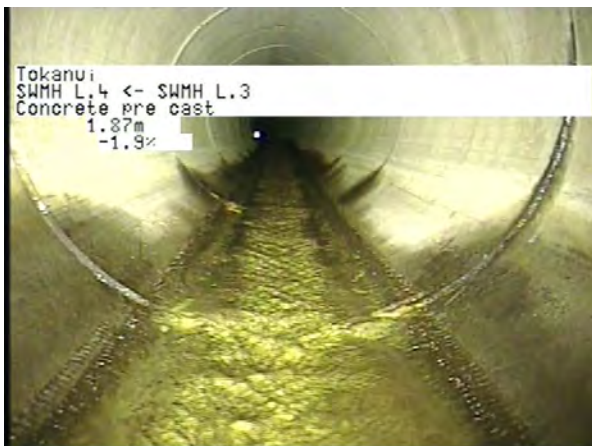
MH L.3 To MH  
L.4\_e2f87596-29fe-4ec1-934e-0f3ccad4d5b2\_20230404\_093  
057\_865.jpg, 00:02:46, 1.87m

| Comments | | | | | | |
|---|---|---|---|---|---|---|
| | 1.87 | JFL | Joint faulty, major cracking or spalling, likely through the pipe wall from 4 o'clock to 8 o'clock / tiny roots protruding | 00:02:46 | MH L.3 To MH L.4_e2f87 | 25 |

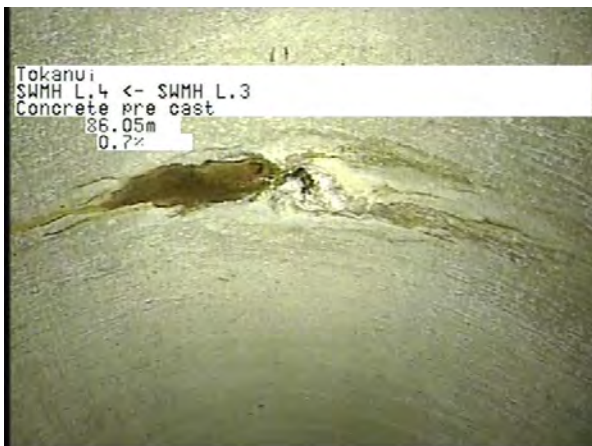
MH L.3 To MH  
L.4\_1145e1e5-58c4-4518-9f96-9c7287b2e87d\_20230404\_09  
5212\_284.jpg, 00:20:52, 86.05m

| 1:420 | m + | OC | Observation | MPEG | Photo | Score |
|---|---|---|---|---|---|---|
| | 86.05 | PHS | Pipe holed, the hole has been repaired at 12 o'clock | 00:20:53 | | 5 |

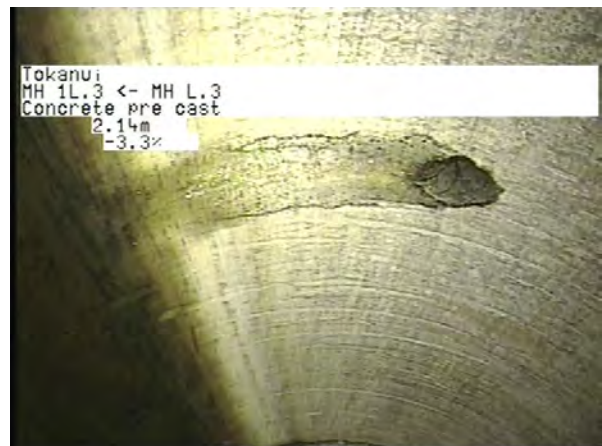
MH L.3 To MH  
1L.3\_8f3149b8-46b5-47b3-a989-f6b5b56313f4\_20230404\_10  
3057\_801.jpg, 00:02:15, 2.14m

| Comments | | | | | | |
|---|---|---|---|---|---|---|
| | 2.14 | PHS | Pipe holed, the hole has been repaired at 10 o'clock | 00:02:15 | MH L.3 To MH 1L.3_8f31 | 5 |

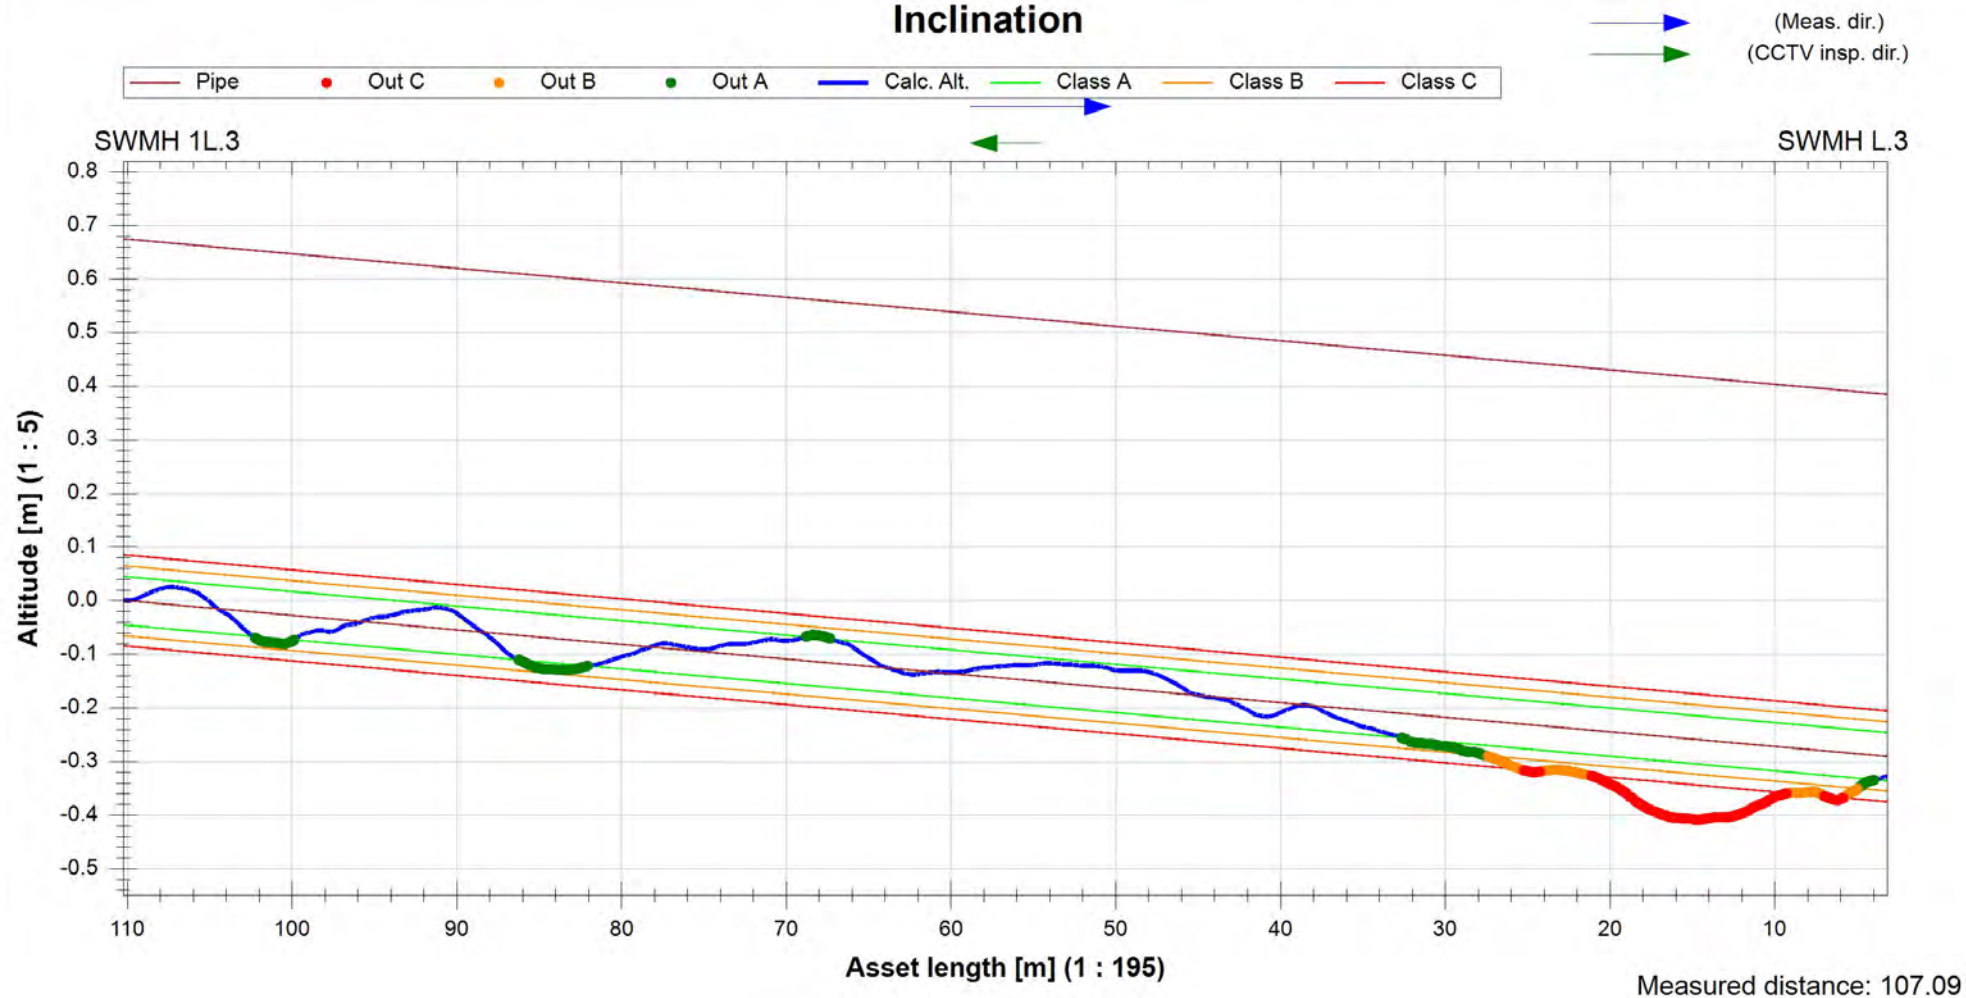
## Inclination

| <b>Asset No.</b><br>MH L.3 To MH 1L.3 | <b>Date</b><br>4/04/2023 | <b>Time</b><br>10:27 am | <b>Operator</b><br>CST Group | <b>Town or Suburb</b><br>Tokanui | <b>Road</b> | <b>Setup</b><br>Downstream node | <b>Surveyed Length</b><br>107.09 m |
| <b>Shape</b><br>Circular pipe | <b>Dia/Height</b><br>675 mm | <b>Width</b><br>675 mm | <b>U/S Node</b><br>SWMH 1L.3 | <b>D/S Node</b><br>SWMH L.3 | <b>Start altitude</b><br>0.000 m | <b>End altitude</b><br>-0.328 m | <b>Measured Inc</b><br>-0.306 % |

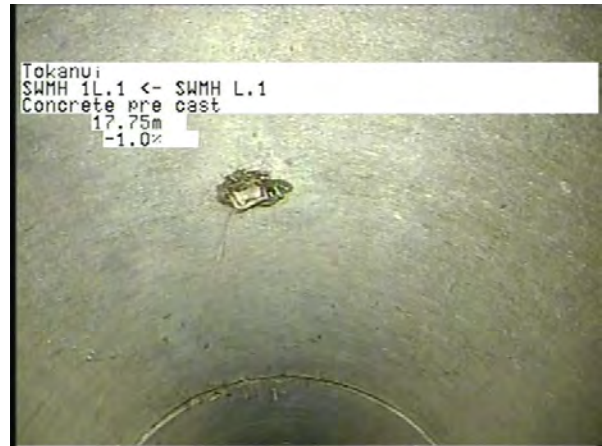
MH L.1 To MH  
1L.1\_f79701cd-4f67-44d8-b66a-579e775648a5\_20230404\_12  
0734\_042.jpg, 00:06:47, 17.75m

| 1:460 | m + | OC | Observation | MPEG | Photo | Score |
|---|---|---|---|---|---|---|
| | 17.75 | PHS | Pipe holed, the hole has been repaired at 12 o'clock | 00:06:49 | | 5 |

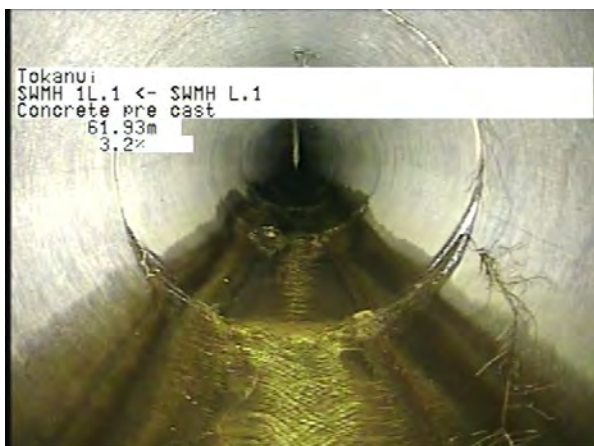
MH L.1 To MH  
1L.1\_3fb91a5d-147c-4c91-8f09-84a6609702d5\_20230404\_12  
1955\_441.jpg, 00:16:58, 61.93m

| 1:460 | m + | OC | Observation | MPEG | Photo | Score |
|---|---|---|---|---|---|---|
| | 61.93 | JFL | Joint faulty, major cracking or spalling, likely through the pipe wall from 3 o'clock to 9 o'clock / Tiny root protruding | 00:16:58 | MH L.1 To MH 1L.1_3fb9 | 25 |

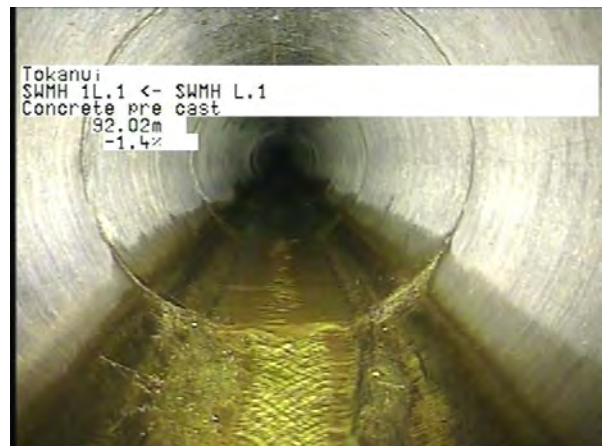
MH L.1 To MH  
1L.1\_ea5826bb-7cb9-4991-806a-6ca7d6780f5d\_20230404\_1  
23032\_106.jpg, 00:25:00, 92.02m

| 1:460 | m + | OC | Observation | MPEG | Photo | Score |
|---|---|---|---|---|---|---|
| | 92.02 | JFL | Joint faulty, major cracking or spalling, likely through the pipe wall from 4 o'clock to 7 o'clock / Roots protruding joint | 00:25:00 | MH L.1 To MH 1L.1_ea58 | 25 |

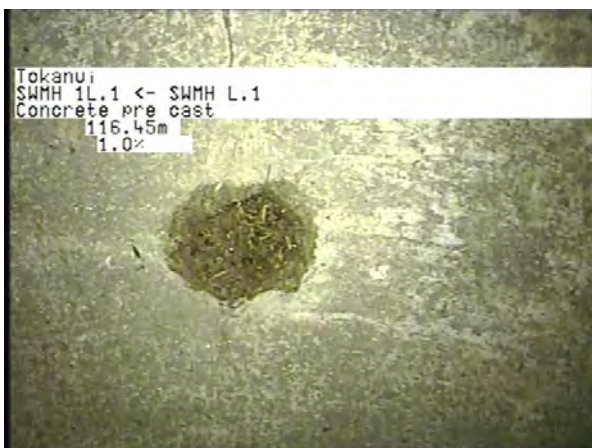
MH L.1 To MH  
1L.1\_62fc0495-b501-4df9-b61d-762ee3180e67\_20230404\_12  
3807\_495.jpg, 00:31:34, 116.45m

| 1:460 | m + | OC | Observation | MPEG | Photo | Score |
|---|---|---|---|---|---|---|
| | 116.45 | PHS | Pipe holed, the hole has been repaired at 12 o'clock | 00:31:34 | MH L.1 To<br>MH<br>1L.1_62fc0 | 5 |

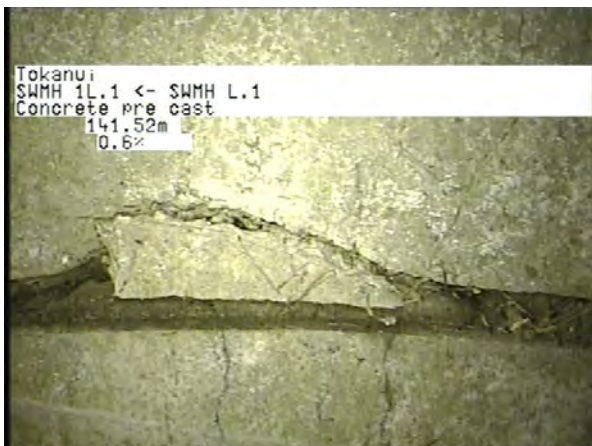
MH L.1 To MH  
1L.1\_b31ae029-cb6a-44cd-b78c-e27016cdda12\_20230404\_1  
24446\_180.jpg, 00:37:24, 141.52m

| 1:460 | m + | OC | Observation | MPEG | Photo | Score |
|---|---|---|---|---|---|---|
| | 141.52 | JFM | Joint faulty, medium cracking or spalling, unlikely through the pipe wall from 11 o'clock to 1 o'clock | 00:37:24 | MH L.1 To<br>MH<br>1L.1_b31a | 10 |

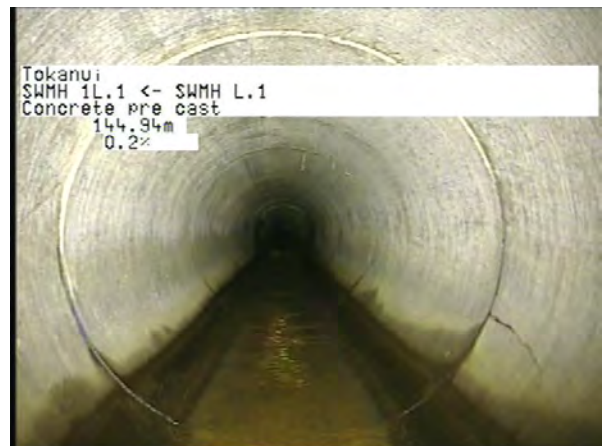
MH L.1 To MH  
1L.1\_7013948b-c463-4cad-98bf-244be2a26ba7\_20230404\_1  
24606\_202.jpg, 00:38:30, 144.94m

| 1:460 | m + | OC | Observation | MPEG | Photo | Score |
|---|---|---|---|---|---|---|
| | 144.94 | JFS | Joint faulty, minor cracking or spalling at 5 o'clock | 00:38:30 | MH L.1 To<br>MH<br>1L.1_7013 | 1 |

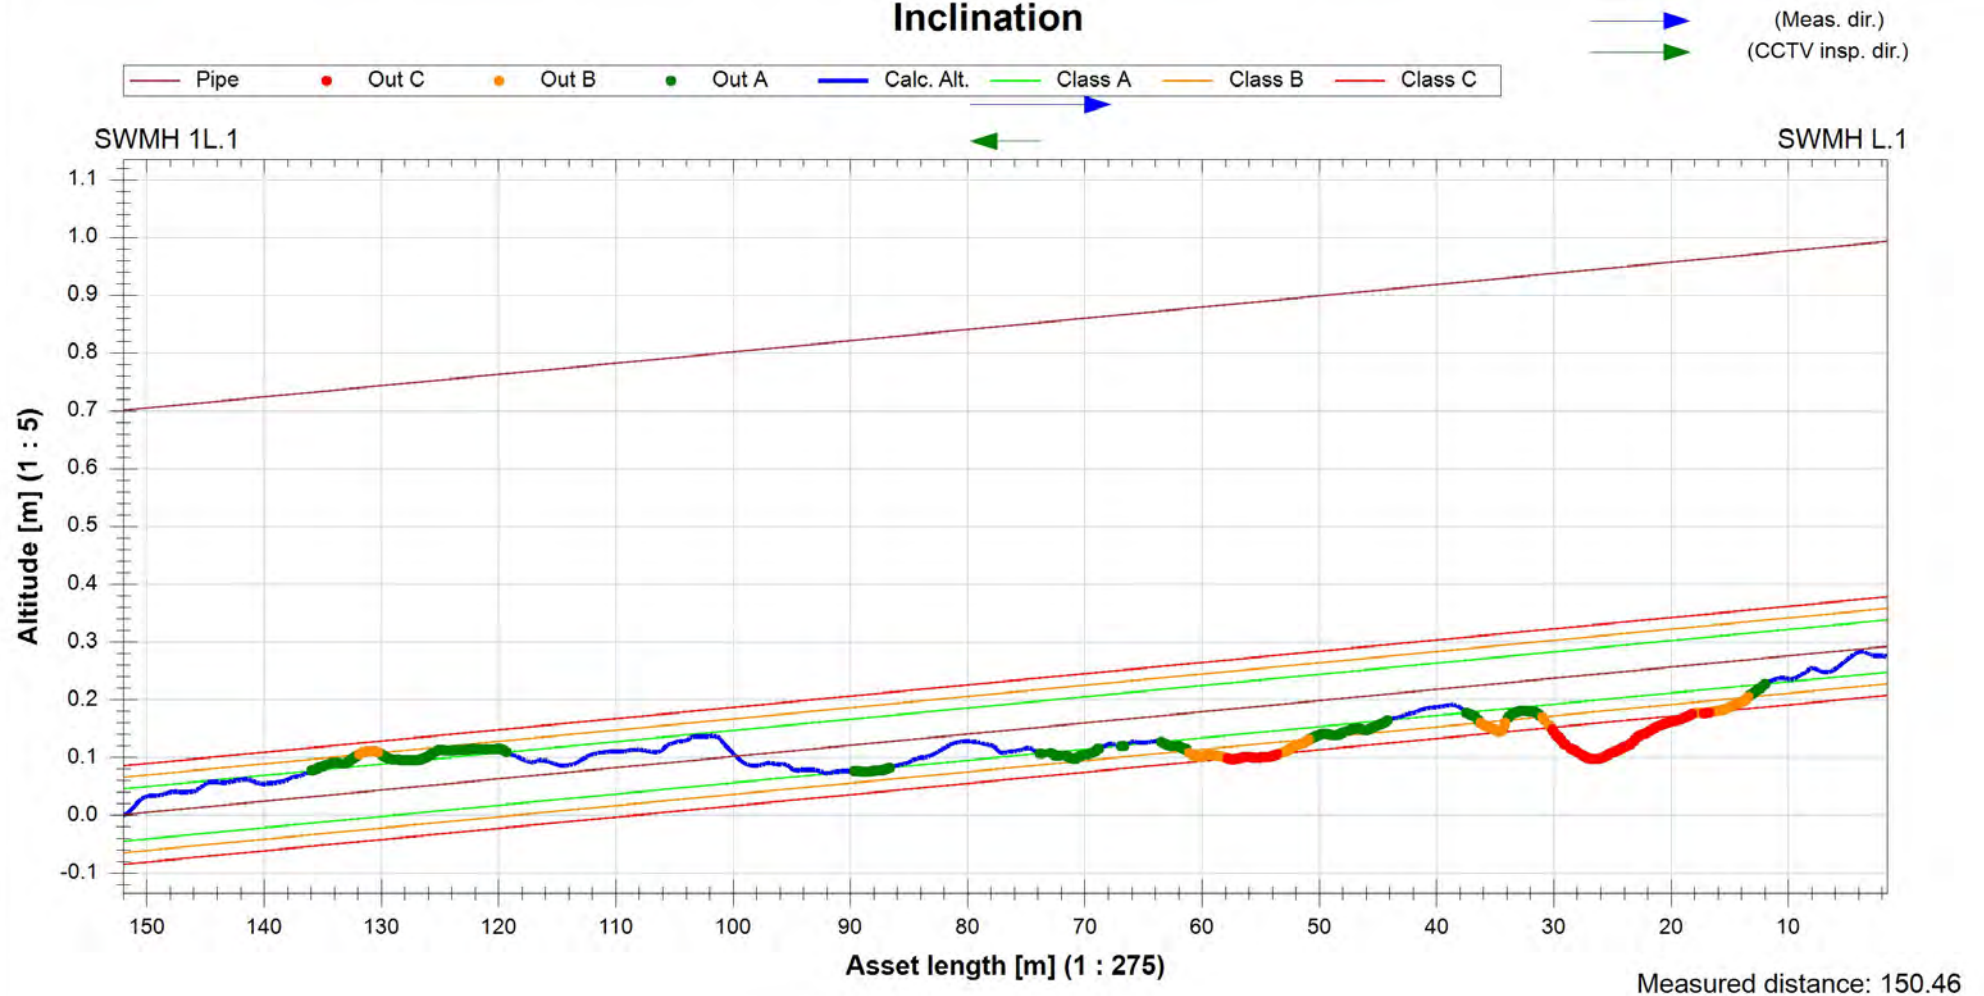
### Inclination

| Asset No.<br>MH L.1 To MH 1L.1 | Date<br>4/04/2023 | Time<br>11:59 am | Operator<br>CST Group | Town or Suburb<br>Tokanui | Road | Setup<br>Downstream node | Surveyed Length<br>150.46 m |
| Shape<br>Circular pipe | Dia/Height<br>700 mm | Width<br>700 mm | U/S Node<br>SWMH 1L.1 | D/S Node<br>SWMH L.1 | Start altitude<br>0.000 m | End altitude<br>0.276 m | Measured Inc<br>0.183 % |

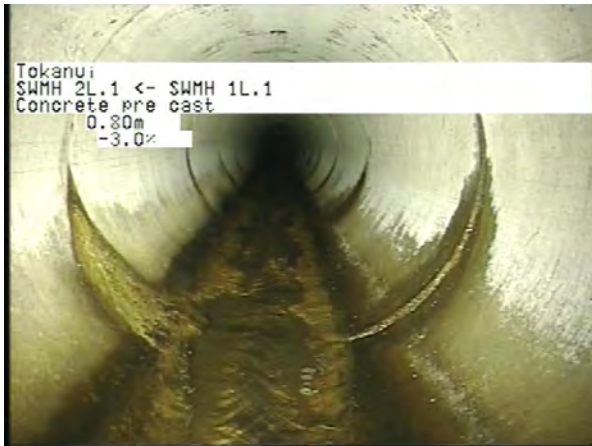
MH 1L.1 To MH  
2L.1\_d4559110-03d0-4742-ac00-2ab37aa6b3cb\_20230406\_1  
31950\_784.jpg, 00:00:57, 0.80m

| 1:408 | m + | OC | Observation | MPEG | Photo | Score |
|---|---|---|---|---|---|---|
| | 0.80 | DGS | Debris greasy, small, clear diameter is reduced by less than 10% from 5 o'clock to 7 o'clock | 00:00:57 | MH 1L.1 To MH 2L.1_d455 | 8 |

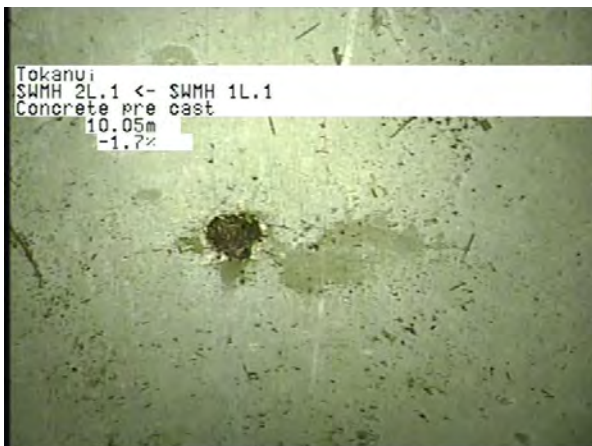
MH 1L.1 To MH  
2L.1\_eda2b90a-1d1c-4106-9b4f-754491419473\_20230406\_1  
32413\_569.jpg, 00:03:53, 10.05m

| 1:408 | m + | OC | Observation | MPEG | Photo | Score |
|---|---|---|---|---|---|---|
| | 10.05 | PHS | Pipe holed, the hole has been repaired from 11 o'clock to 1 o'clock / Faulty lifting eye | 00:03:53 | MH 1L.1 To MH 2L.1_eda2 | 5 |

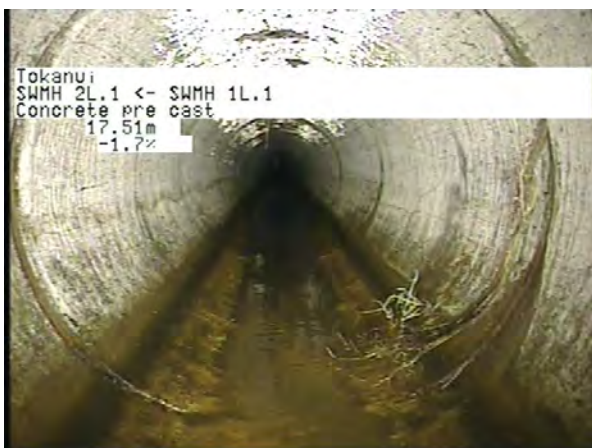
MH 1L.1 To MH  
2L.1\_1fe58d7c-9b98-4df4-9b4c-a75e3ba0233c\_20230406\_13  
2700\_939.jpg, 00:06:22, 17.51m

| 1:408 | m + | OC | Observation | MPEG | Photo | Score |
|---|---|---|---|---|---|---|
| | 17.51 | JFL | Joint faulty, major cracking or spalling, likely through the pipe wall from 2 o'clock to 7 o'clock / Roots protruding joint | 00:06:22 | MH 1L.1 To MH 2L.1_1fe5 | 25 |

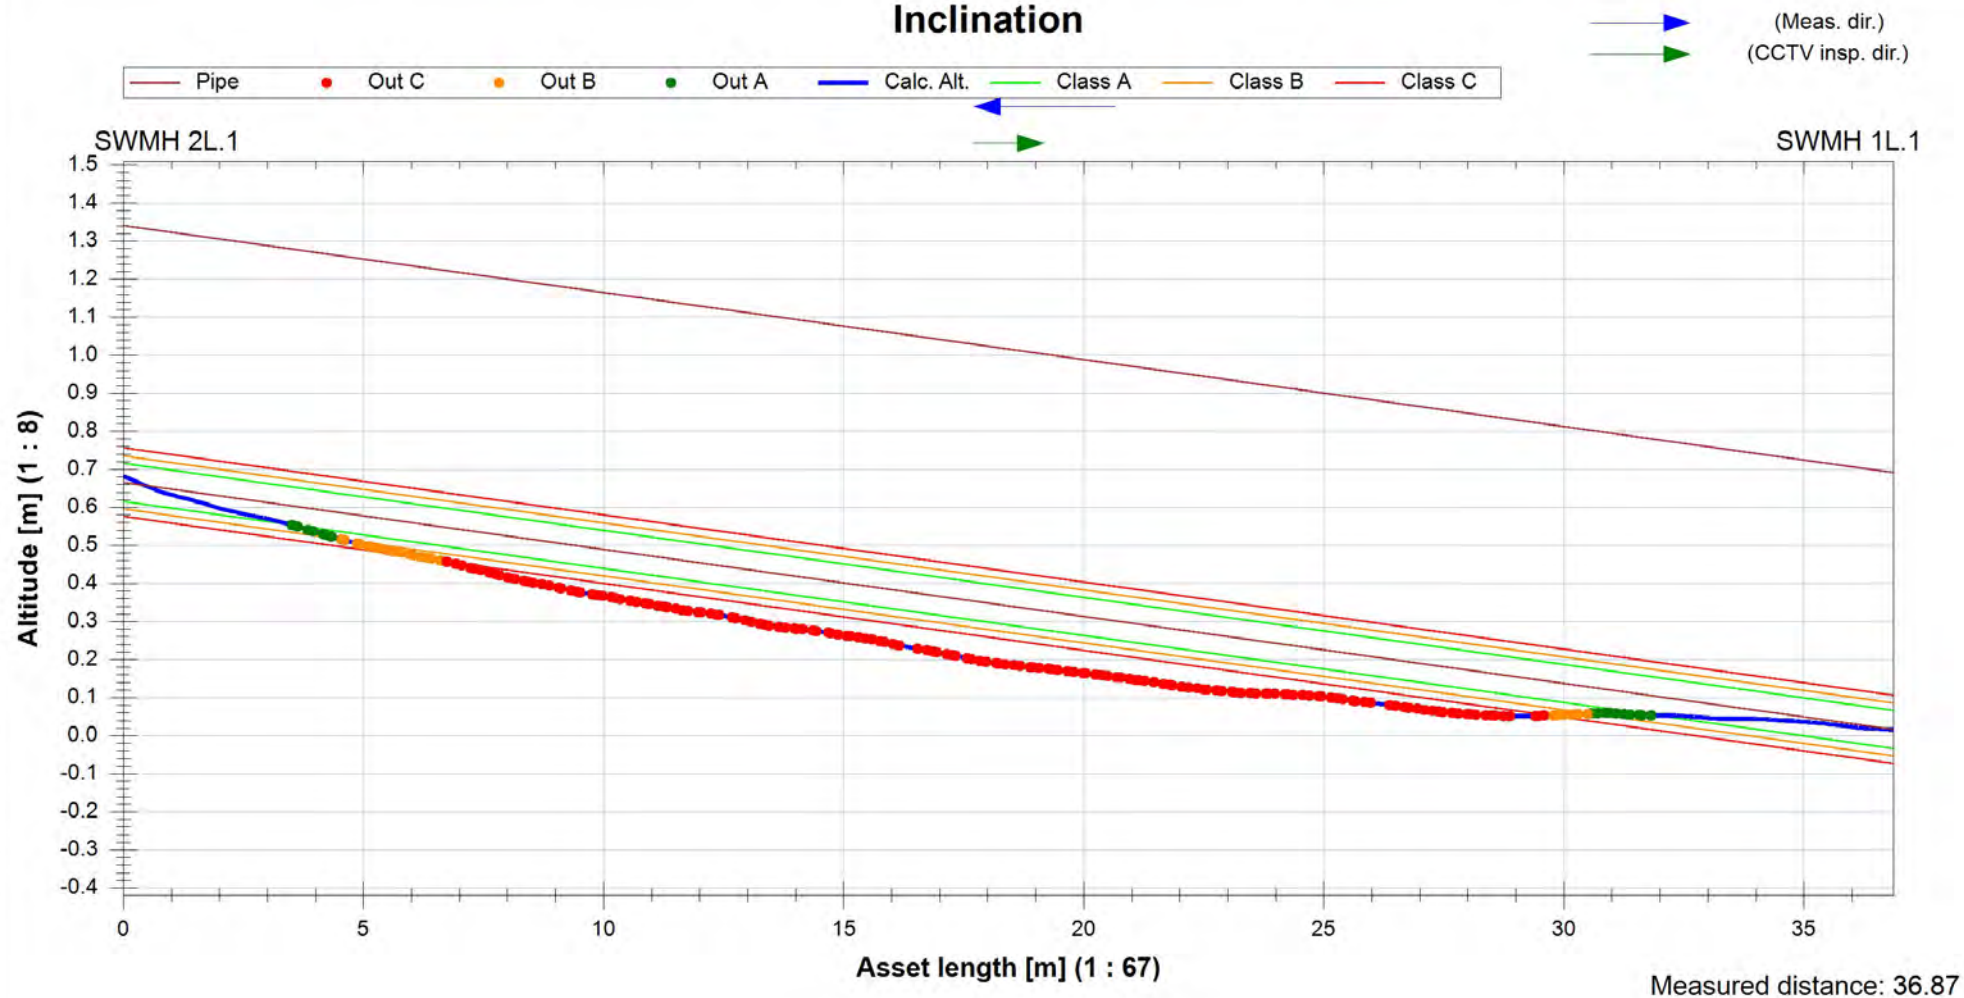
## Inclination

| Asset No.<br>MH 1L.1 To MH 2L.1 | Date<br>6/04/2023 | Time<br>1:18 pm | Operator<br>CST Group | Town or Suburb<br>Tokanui | Road | Setup<br>Upstream node | Surveyed Length<br>36.87 m |
| Shape<br>Circular pipe | Dia/Height<br>675 mm | Width<br>675 mm | U/S Node<br>SWMH 2L.1 | D/S Node<br>SWMH 1L.1 | Start altitude<br>0.016 m | End altitude<br>0.682 m | Measured Inc<br>-1.806 % |

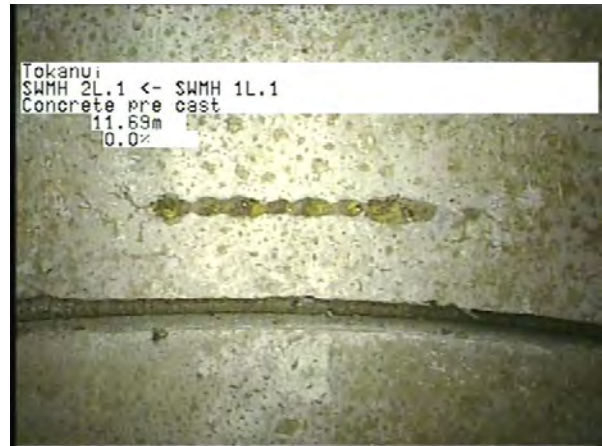
MH 1L.1 To MH  
 2L.1\_9c730f4d-16b9-4017-8de4-735069fda835\_20230404\_12  
 5529\_719.jpg, 00:02:51, 11.69m

| 1:406 | m + | OC | Observation | MPEG | Photo | Score |
|---|---|---|---|---|---|---|
| | 11.69 | SDS | Surface damage, superficial only, cement Lining spalled from steel pipe from 11 o'clock to 1 o'clock | 00:02:51 | MH 1L.1<br>To MH<br>2L.1_9c73 | 3 |

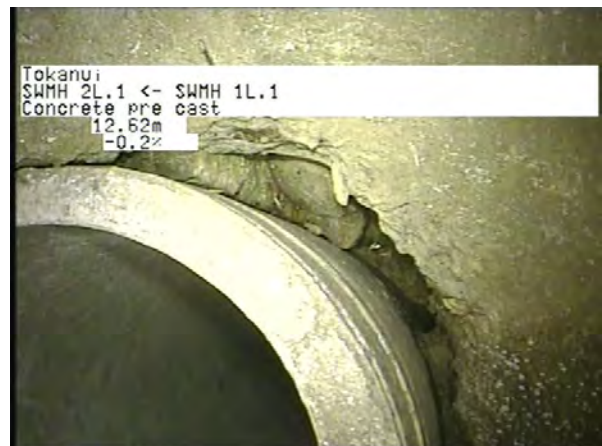
MH 1L.1 To MH  
 2L.1\_324b1f6d-28ae-4dbf-a417-5cecea7b1012\_20230404\_12  
 5708\_954.jpg, 00:03:56, 12.62m

| 1:406 | m + | OC | Observation | MPEG | Photo | Score |
|---|---|---|---|---|---|---|
| | 12.62 | LFL | Lateral sealing faulty, evidence exist that the connection between the lateral and the main pipe is leaking at 2 o'clock | 00:03:56 | MH 1L.1<br>To MH<br>2L.1_324b | 25 |

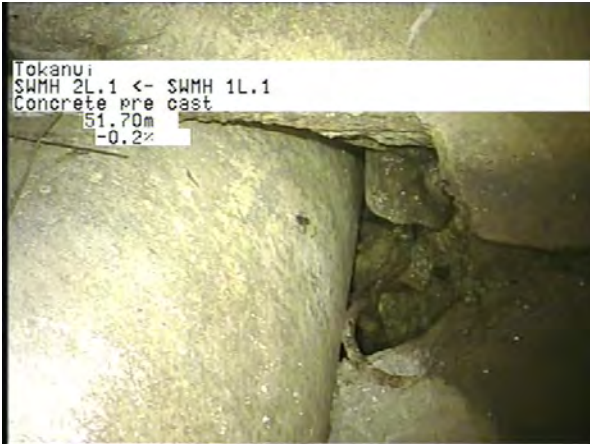
MH 1L.1 To MH  
 2L.1\_d2d5e66b-6c21-4dc5-809b-275de36f7b36\_20230404\_1  
 30832\_089.jpg, 00:13:37, 51.71m

| 1:406 | m + | OC | Observation | MPEG | Photo | Score | | | |
|---|---|---|---|---|---|---|---|---|---|
| | 51.71 | LFL | Lateral sealing faulty, evidence exist that the connection between the lateral and the main pipe is leaking at 3 o'clock | 00:13:37 | MH 1L.1<br>To MH<br>2L.1_d2d5 | 25 | | | |

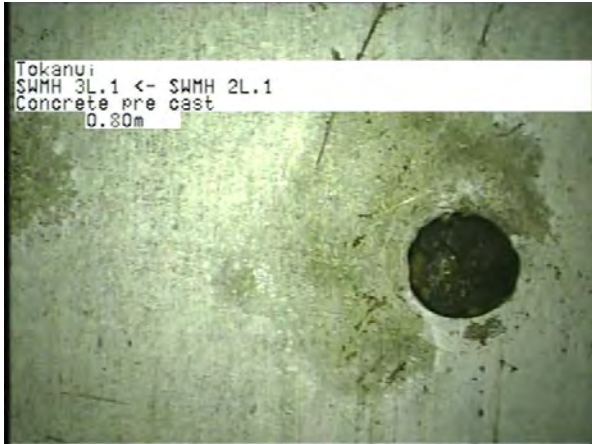
MH 2L.1 To MH  
3L.1\_b20df469-94c0-402b-8b8c-79a977d35bfc\_20230406\_11  
5653\_807.jpg, 00:00:18, 0.80m

| Comments | | | | | | |
|---|---|---|---|---|---|---|
| | 0.80 | CF | Construction feature at 12 o'clock / Lifting eye | 00:00:18 | MH 2L.1 To MH 3L.1_b20d | |

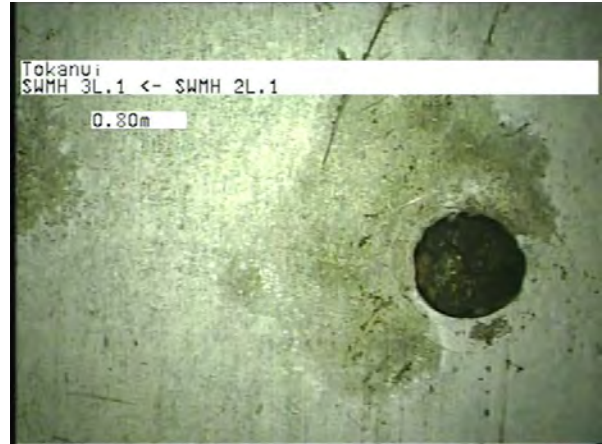
MH 2L.1 To MH  
3L.1\_f3e577a9-28ba-4560-b89e-0da46a5d7ccd\_20230406\_1  
15700\_124.jpg, 00:00:19, 0.80m

| Comments | | | | | | |
|---|---|---|---|---|---|---|
| | 0.80 | PHS | Pipe holed, the hole has been repaired at 12 o'clock | 00:00:19 | MH 2L.1 To MH 3L.1_f3e5 | 5 |

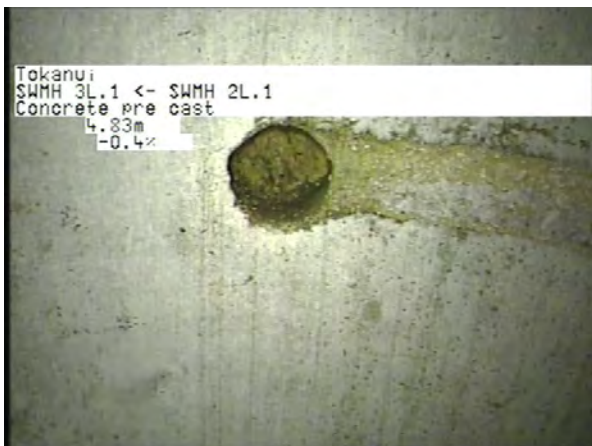
MH 2L.1 To MH  
3L.1\_9af431fd-b2b1-4d42-a45b-882d6635cdf3\_20230406\_11  
5851\_257.jpg, 00:01:57, 4.83m

| Comments | | | | | | |
|---|---|---|---|---|---|---|
| | 4.83 | S01 PHS | Pipe holed, the hole has been repaired from 11 o'clock to 1 o'clock, start / Lifting eye | 00:01:57 | MH 2L.1 To MH 3L.1_9af4 | |

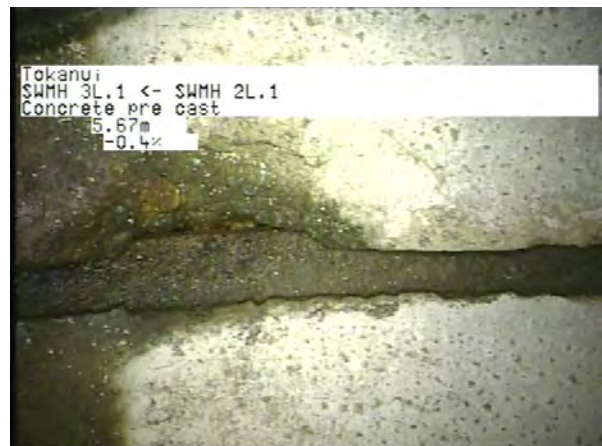
MH 2L.1 To MH  
3L.1\_e35f5190-348a-4a58-bd9f-28573eeeee306\_20230406\_11  
5942\_547.jpg, 00:02:41, 5.67m

| Comments | | | | | | |
|---|---|---|---|---|---|---|
| | 5.67 | JFS | Joint faulty, minor cracking or spalling from 7 o'clock to 9 o'clock | 00:02:41 | MH 2L.1 To MH 3L.1_e35f | 1 |

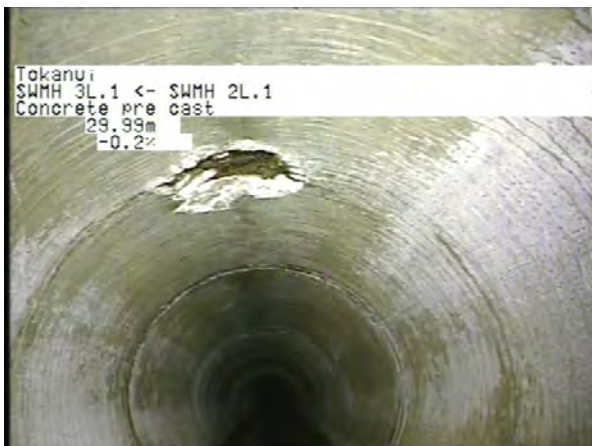
MH 2L.1 To MH  
3L.1\_eba0790a-3924-4b26-907a-3cd8429df09d\_20230406\_1  
20730\_087.jpg, 00:09:52, 29.99m

| Comments | | | | | | |
|---|---|---|---|---|---|---|
| | 29.99 | PHM | Pipe holed, the hole is up to 20% of the pipe circumference and has not been repaired from 11 o'clock to 1 o'clock | 00:09:52 | MH 2L.1 To MH 3L.1_eba0 | 25 |

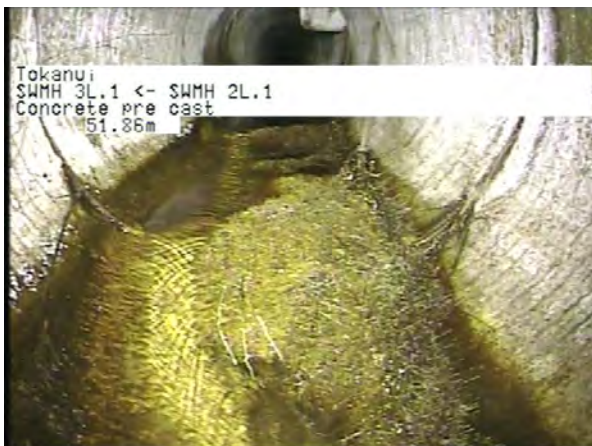
MH 2L.1 To MH  
3L.1\_a3cc5103-f815-4127-be36-5974781bb71f\_20230406\_12  
1434\_603.jpg, 00:16:05, 51.86m

| Comments | | | | | | |
|---|---|---|---|---|---|---|
| | 51.86 | JFL | Joint faulty, major cracking or spalling, likely through the pipe wall from 4 o'clock to 8 o'clock / Roots protruding joint | 00:16:05 | MH 2L.1 To MH 3L.1_a3cc | 25 |

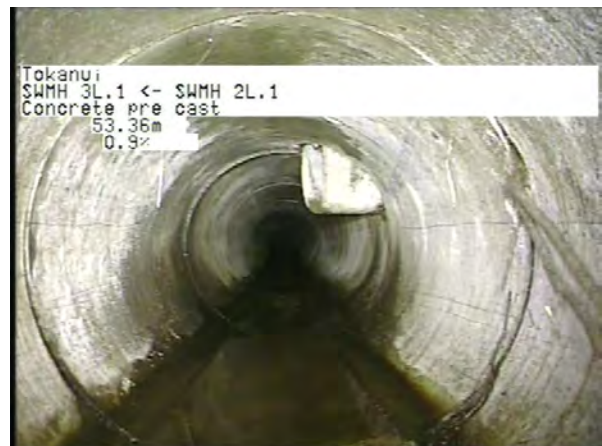
MH 2L.1 To MH  
3L.1\_da89f198-a029-4dd7-9e50-f13d7dbff8b4\_20230406\_121  
540\_689.jpg, 00:17:02, 53.36m

| Comments | | | | | | |
|---|---|---|---|---|---|---|
| | 53.36 | JFL | Joint faulty, major cracking or spalling, likely through the pipe wall from 2 o'clock to 7 o'clock / Roots protruding joint | 00:17:02 | MH 2L.1 To MH 3L.1_da89 | 25 |

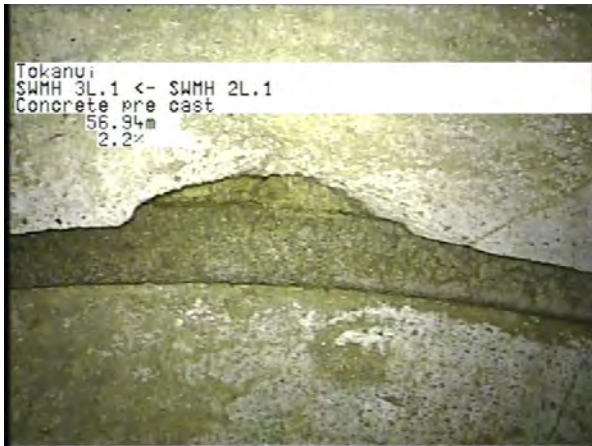
MH 2L.1 To MH  
3L.1\_61a6279a-f437-4444-93b9-dfccaec0b7e\_20230406\_12  
1716\_659.jpg, 00:18:08, 56.94m

| 1:459 | m + | OC | Observation | MPEG | Photo | Score |
|---|---|---|---|---|---|---|
| | 56.94 | JFM | Joint faulty, medium cracking or spalling, unlikely through the pipe wall from 1 o'clock to 3 o'clock | 00:18:08 | MH 2L.1<br>To MH<br>3L.1_61a6 | 10 |

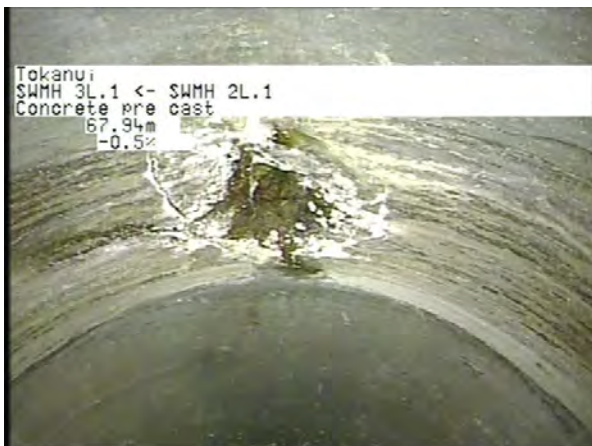
MH 2L.1 To MH  
3L.1\_03b9ea51-5a63-4fa5-8fff-331a83bb6ca2\_20230406\_122  
114\_253.jpg, 00:21:48, 67.94m

| 1:459 | m + | OC | Observation | MPEG | Photo | Score |
|---|---|---|---|---|---|---|
| | 67.94 | PHM | Pipe holed, the hole is up to 20% of the pipe circumference and has not been repaired at 12 o'clock | 00:21:48 | MH 2L.1<br>To MH<br>3L.1_03b9 | 25 |

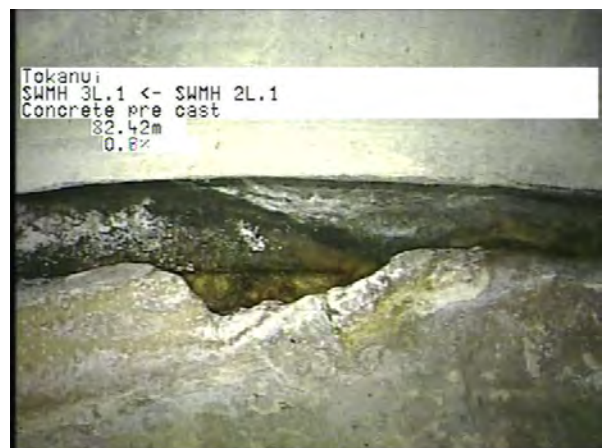
MH 2L.1 To MH  
3L.1\_076b8fb5-4238-4183-b4a1-5861ccafb161\_20230406\_12  
2456\_980.jpg, 00:25:16, 82.42m

| 1:459 | m + | OC | Observation | MPEG | Photo | Score |
|---|---|---|---|---|---|---|
| | 82.42 | JFM | Joint faulty, medium cracking or spalling, unlikely through the pipe wall from 10 o'clock to 12 o'clock | 00:25:16 | MH 2L.1<br>To MH<br>3L.1_076b | 10 |

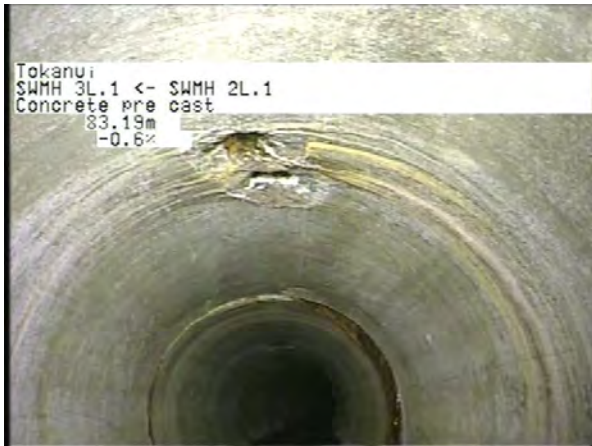
MH 2L.1 To MH  
 3L.1\_cfd606d4-2baa-4957-9a26-e42d5893397a\_20230406\_1  
 22520\_992.jpg, 00:25:35, 83.19m

| 1:459 | m + | OC | Observation | MPEG | Photo | Score |
|---|---|---|---|---|---|---|
| | 83.19 | PHM | Pipe holed, the hole is up to 20% of the pipe circumference and has not been repaired from 11 o'clock to 1 o'clock | 00:25:35 | MH 2L.1<br>To MH<br>3L.1_cfd60 | 25 |

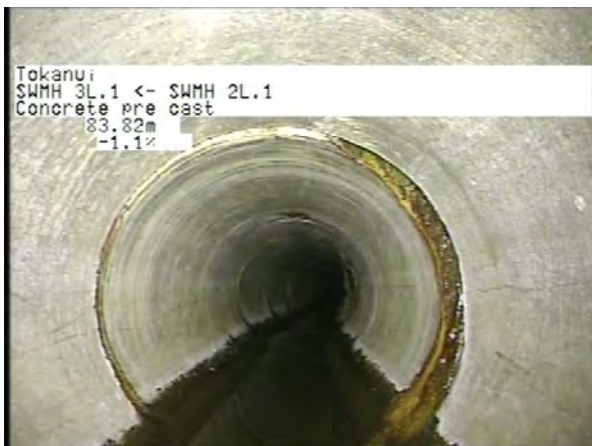
MH 2L.1 To MH  
 3L.1\_13f3426a-5d68-482f-85e6-5cdaf74485b9\_20230406\_12  
 2629\_068.jpg, 00:26:38, 83.82m

| 1:459 | m + | OC | Observation | MPEG | Photo | Score |
|---|---|---|---|---|---|---|
| | 83.82 | JFL | Joint faulty, major cracking or spalling, likely through the pipe wall from 12 o'clock to 10 o'clock | 00:26:38 | MH 2L.1<br>To MH<br>3L.1_13f3 | 25 |

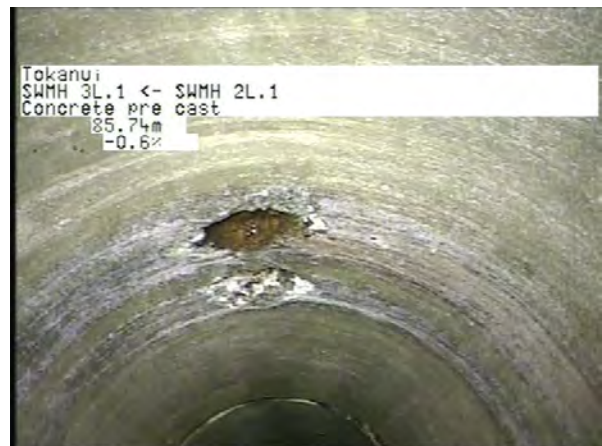
MH 2L.1 To MH  
 3L.1\_72767a2a-11d7-4fb3-a775-4c123d77f17e\_20230406\_12  
 2646\_970.jpg, 00:26:51, 85.74m

| 1:459 | m + | OC | Observation | MPEG | Photo | Score |
|---|---|---|---|---|---|---|
| | 85.74 | PHM | Pipe holed, the hole is up to 20% of the pipe circumference and has not been repaired at 12 o'clock | 00:26:51 | MH 2L.1<br>To MH<br>3L.1_7276 | 25 |
