**RE: Information Requested – LU/0231/24 & LU/0232/24 Former Tokanui  
Psychiatric Hospital**

FORMER TOKANUI HOSPITAL  
DEMOLITION AND REMEDIATION  
DEMOLITION, DECONSTRUCTION & REMEDIATION  
MANAGEMENT PLAN - DRAFT

Toitū Te Whenua Land Information New Zealand  
 Demolition Management Plan  
 Former Tokanui Hospital Demolition and Remediation Project  
 Tokanui  
 Te Awamutu

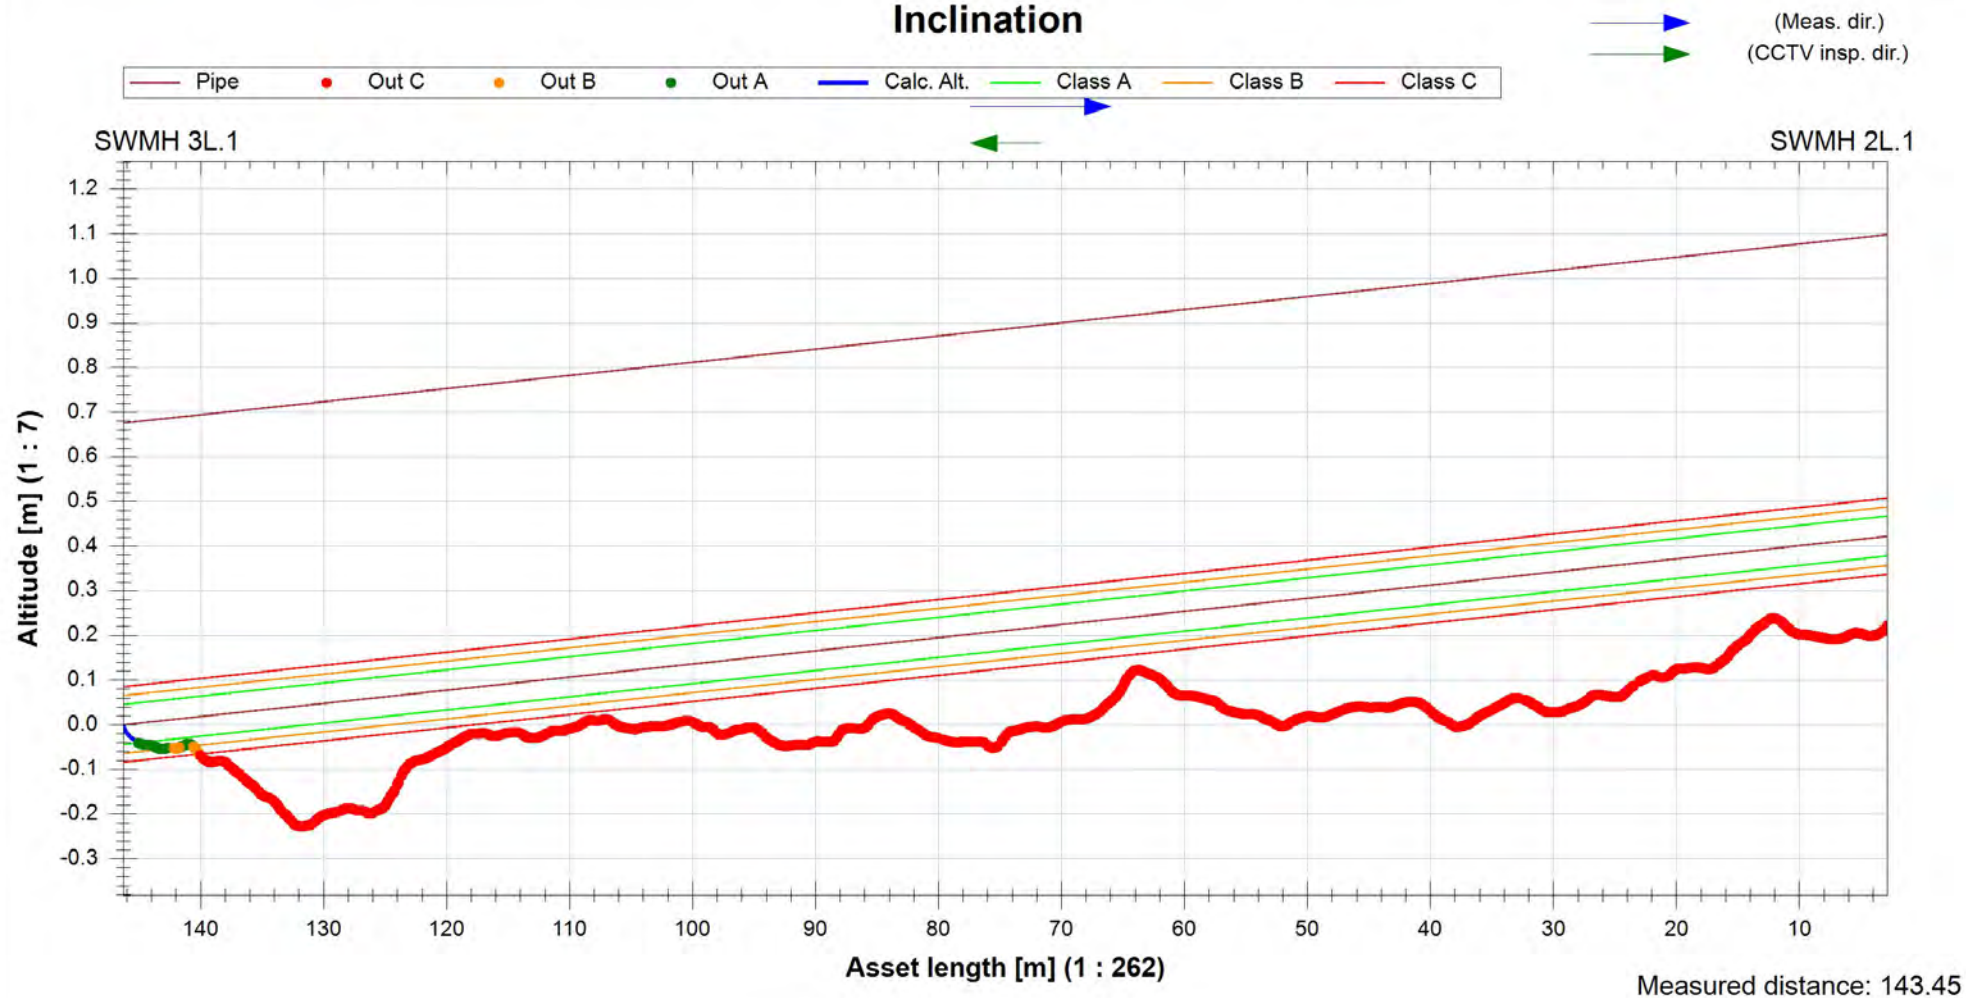
### Inclination

| <b>Shape</b><br>Circular pipe | <b>Dia/Height</b><br>675 mm | <b>Width</b><br>675 mm | <b>U/S Node</b><br>SWMH 3L.1 | <b>D/S Node</b><br>SWMH 2L.1 | <b>Start altitude</b><br>0.000 m | <b>End altitude</b><br>0.221 m | <b>Measured Inc</b><br>0.154 % |

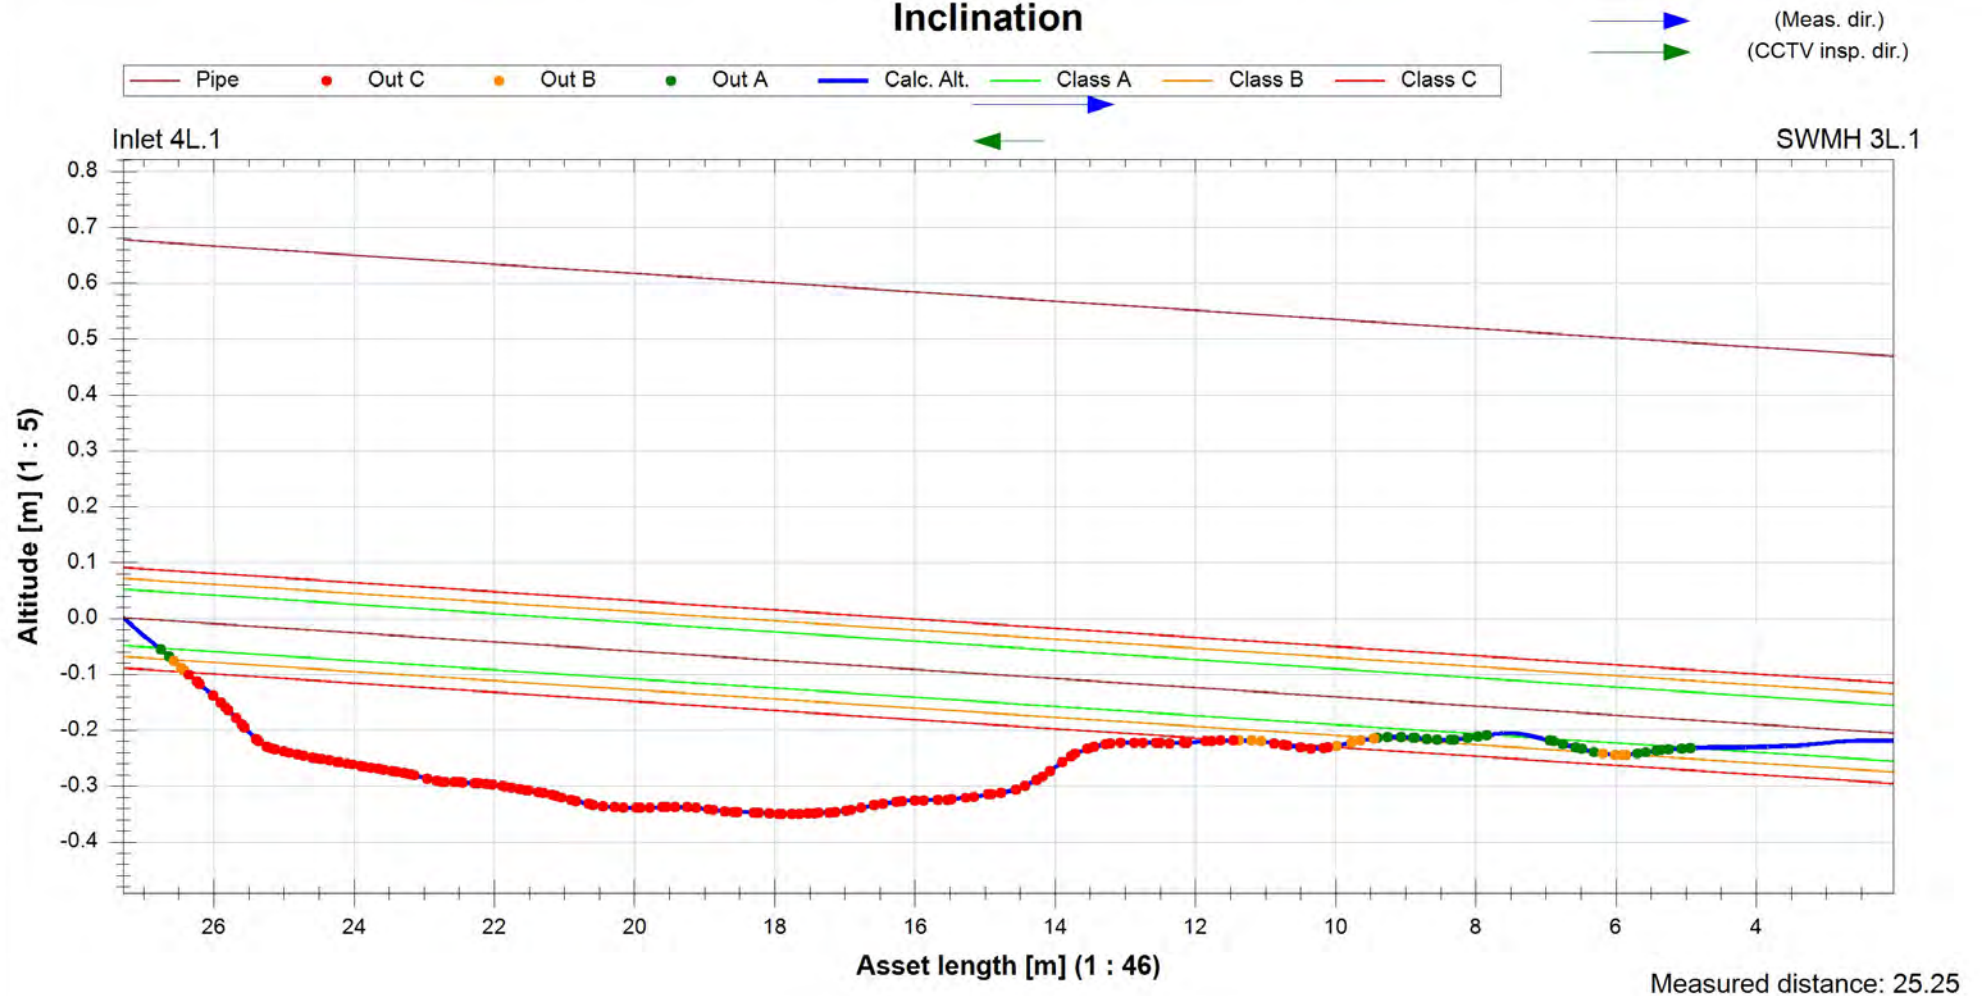
## Inclination

| <b>Shape</b><br>Circular pipe | <b>Dia/Height</b><br>675 mm | <b>Width</b><br>675 mm | <b>U/S Node</b><br>Inlet 4L.1 | <b>D/S Node</b><br>SWMH 3L.1 | <b>Start altitude</b><br>0.002 m | <b>End altitude</b><br>-0.219 m | <b>Measured Inc</b><br>-0.871 % |

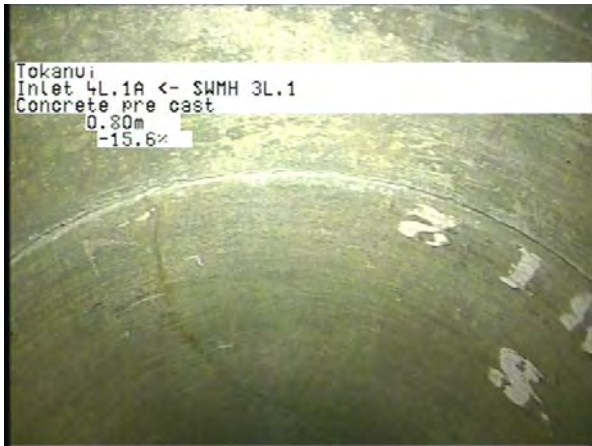
MH 3L.1 To 4L.1A  
Inlet\_6e2fd88e-489a-4334-925a-5ea1c237ff7c\_20230406\_14  
2434\_799.jpg, 00:00:36, 0.80m

| 1:329 | m + | OC | Observation | MPEG | Photo | Score | | | |
|---|---|---|---|---|---|---|---|---|---|
| | 0.80 | JFS | Joint faulty, minor cracking or spalling at 11 o'clock | 00:00:36 | MH 3L.1<br>To 4L.1A<br>Inlet_6e2fd | 1 | | | |

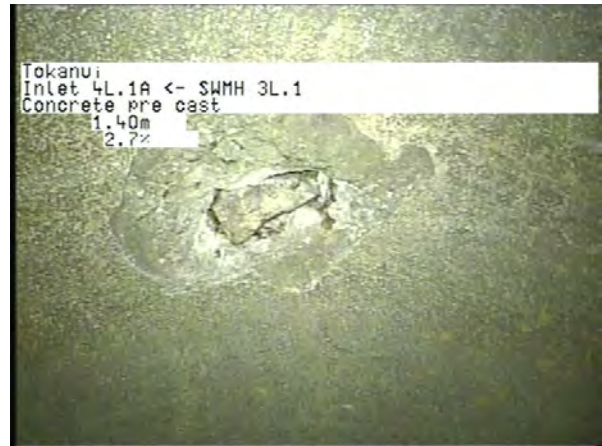
MH 3L.1 To 4L.1A  
Inlet\_ff668f9b-7c2e-42c4-b980-c91699fd68e9\_20230406\_142  
518\_512.jpg, 00:01:01, 1.40m

| 1:329 | m + | OC | Observation | MPEG | Photo | Score | | | |
|---|---|---|---|---|---|---|---|---|---|
| | 1.40 | PHS | Pipe holed, the hole has been repaired from 11 o'clock to 1 o'clock | 00:01:01 | MH 3L.1<br>To 4L.1A<br>Inlet_ff668 | 5 | | | |

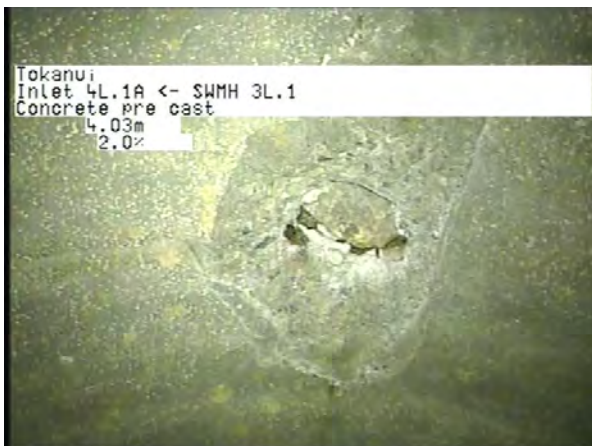
MH 3L.1 To 4L.1A  
Inlet\_996a0ca0-0fb5-4ab1-8c77-3beade6c34b4\_20230406\_14  
2602\_793.jpg, 00:01:36, 4.03m

| 1:329 | m + | OC | Observation | MPEG | Photo | Score | | | |
|---|---|---|---|---|---|---|---|---|---|
| | 4.03 | S01 PHS | Pipe holed, the hole has been repaired from 11 o'clock to 1 o'clock, start / Faulty lifting eye | 00:01:36 | MH 3L.1<br>To 4L.1A<br>Inlet_996a | | | | |

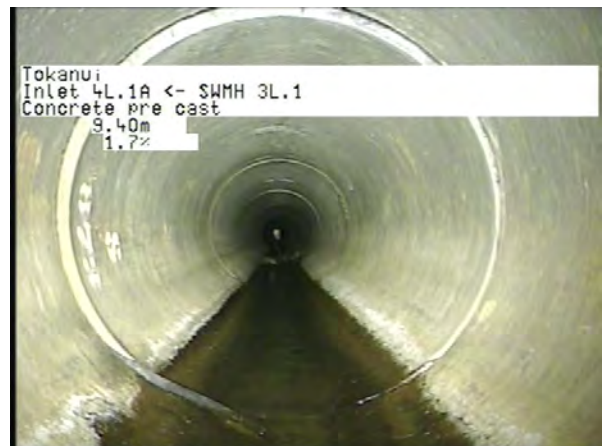
MH 3L.1 To 4L.1A  
Inlet\_47aebede-4187-4981-a74e-e369e4ee9c31\_20230406\_1  
42704\_666.jpg, 00:02:26, 9.40m

| 1:329 | m + | OC | Observation | MPEG | Photo | Score | | | |
|---|---|---|---|---|---|---|---|---|---|
| | 9.40 | JFL | Joint faulty, major cracking or spalling, likely through the pipe wall from 6 o'clock to 9 o'clock / Rubber seal out | 00:02:26 | MH 3L.1<br>To 4L.1A<br>Inlet_47ae | 25 | | | |

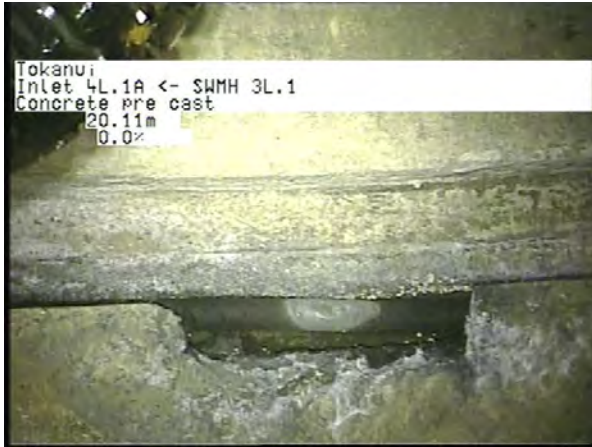
MH 3L.1 To 4L.1A  
Inlet\_87e499ee-67c2-4bf4-9c4e-d0c141d2ad9f\_20230406\_14  
3037\_117.jpg, 00:05:22, 20.11m

| 1:329 | m + | OC | Observation | MPEG | Photo | Score | | | |
|---|---|---|---|---|---|---|---|---|---|
| | 20.11 | JFL | Joint faulty, major cracking or spalling, likely through the pipe wall from 8 o'clock to 10 o'clock | 00:05:22 | MH 3L.1<br>To 4L.1A<br>Inlet_87e4 | 25 | | | |

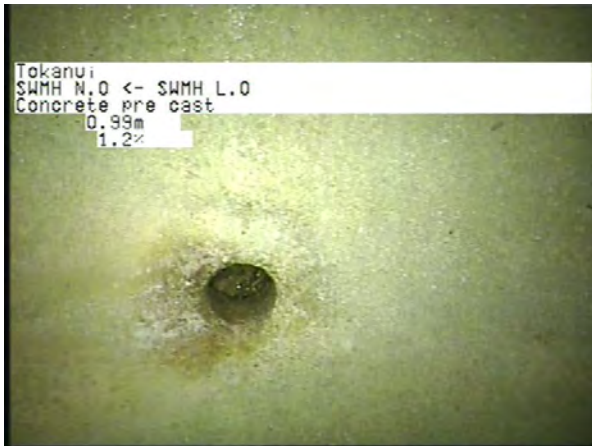
MH L.0 To MH  
N.O\_d86cde5e-42e8-4368-8579-a99ad8755ca5\_20230406\_15  
2537\_334.jpg, 00:00:25, 0.99m

| 1:611 | m + | OC | Observation | MPEG | Photo | Score |
|---|---|---|---|---|---|---|
| | 0.99 | S01 PHS | Pipe holed, the hole has been repaired at 12 o'clock, start / Lifting eyes faulty, seeping water | 00:00:25 | MH L.0 To MH N.0_d86cd | |

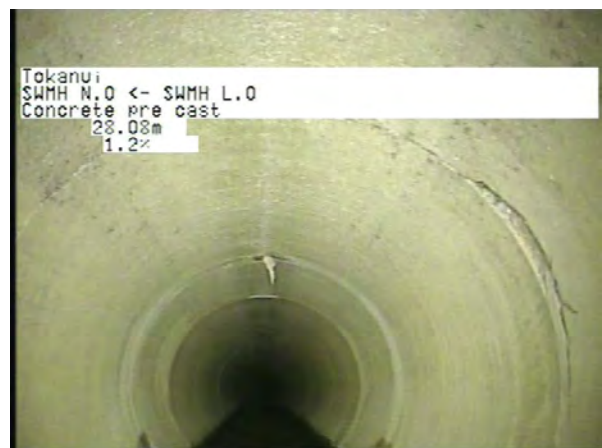
MH L.0 To MH  
N.O\_84f4b8db-3f8a-488a-96d1-36db2789082d\_20230406\_15  
3157\_560.jpg, 00:05:59, 28.08m

| 1:611 | m + | OC | Observation | MPEG | Photo | Score |
|---|---|---|---|---|---|---|
| | 28.08 | JFS | Joint faulty, minor cracking or spalling from 1 o'clock to 3 o'clock | 00:05:59 | MH L.0 To MH N.0_84f4b | 1 |

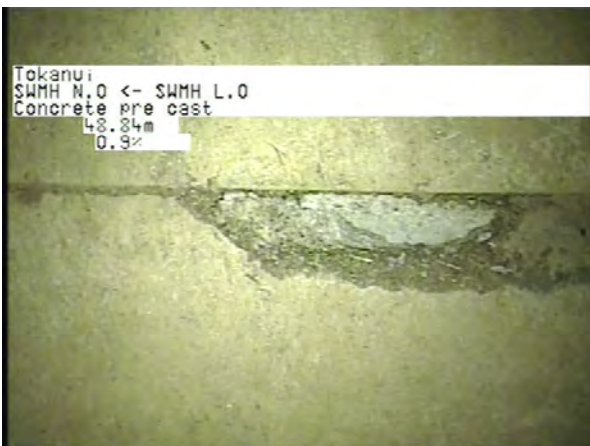
MH L.0 To MH  
 N.0\_bdf7bd39-fd77-4658-863c-e918b1a400a8\_20230406\_15  
 3452\_225.jpg, 00:08:37, 48.84m

| 1:611 | m + | OC | Observation | MPEG | Photo | Score |
|---|---|---|---|---|---|---|
| | 48.84 | JFS | Joint faulty, minor cracking or spalling from 12 o'clock to 2 o'clock | 00:08:37 | MH L.0 To MH N.0_bdf7b | 1 |

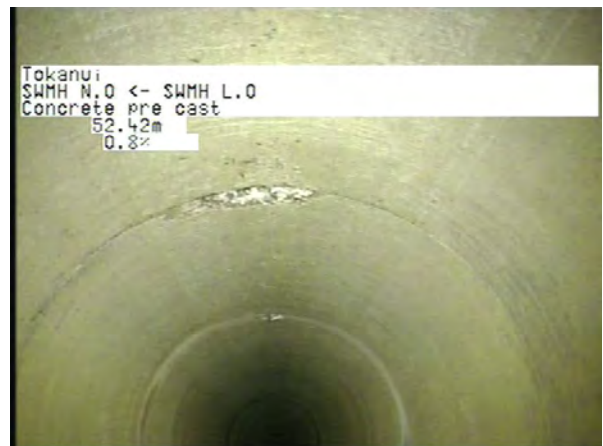
MH L.0 To MH  
 N.0\_f1a43aad-f720-4bba-89eb-06cf6aa0544d\_20230406\_153  
 541\_152.jpg, 00:09:21, 52.42m

| 1:611 | m + | OC | Observation | MPEG | Photo | Score |
|---|---|---|---|---|---|---|
| | 52.42 | JFS | Joint faulty, minor cracking or spalling from 11 o'clock to 1 o'clock | 00:09:21 | MH L.0 To MH N.0_f1a43 | 1 |

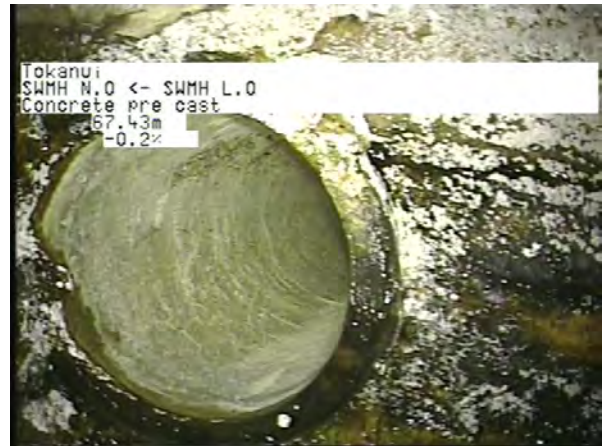
MH L.0 To MH  
N.0\_8ef91109-dd1e-48f5-b4a7-1bee298a1b75\_20230406\_153811\_012.jpg, 00:11:18, 67.43m

| 1:611 | m + | OC | Observation | MPEG | Photo | Score |
|---|---|---|---|---|---|---|
| | 67.43 | LXM | Lateral problem, medium defect at 2 o'clock / Constant water trickling in | 00:11:18 | MH L.0 To MH N.0_8ef91 | 20 |

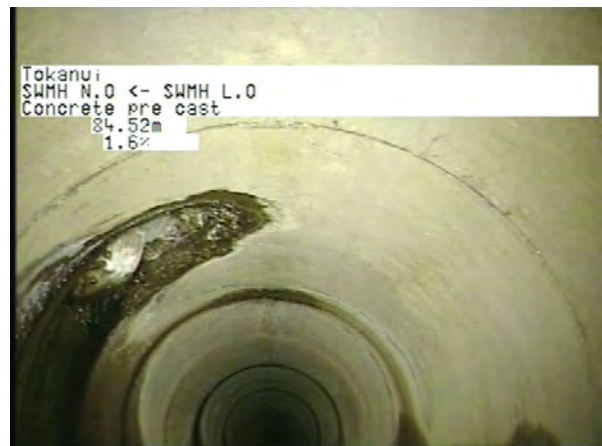
MH L.0 To MH  
N.0\_c8ce0c33-58b0-487e-8ed6-a217ba6b1107\_20230406\_154114\_388.jpg, 00:14:06, 84.52m

| 1:611 | m + | OC | Observation | MPEG | Photo | Score | | | |
|---|---|---|---|---|---|---|---|---|---|
| | 84.52 | CF | Construction feature from 9 o'clock to 11 o'clock / Lateral connection | 00:14:06 | MH L.0 To MH N.0_c8ce0 | | | | |

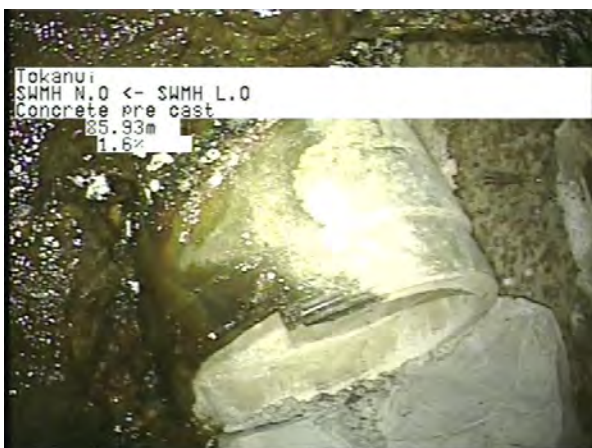
MH L.0 To MH  
N.0\_e4918654-d695-4254-a153-06d53a8b685d\_20230406\_154149\_638.jpg, 00:14:26, 85.93m

| 1:611 | m + | OC | Observation | MPEG | Photo | Score | | | |
|---|---|---|---|---|---|---|---|---|---|
| | 85.93 | LFM | Lateral sealing faulty, gaps between the lateral pipe and the main pipe that appear open at 10 o'clock / Water seeping in around lateral | 00:14:26 | MH L.0 To MH N.0_e4918 | 10 | | | |

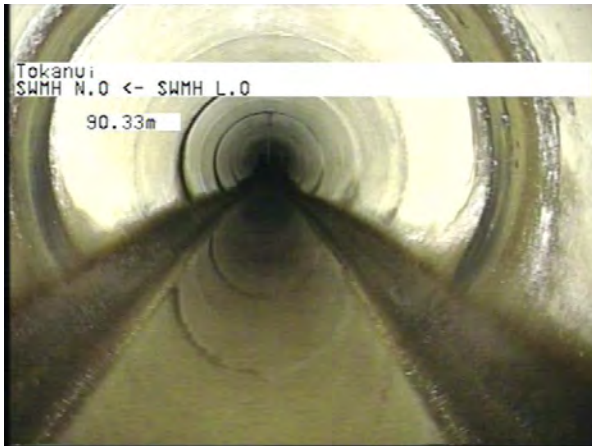
MH L.0 To MH  
N.0\_69e208ac-ab81-40d5-bae9-4e431ffb17ef\_20230406\_154  
329\_172.jpg, 00:15:45, 90.33m

| 1:611 | m + | OC | Observation | MPEG | Photo | Score | | | |
|---|---|---|---|---|---|---|---|---|---|
| | 90.33 | GC | General comment / General condition photo | 00:15:45 | MH L.0 To MH N.0_69e20 | | | | |

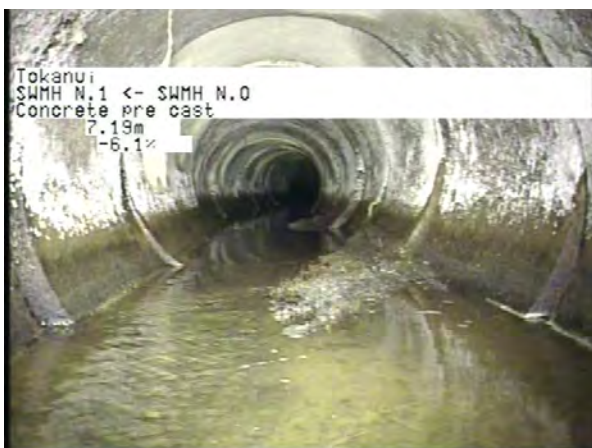
MH N.0 To MH  
N.1\_c7232d6d-8ca5-4339-b763-ab7e100d83d2\_20230406\_155248\_798.jpg, 00:01:59, 7.19m

| 1:301 | m + | OC | Observation | MPEG | Photo | Score |
|---|---|---|---|---|---|---|
| | 7.19 | JFL | Joint faulty, major cracking or spalling, likely through the pipe wall from 3 o'clock to 7 o'clock / Roots protruding joint | 00:01:59 | MH N.0 To MH N.1_c7232 | 25 |

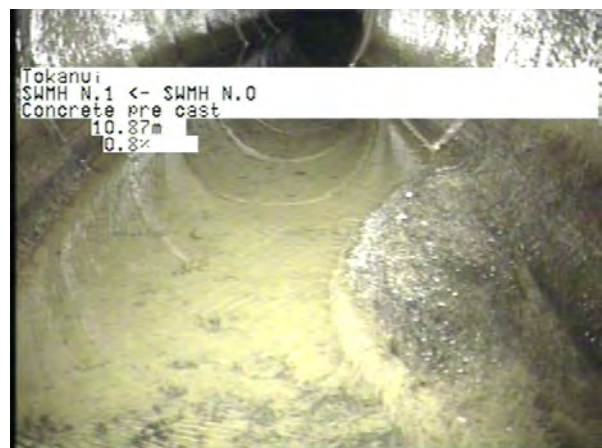
MH N.0 To MH  
N.1\_11209ceb-76f4-48d7-87bc-2711dad56384\_20230406\_155403\_423.jpg, 00:03:01, 10.87m

| 1:301 | m + | OC | Observation | MPEG | Photo | Score |
|---|---|---|---|---|---|---|
| | 10.87 | JFL | Joint faulty, major cracking or spalling, likely through the pipe wall from 3 o'clock to 6 o'clock / Roots protruding joint | 00:03:01 | MH N.0 To MH N.1_11209 | 25 |

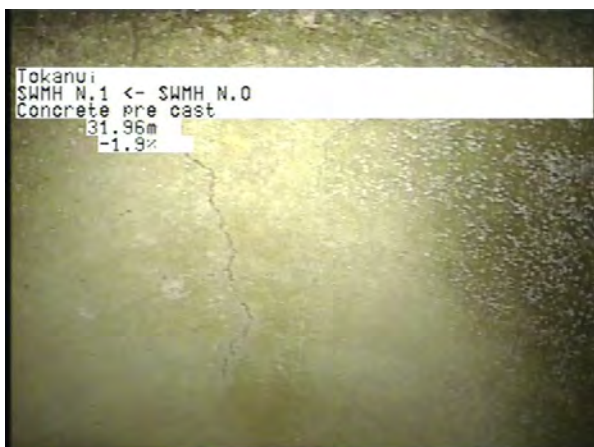
MH N.0 To MH  
N.1\_30d3853e-2439-4199-8db5-d60147d27aa8\_20230406\_160002\_120.jpg, 00:07:54, 31.96m

| 1:301 | m + | OC | Observation | MPEG | Photo | Score |
|---|---|---|---|---|---|---|
| | 31.96 | CLS | Crack longitudinal, small, visible but not open at 12 o'clock | 00:07:54 | MH N.0 To MH N.1_30d38 | 3 |

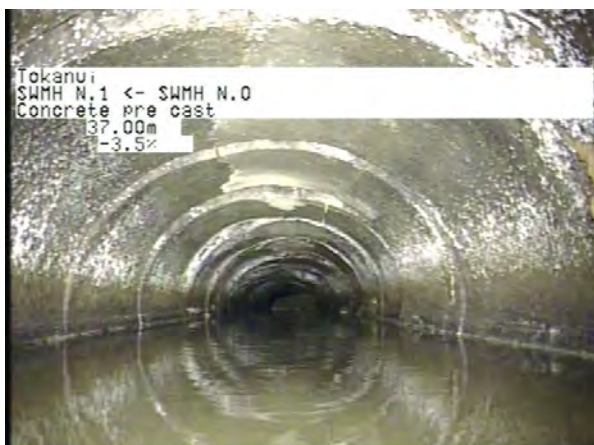
MH N.0 To MH  
N.1\_b35e9991-e497-44ad-afd6-10aac7df1d05\_20230406\_160131\_447.jpg, 00:09:07, 37.00m

| 1:301 | m + | OC | Observation | MPEG | Photo | Score |
|---|---|---|---|---|---|---|
| | 37.00 | JFS | Joint faulty, minor cracking or spalling from 12 o'clock to 11 o'clock / All joints | 00:09:07 | MH N.0 To MH N.1_b35e9 | 1 |

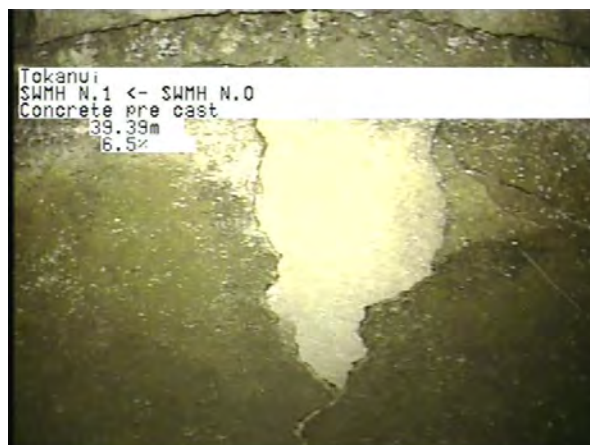
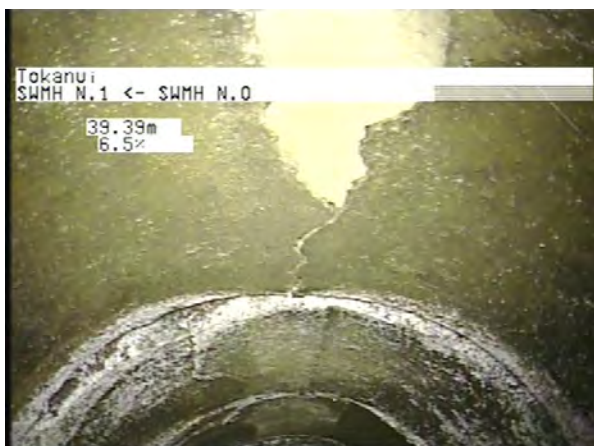
| 1:301 | m + | OC | Observation | MPEG | Photo | Score |
|---|---|---|---|---|---|---|
| | 39.39 | PBM | Pipe broken, damage extends 10% - 25% of circumference, displaced by less than half the pipe wall thickness from 11 o'clock to 1 o'clock | 00:10:07 | MH N.0 To MH N.1_f2864f | 30 |

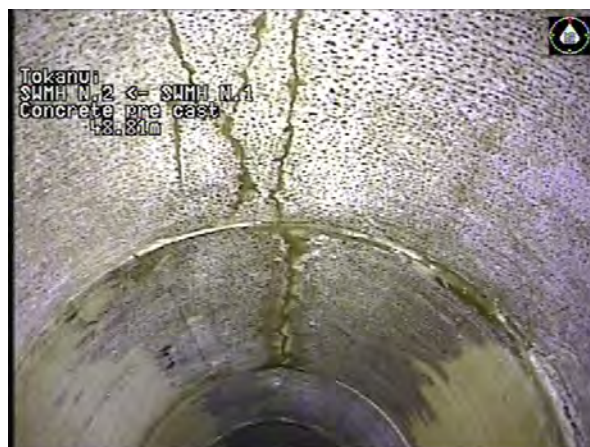
MH N.1 To MH  
N.2\_5871115d-83dd-4e24-b180-30adad29c29d\_20230424\_1  
00033\_719.jpg, 00:12:48, 48.81m

| 1:461 | m + | OC | Observation | MPEG | Photo | Score |
|---|---|---|---|---|---|---|
| | 48.81 | CLM | Crack longitudinal, medium, crack open but there is no evidence that the crack extends to the outside wall at 12 o'clock | 00:12:48 | MH N.1 To MH N.2_58711 | 15 |

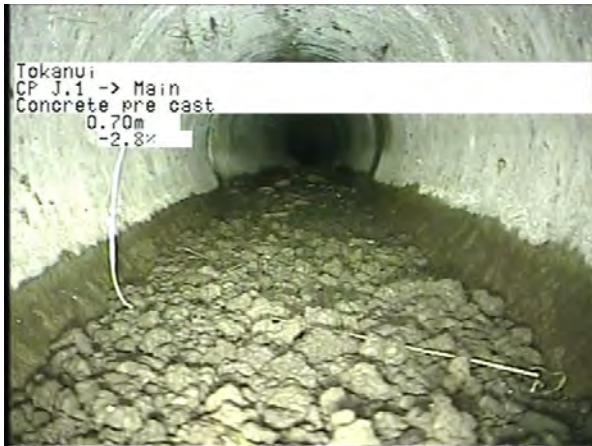
CP J.1 To  
Main\_d4033b3c-ad8c-4d5a-ab4d-ad89e06926d9\_20230327\_125649\_207.jpg, 00:00:18, 0.70m

| Comments | | | | | | |
|---|---|---|---|---|---|---|
| | 0.70 | S01 DES | Debris silt, small, clear diameter reduced by less than 10%, start | 00:00:18 | CP J.1 To Main_d403 3b3c-ad8c | |

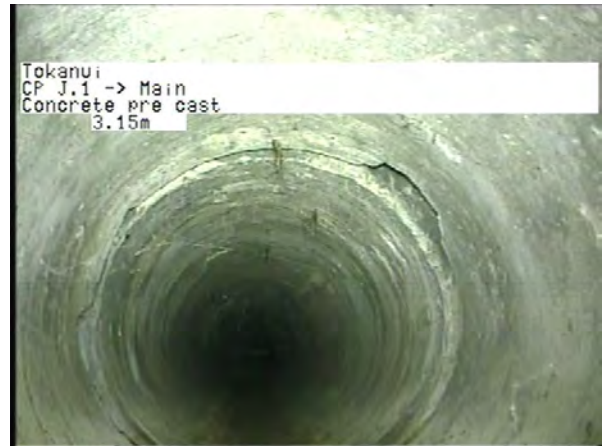
CP J.1 To  
Main\_12aa38e7-de58-49df-8560-95b462b03d59\_20230327\_125738\_184.jpg, 00:00:57, 3.15m

| Comments | | | | | | |
|---|---|---|---|---|---|---|
| | 3.15 | JFS | Joint faulty, minor cracking or spalling from 1 o'clock to 9 o'clock | 00:00:57 | CP J.1 To Main_12aa 38e7-de58 | 1 |

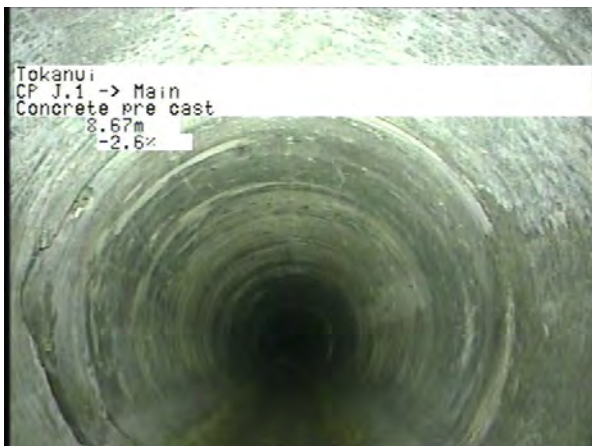
CP J.1 To  
Main\_5be21a3c-ac2a-4955-96c5-c1514c1df63f\_20230327\_125954\_613.jpg, 00:03:06, 8.67m

| Comments | | | | | | |
|---|---|---|---|---|---|---|
| | 8.67 | JFS | Joint faulty, minor cracking or spalling from 8 o'clock to 10 o'clock | 00:03:06 | CP J.1 To Main_5be2 1a3c-ac2a | 1 |

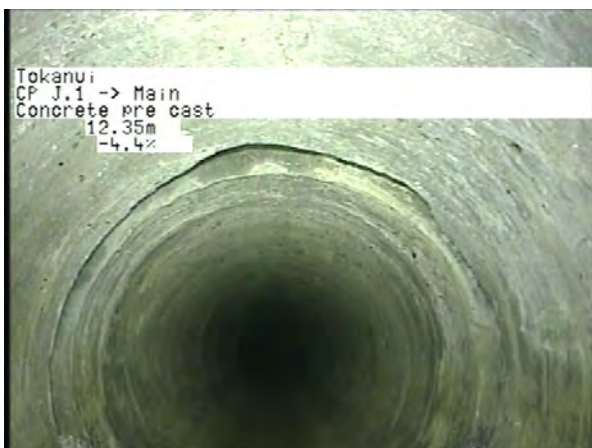
CP J.1 To  
Main\_04e528a1-f5c8-42f0-929d-68fad9dbd7fa\_20230327\_130139\_352.jpg, 00:04:35, 12.35m

| Comments | | | | | | |
|---|---|---|---|---|---|---|
| | 12.35 | JFS | Joint faulty, minor cracking or spalling from 11 o'clock to 1 o'clock | 00:04:35 | CP J.1 To Main_04e5 28a1-f5c8- | 1 |

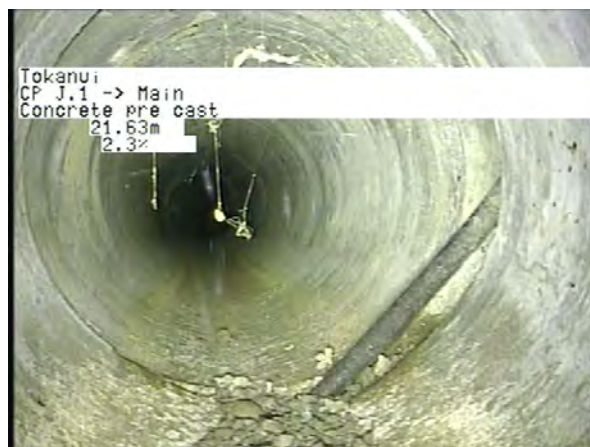
CP J.1 To  
Main\_be7a1704-4782-4de7-878e-bddef75a6674\_20230327\_1  
30558\_456.jpg, 00:07:42, 21.63m

| Comments | | | | | | |
|---|---|---|---|---|---|---|
| | 21.63 | JFL | Joint faulty, major cracking or spalling, likely through the pipe wall from 3 o'clock to 6 o'clock / Seal visible | 00:07:42 | CP J.1 To Main_be7a 1704-4782 | 25 |

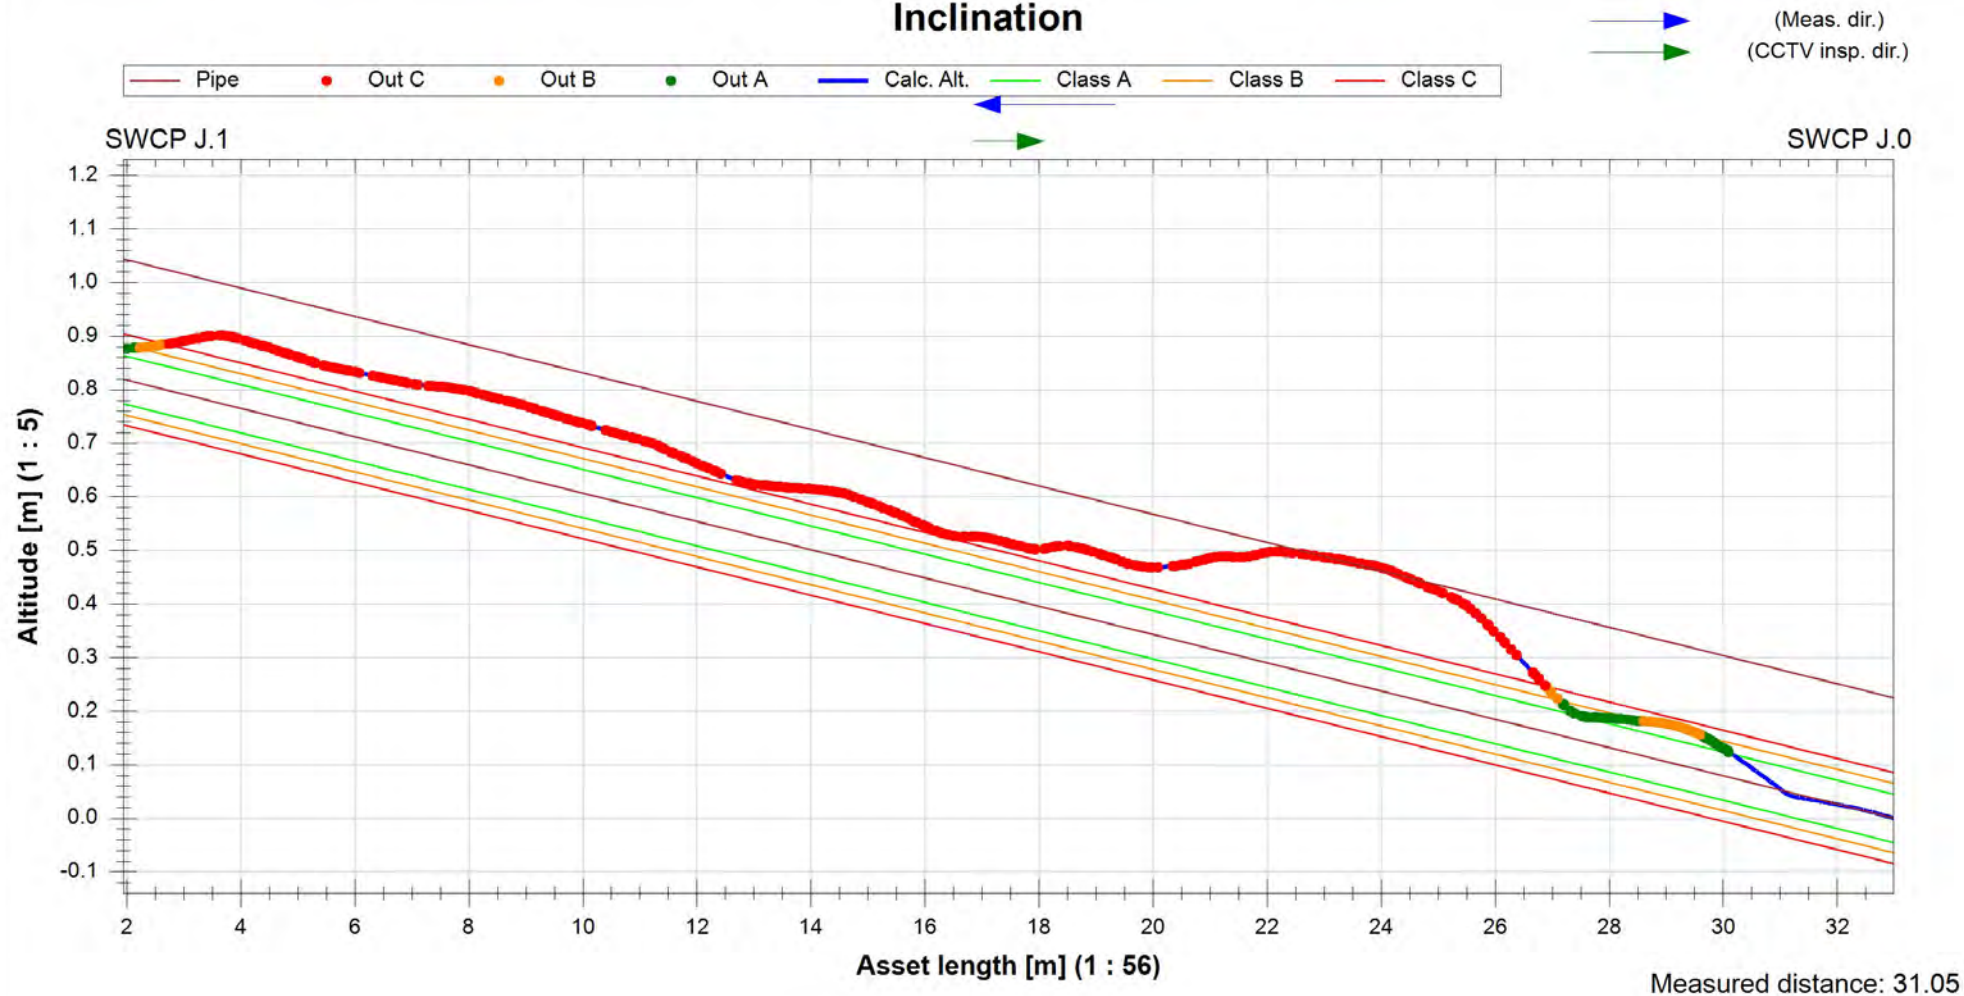
### Inclination

| Asset No.<br>CP J.1 To CP J,0 | Date<br>27/03/2023 | Time<br>12:56 pm | Operator<br>CST Group | Town or Suburb<br>Tokanui | Road | Setup<br>Upstream node | Surveyed Length<br>31.05 m |
| Shape<br>Circular pipe | Dia/Height<br>225 mm | Width<br>225 mm | U/S Node<br>SWCP J.1 | D/S Node<br>SWCP J.0 | Start altitude<br>0.000 m | End altitude<br>0.876 m | Measured Inc<br>-2.822 % |
