## Remediation of Former Tokanui Hospital Site

FORMER TOKANUI HOSPITAL  
DEMOLITION AND REMEDIATION  
REMEDIAL OPTIONS REPORT

## FORMER TOKANUI HOSPITAL DEMOLITION AND REMEDIATION

### REMEDIAL OPTIONS REPORT

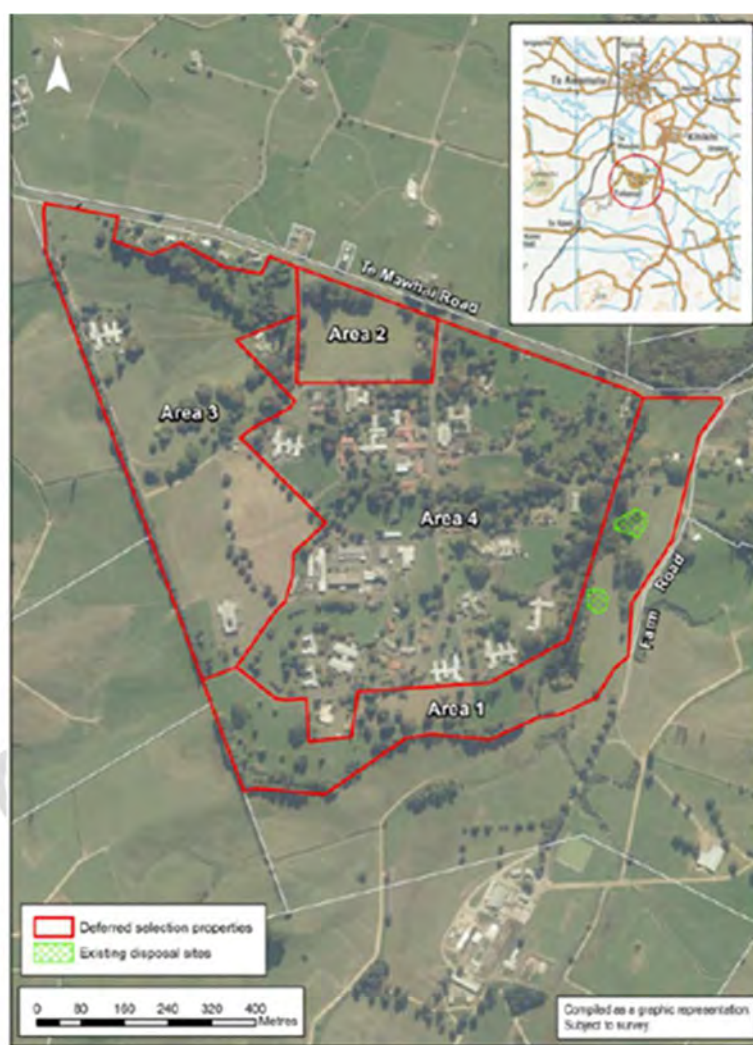
**Figure 1: Site location and extent showing 4 deferred selection properties (refer section 4.3.1 for explanation)**

The former Tokanui Psychiatric Hospital (the Site) is approximately 80 hectares (ha) in area and is located approximately 14km southeast of Te Awamutu, Waikato. It contains 74 buildings, a decommissioned wastewater treatment plant, swimming pool, eight substations, closed landfill (also referred to as the 'existing disposal site') and substantial roading and underground infrastructure and services. The buildings on the site contain some hazardous materials, including friable asbestos and lead-based paint and are in varying states of disrepair. The site location and extent is shown in Figure 1 below.

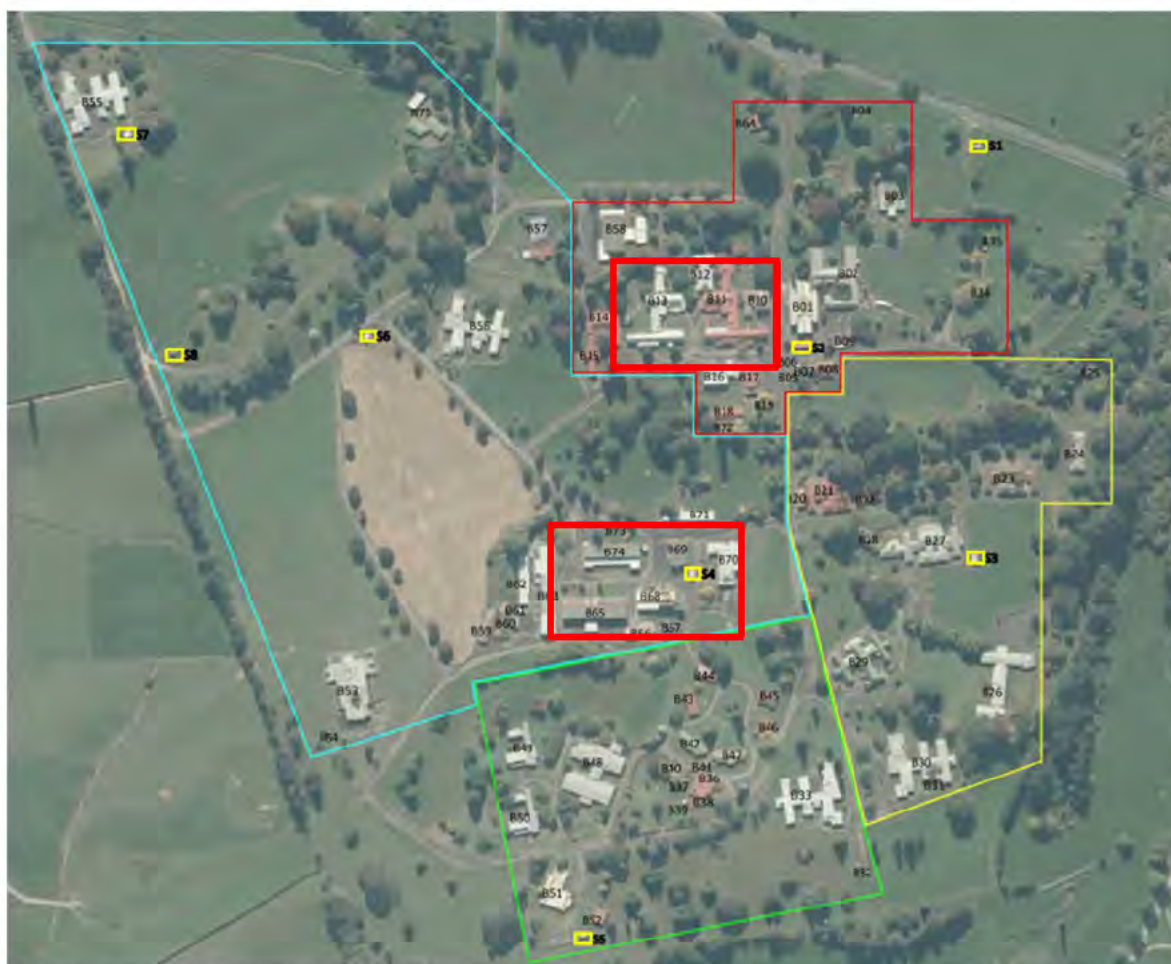
**Figure 8: Main Building Areas (red rectangles) considered for Backfill of Low-Level Contaminated Soils**

In summary, this assessment shows that the low-level contaminated soil can be placed within a localised area, using one of the options listed above. The backfilling could be concentrated into a very localised area, if the entire building footprints are excavated out for this purpose along with adjacent paved areas and potentially associated pervious areas. The most suitable area is considered to be the former industrial area, due to the building and paving/roading density in this area being the highest across the entire Site.

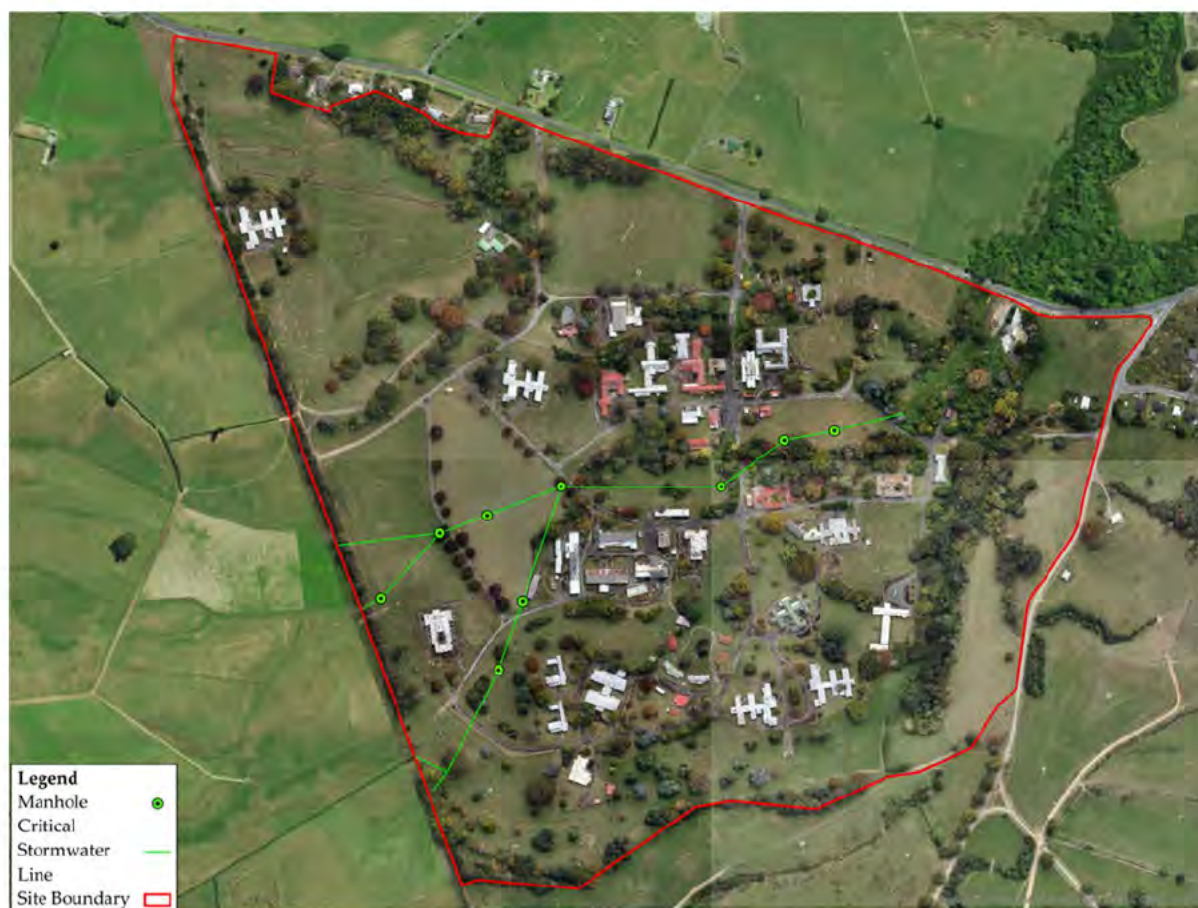
**Figure 19: Tokanui Hospital Site – Current Trunk Stormwater Reticulation conveying upgradient runoff through Site**

It is preferable that any backfill area or blended low level contaminated soil area or new containment cell is not located over the trunk main stormwater drainage system or in close proximity to any reinstated watercourse.
